Cascade Metro Park Cuyahoga River Restoration Valley View Phase 2 (NA16NMF4630341)

Post-Construction Monitoring Report: Year 2 (2022)

January 2023

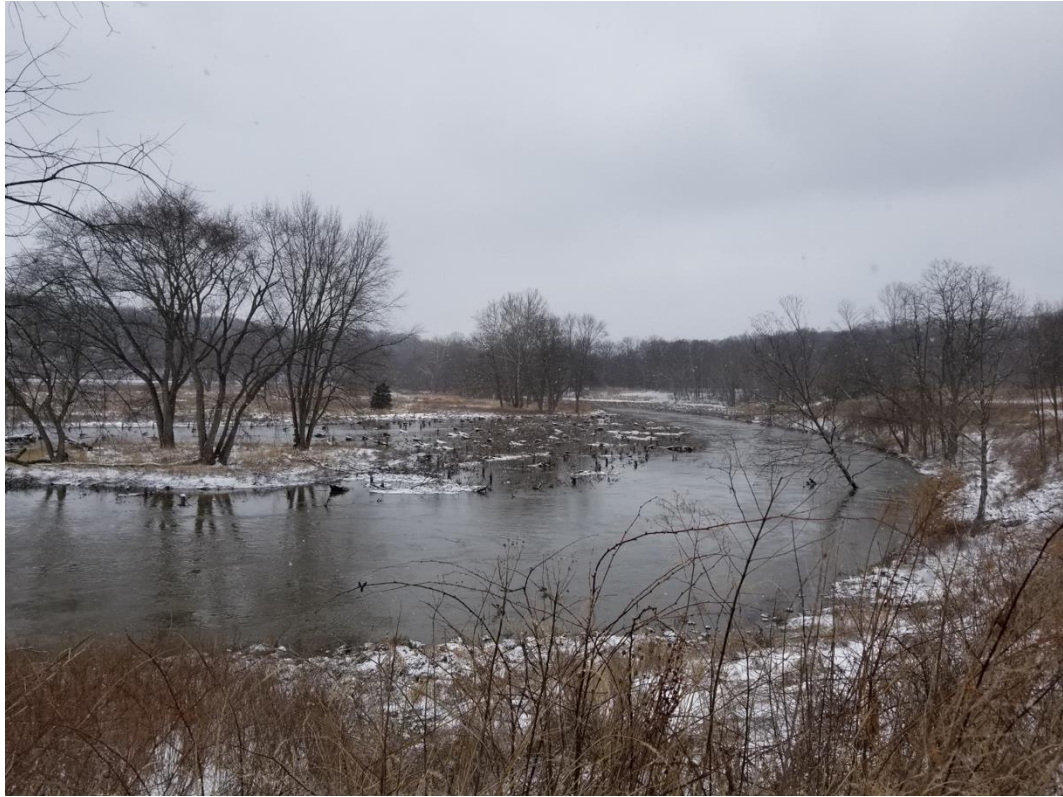
Two major flooding events were recorded in 2022, February 18 and March 8. Photos were taken of the flooding events and the floodplain is behaving as designed and desired. Discharges above ~3,800 cubic feet per second will expand the river into the restored floodplain and potentially alleviate downstream flooding events.

Photo 1: Flooding Event, Feb. 18 at Valley View Showing River Elevations and Debris Accumulation

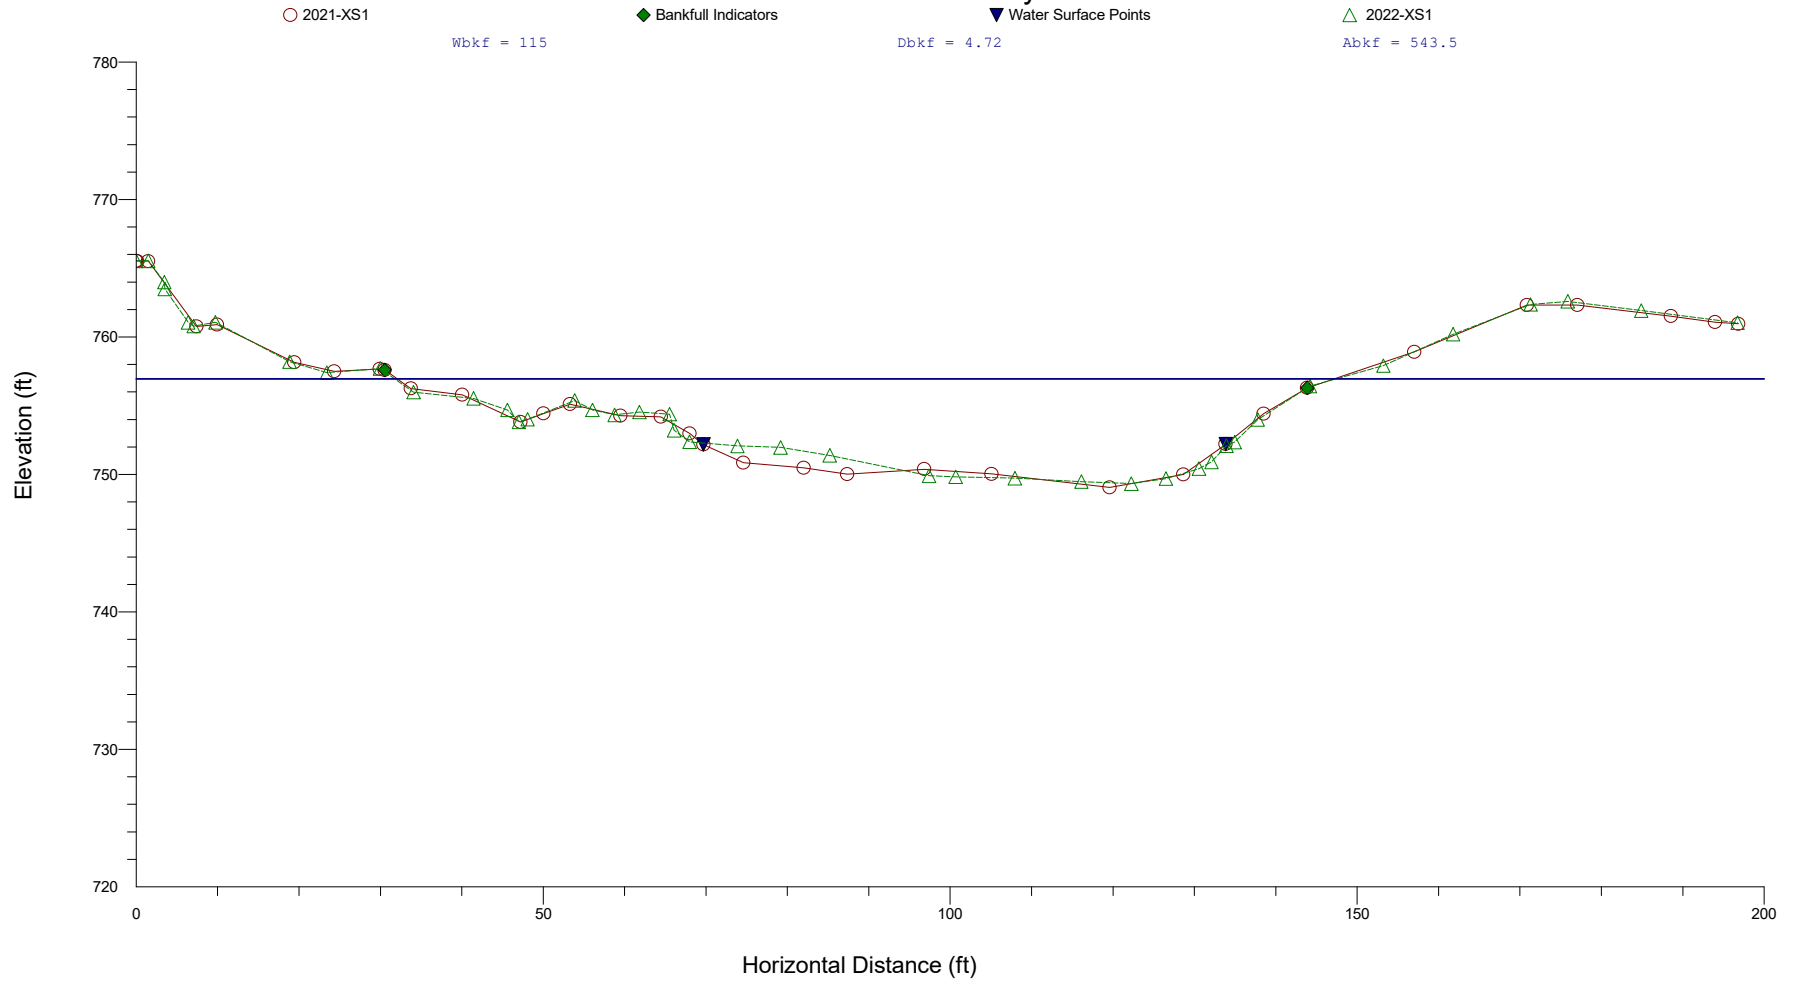
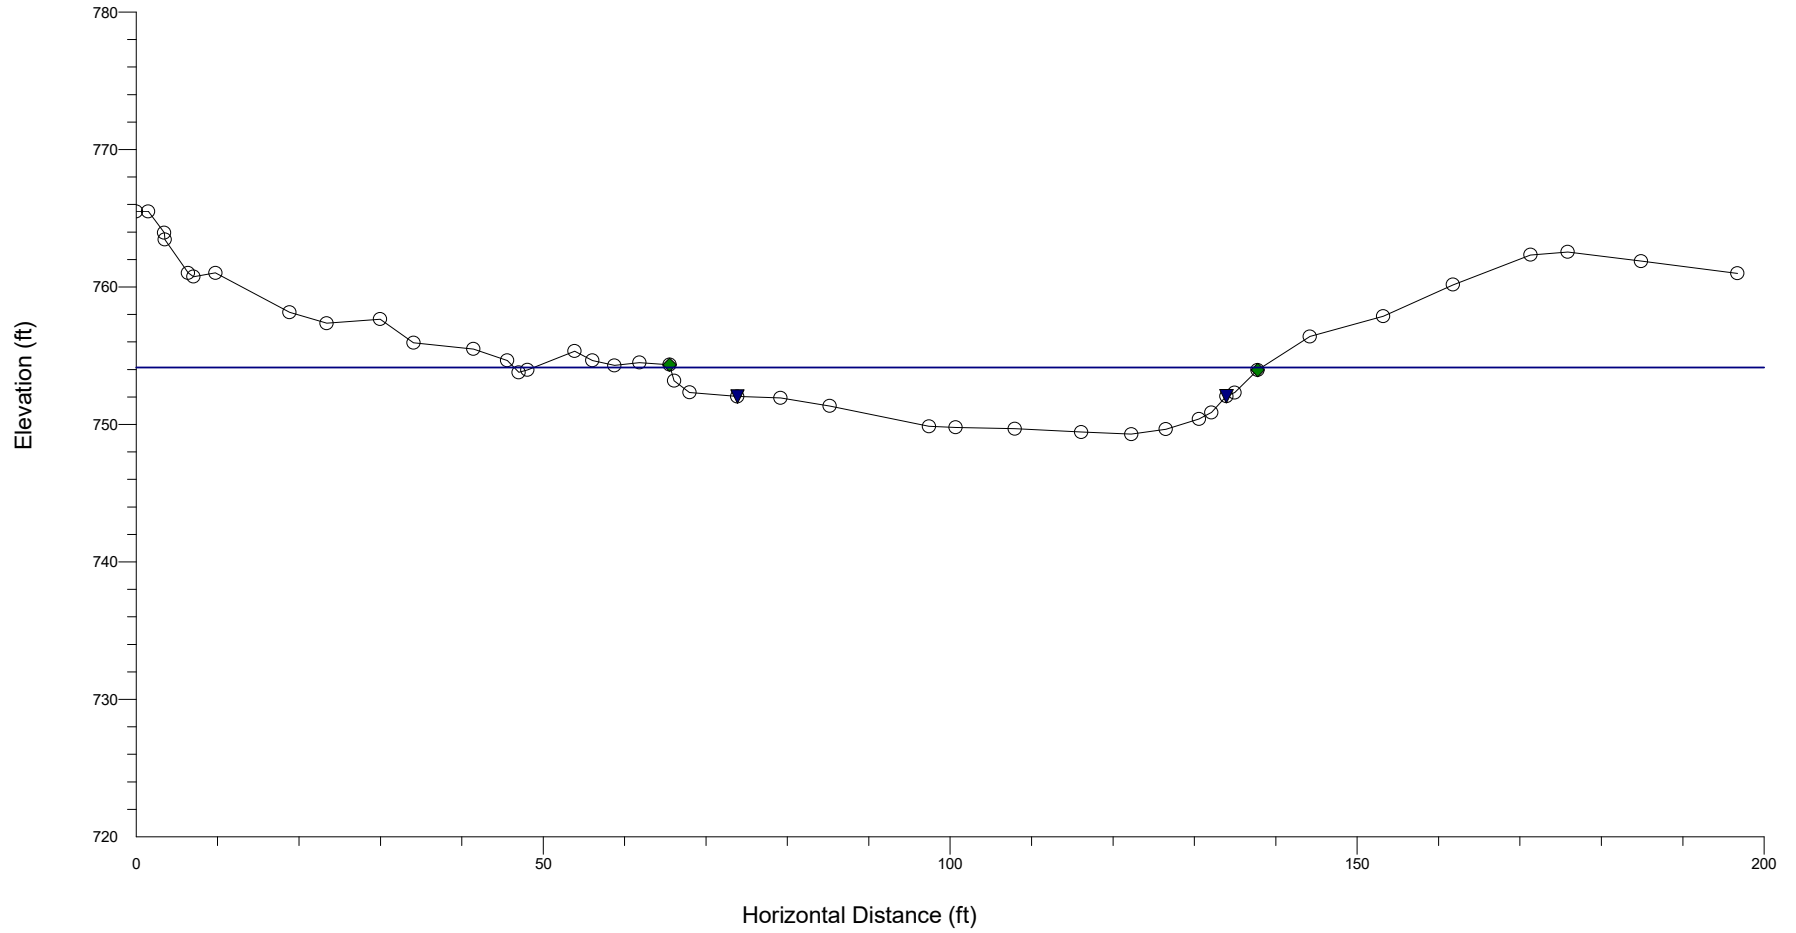
XS1: 2021 & 2022 Overlay

Comparison between the Year 1 (2021) and Year 2 (2022) cross section data shows very little difference indicating a stable bed load and, hopefully, a completed restoration of the Cuyahoga River in this park.
