Monitoring Report

TOE OF KATHERINE STREET PENINSULA

Buffalo, NY

2018

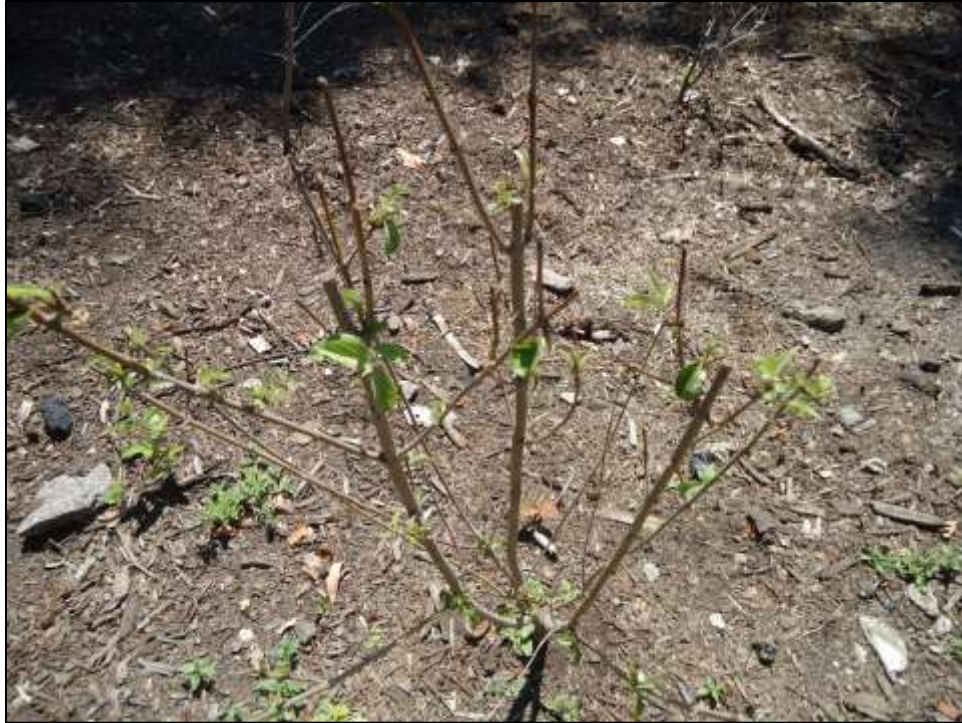
[Table 3-1](#) shows plant composition and structure, process, and environment grading factors. Plant richness and plant community structure have improved due to plantings. Habitat improvement efforts included the installation of 1,700 native trees and shrubs composed of twenty-six species. Gomez and Sullivan found that many of the planted trees and shrubs were dead or dying, but some have survived. A staff person from the planting contractor was on site during the monitoring visit, and he was recording which installed plants needed to be replaced. [Figures 3-1](#) and [3-2](#) show examples of planted shrubs and saplings that appeared dead or dying. [Table 3-2](#) lists plant species that were observed at the site.

Figure 3-1. Planted dogwood shrub

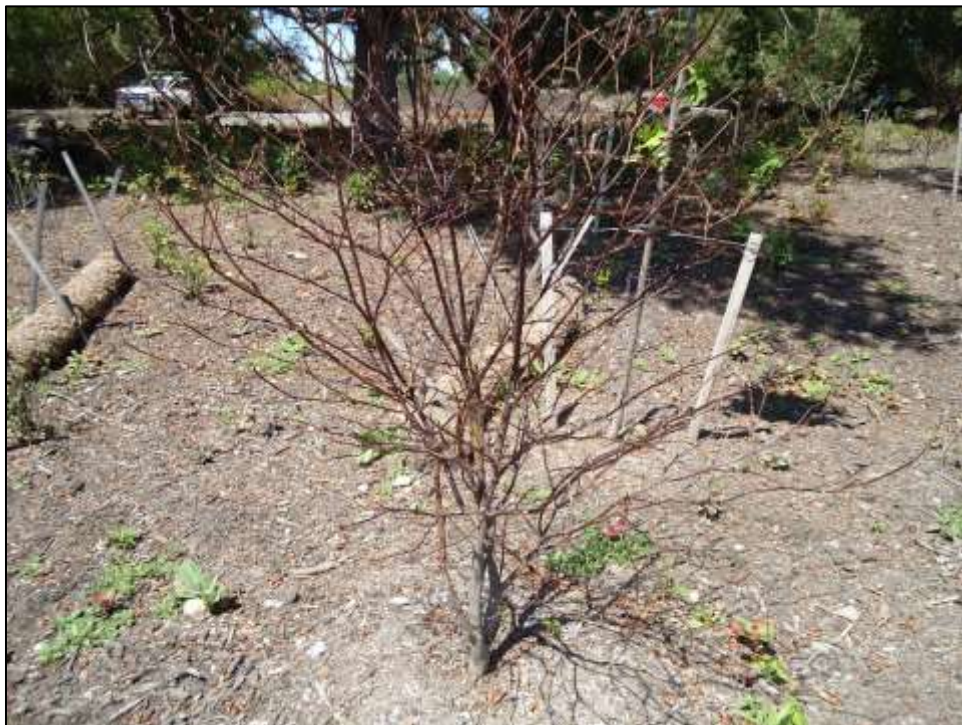
Figure 3-2. Dead installed alternate leaved dogwood shrub

Shrubs have been installed at approximately 2' OC, but they are not healthy. Many have few leaves. These should be replaced by the planting contractor.

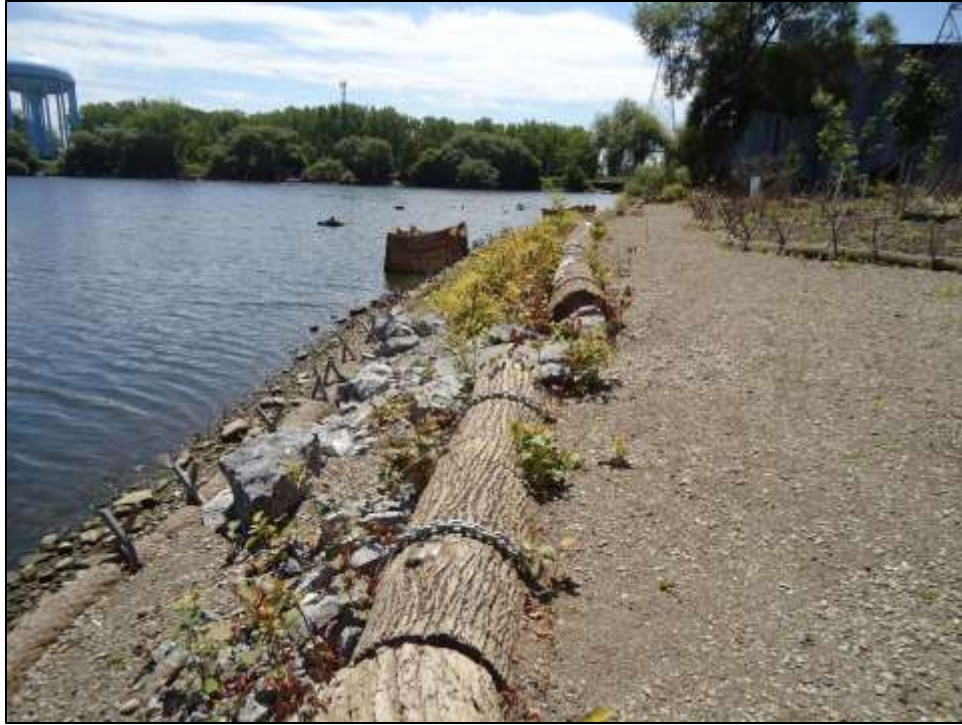
The shoreline along the Toe of Katherine Street Peninsula is stable, and erosion, classified on [Table 3-1](#) as "Lack of Erosion," improved from Low to High. This is due to regrading of the shoreline and installation tiered habitat logs and stones, which give the shoreline stability while also providing habitat and accessibility to and from the river for native animals. The habitat logs and stones all appeared to be in place and well secured and did not show signs of decay. The shoreline features complimented the emergent plantings that were installed near the site as part of a separate project. [Figure 3-3](#) shows an example of the shoreline. More photographs of the shoreline are included in [Appendix C](#). No erosion was visible at the time of monitoring.

Figure 3-3. Shoreline Restoration Area

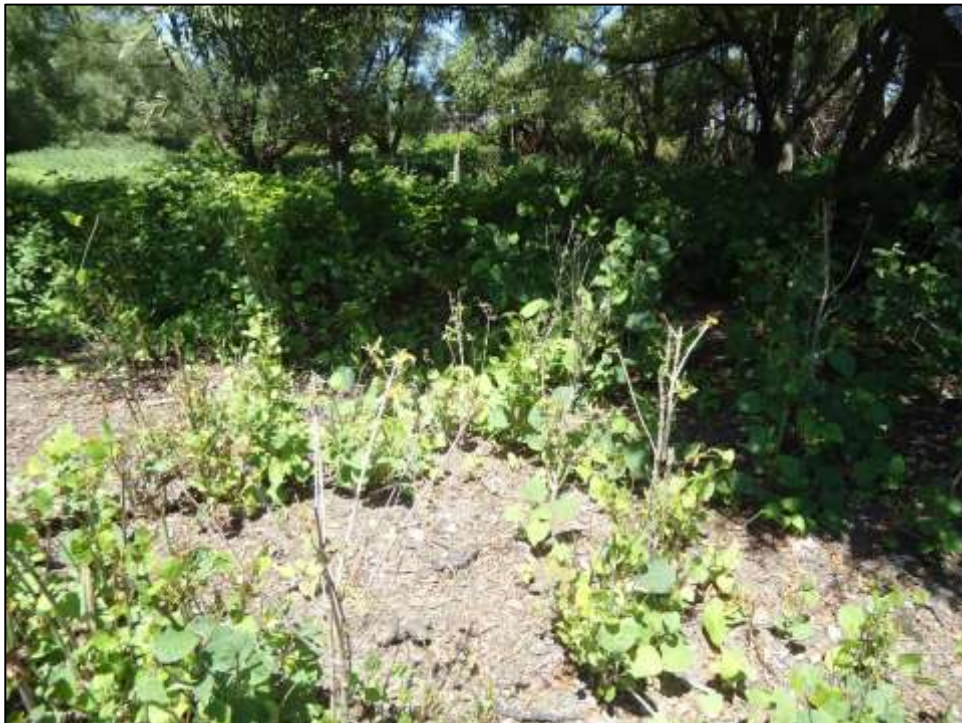
Understory regrowth dominated by invasive species

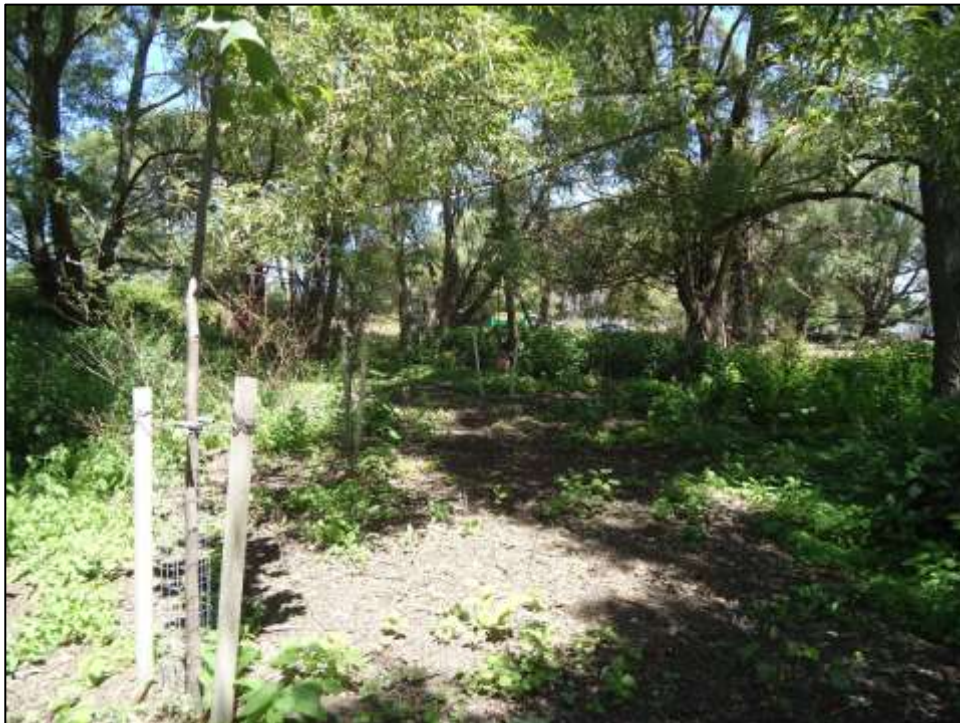
Dense stand of non-native catnip growing in the forest understory

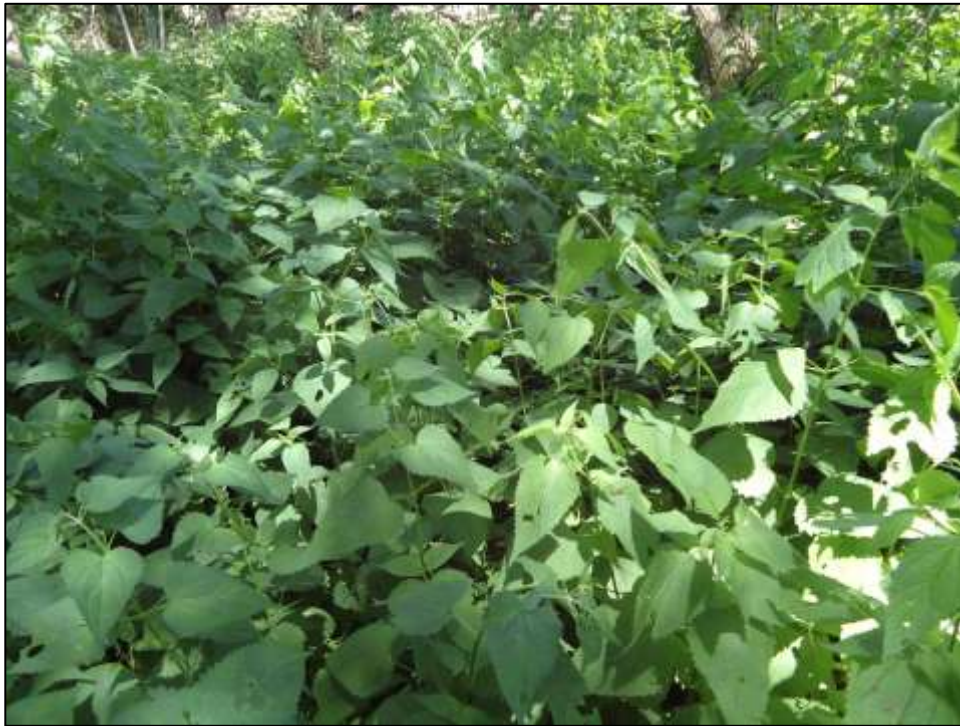
Invasive plant species, particularly Japanese knotweed, were reduced by herbicide treatments, but remained the abundant and dominant throughout the project area. Treated Japanese knotweed showed signs of significant regrowth. Based on Gomez and Sullivan's observations at other natural sights, routine management will be required to keep the knotweed stands from reestablishing.

Treated knotweed in the Premier Towing Extension Area

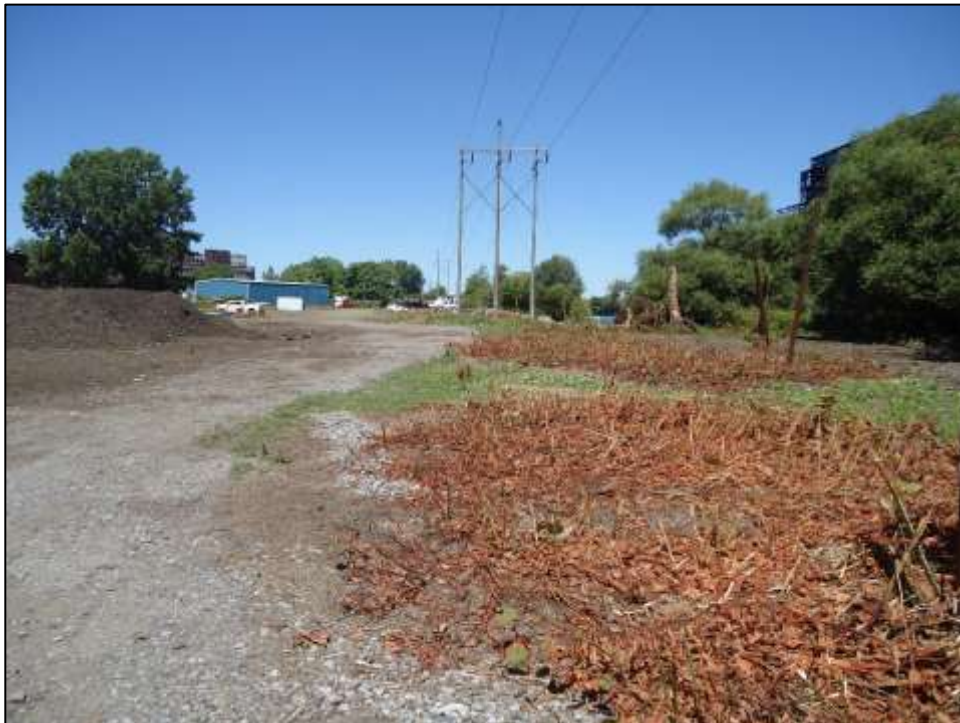
Treated knotweed in the Premier Towing Extension Area

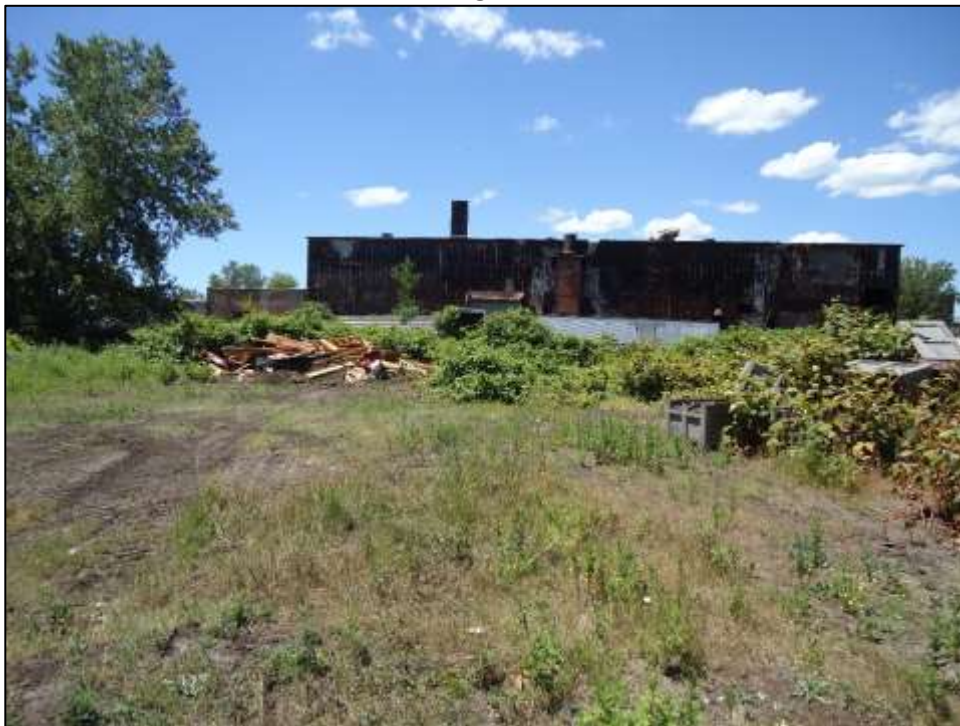
Knotweed and storage in the Premier Towing Extension Area

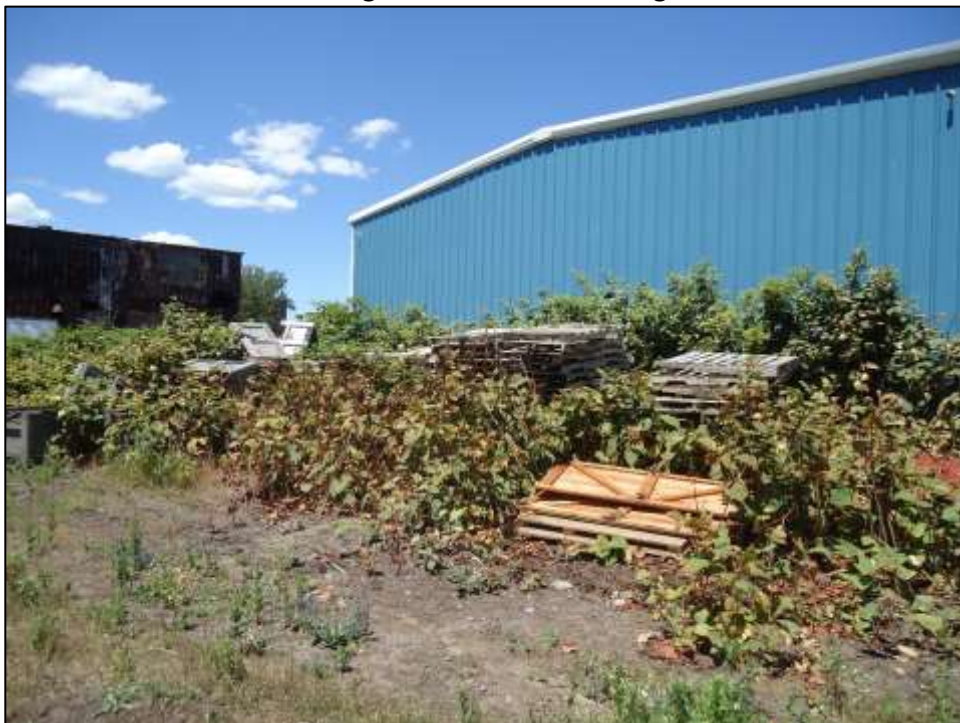
Knotweed in the Premier Towing Extension Area
