September 2018 Buffalo Motor Generator Corporation and Blue Tower Turning Basin Habitat Restoration

## Habitat Restoration Monitoring Report

Prepared for Buffalo Niagara Waterkeeper

Anchor QEA Engineering, PLLC 290 Elwood Davis Road, Suite 340 Liverpool, New York 13088

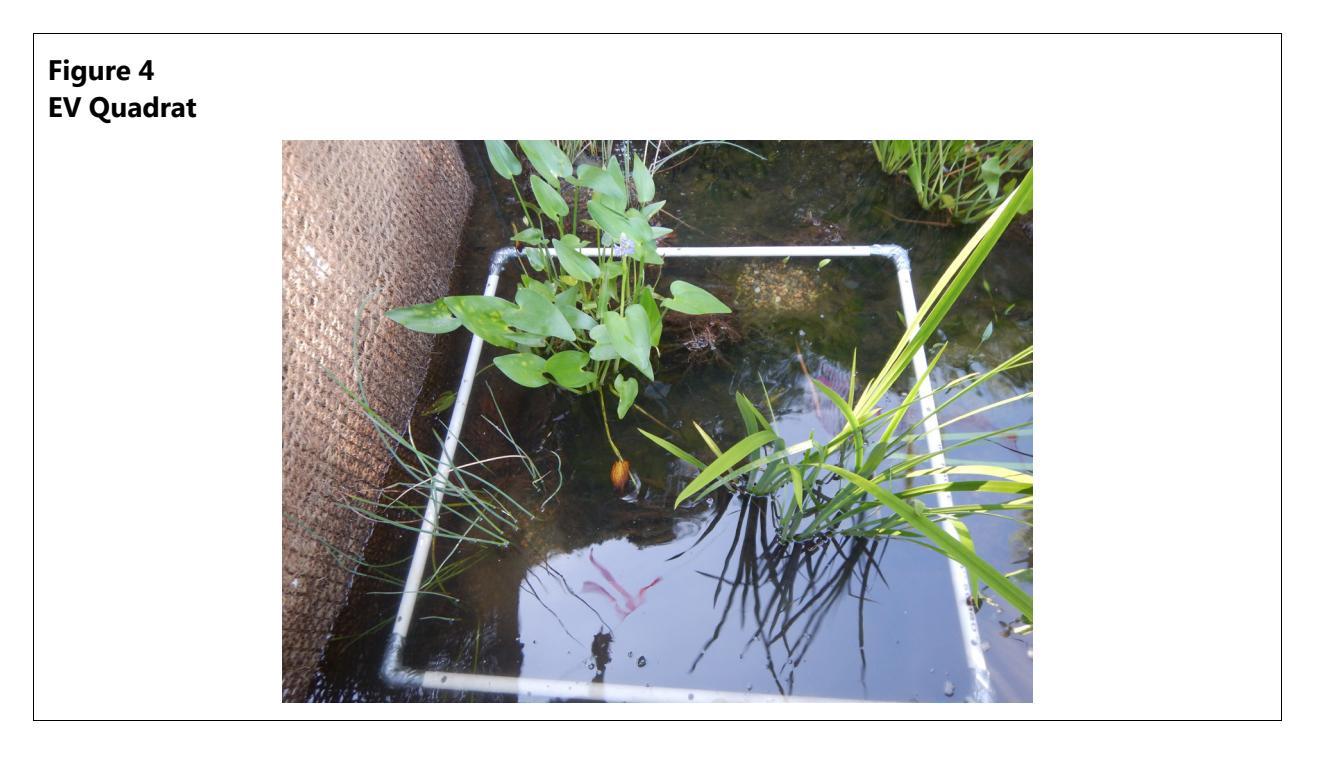
EV quadrat monitoring results are summarized in Table 1. Corresponding quadrat locations are shown on Figures 1-2 through 1-4 in Attachment 1. The recently installed rock sock plantings were generally in good condition in BTTB and fair condition in BMGC. Coverage within the planted polygons were generally consistent with conditions following initial planting, and plant stock was in visually good health with few apparent signs of stressors (e.g., disease, herbivory, algal growth). An example quadrat plot from the BTTB site is shown on Figure 4.

- All planted polygon areas were present and populated at the time of inspection. All planted species exhibited similar health and in some instances were expanding in coverage within the polygons. Estimated plant density varied from 20% to 60%, as expected from the point planting basis of the rock sock installations.
- Volunteer species outside of the polygons planted in 2018 were not observed in either project area.

- No invasive species were observed in the EV planting areas during the course of the monitoring event. Algal growth was observed on EV species in one quadrat of the BMGC site.
- There were no obvious signs of herbivory in the planted polygons. The perimeter controls and herbivory deterrent flagging will be left in place to continue to provide protection of the polygon areas until mid-October 2018.
- SAV species were observed in some of the EV quadrats.

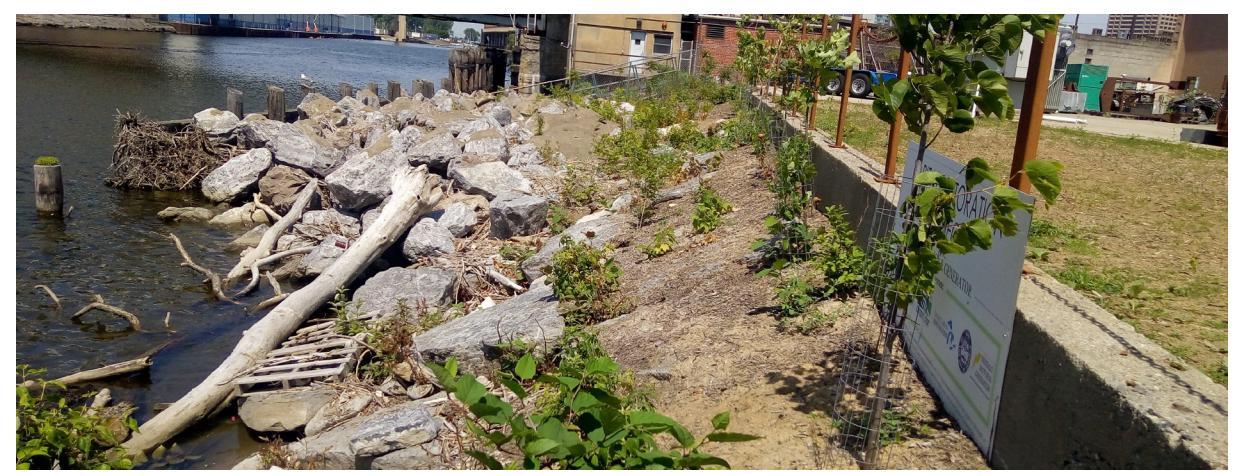
#### Figure 5 Riparian Planting Area

although some losses from the 2017 planting were observed. A photograph of the planting area is provided on Figure 5. The following are pertinent observations of this project area:

- Riparian vegetation species present were in good health, with tree species performing particularly well. Approximately 50% of shrub species survived. Shrub species were observed in the third of the planted crib structure closest to the shoreline.

- There were no visible signs of herbivory, and herbivory protection fencing around trees remained in place.
- At the time of the inspection, two monthly rounds of chemical herbicide treatment had taken place. Only trace Japanese Knotweed was observed and appeared to be emanating from the adjacent city-owned property downstream. Trace Tree of Heaven was also observed. Due to the proximity of some shrub species to the Japanese Knotweed populations, there appeared to be limited non-target species loss as a result of the herbicide treatment.

- The seeded meadow area continues to establish itself, and coverage at the time of the inspection was fair.
- Woody debris were observed along the shoreline of BMGC but did not appear to impact vegetation at higher elevations.
