Cascade Metro Park Cuyahoga River Restoration Valley View Phase 2 (NA16NMF4630341)

Post-Construction Monitoring Report: Year I (2021)

June 2022

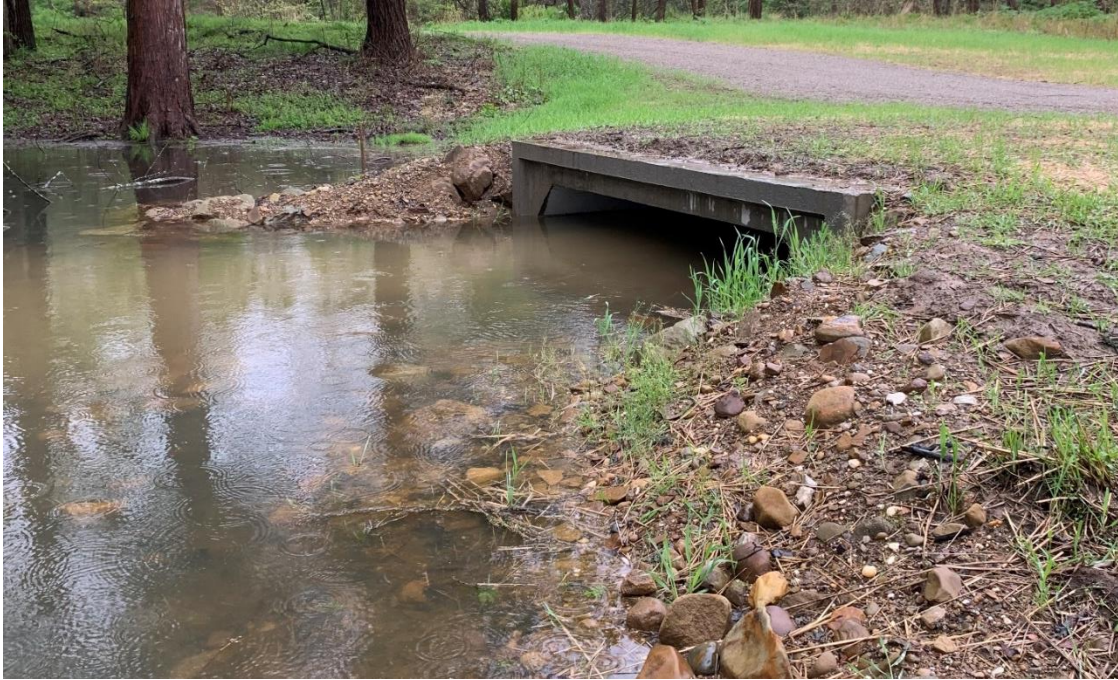
Photo 1: Point of Hydrologic Reconnection to the Cuyahoga River Functioning as Required

As part of the NOAA funding, a three-sided box culvert was installed under the existing access road and now permanent park trail to provide hydrologic connectivity with the Cuyahoga River and allow for fish passage upstream to the stream/wetland complex. This culvert does indeed connect approximately 15 acres of restored wetland and some 1,000 linear feet of restored headwater stream to the Cuyahoga River.

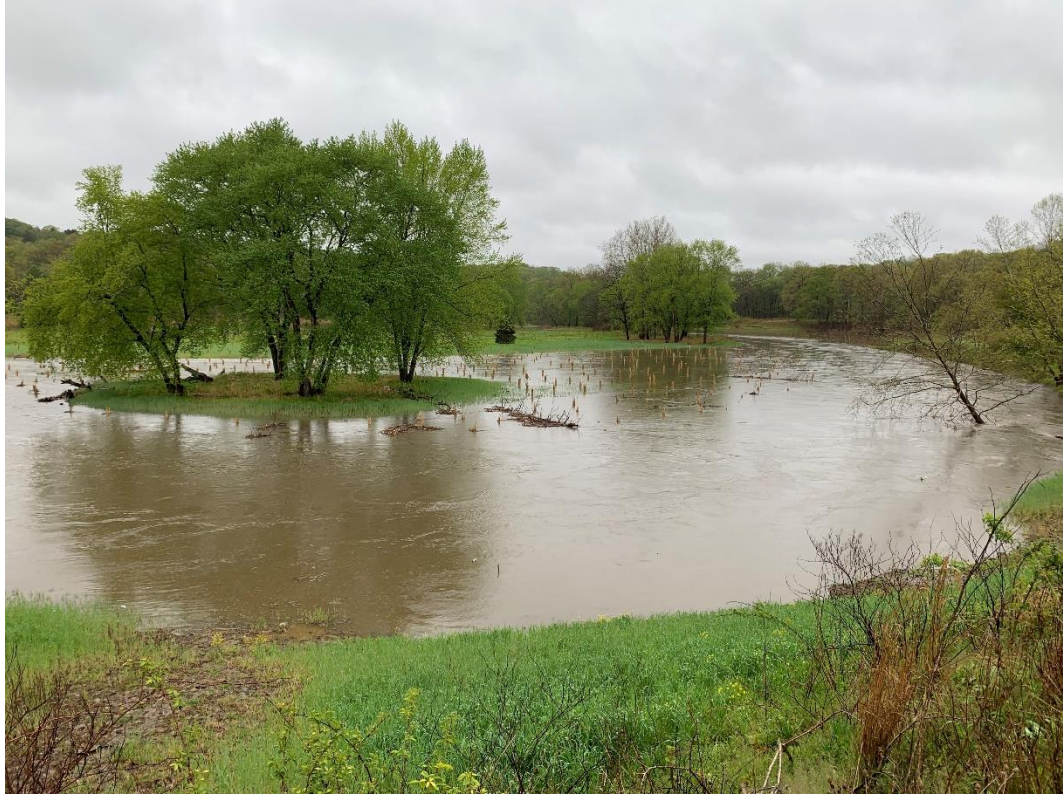
Photo 2: Flooding Event, May 9, 2021 at Valley View Showing River Elevations and Debris Accumulation

Two major flooding events were recorded in 2021, May 9 and July 18. Photos were taken May 9 to capture the Cuyahoga River breaking its previously entrenched banks to expand into the restored floodplain areas. Debris lines and original elevations can be seen in the photo. An additional flooding event took place on July 8, but the time-lapse cameras set to record the event were malfunctioning at that time and no photos were taken. This will be remedied for Year 2 (2022) monitoring by a combination of functioning flood monitors, USGS gauge, and on-site photography.

Recommendations for Continued Monitoring: Monitors will be re-deployed in 2022 and will be used to corroborate USGS data for Year 2 (2022). Time lapse cameras will be used in conjunction with flood monitors / USGS data to alert SMP staff to major flooding events and on-site photos will be taken as well.
