Muskegon Lake Nature Preserve

Herpetofauna Report

West Michigan Shoreline Regional Development Commission

Muskegon Lake Nature Preserve
 MERES Fish and Wildlife Habitat
 Restoration Project
 EXISTING CONDITIONS

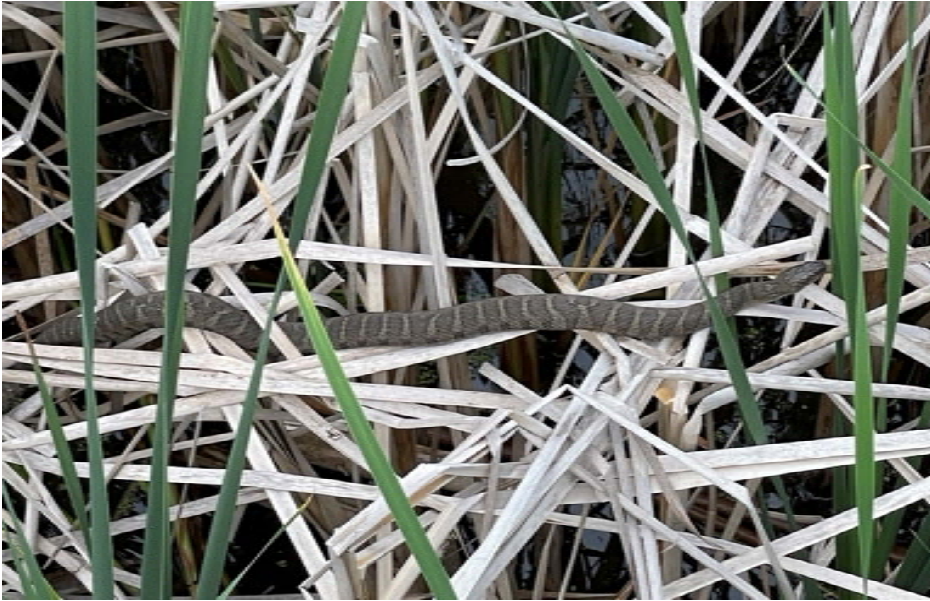
Image 2.4.4 Northern Water Snakes can be seen utilizing dead cattails along the Wilder River Trail as basking sites for thermoregulation.

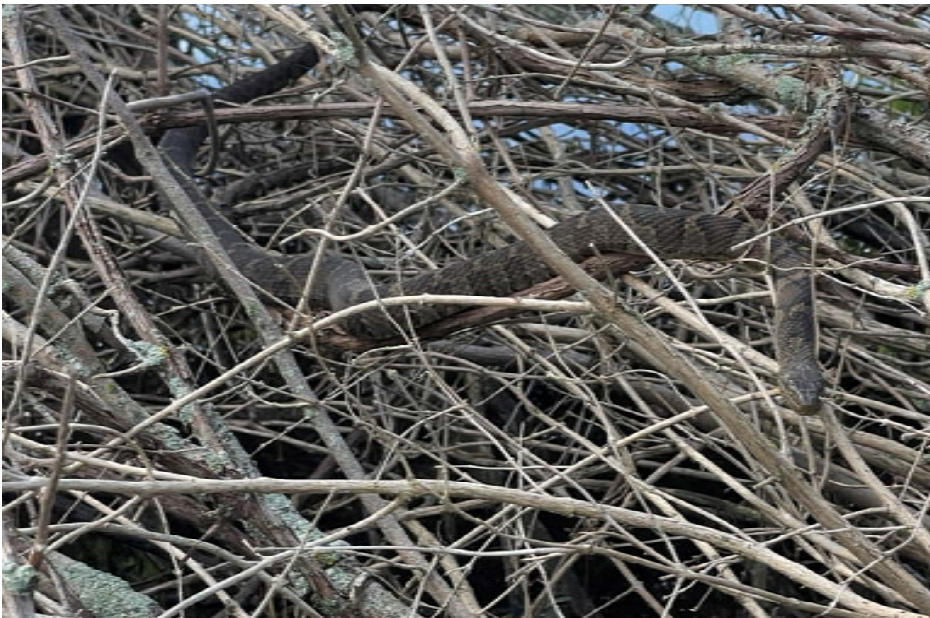
Image 2.4.5 Buttonbush throughout the Muskegon Lake Nature Preserve make excellent basking sites while providing protection from potential predators, making them a critical microhabitat feature.

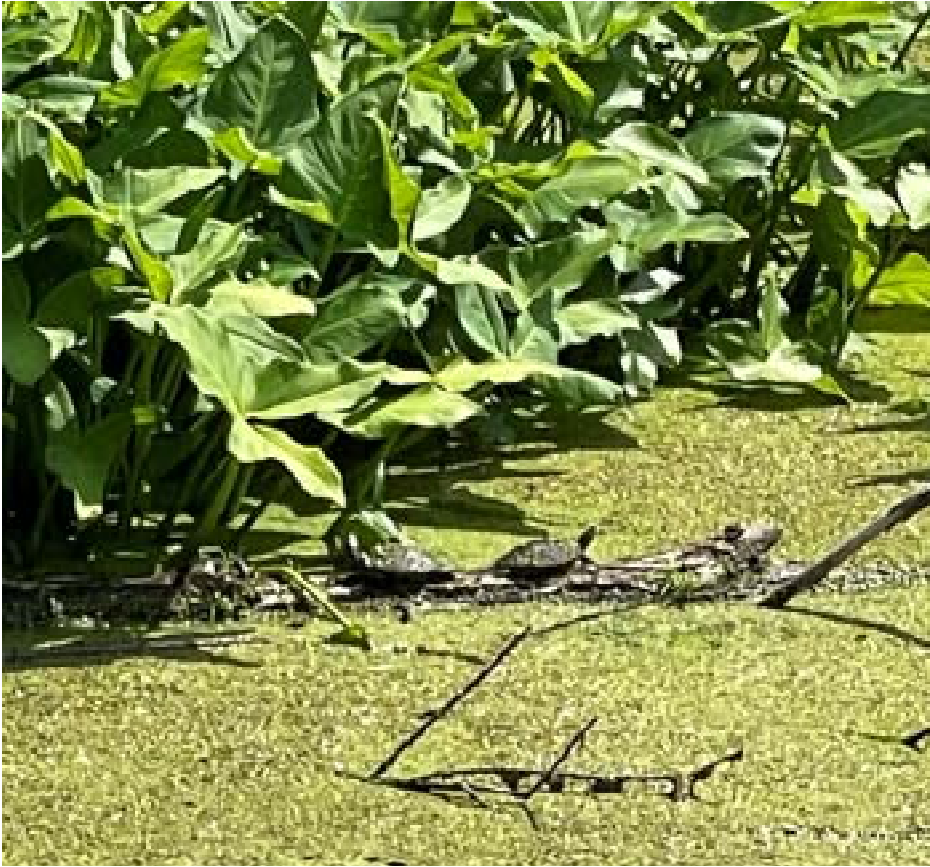
Image 2.4.6 Logs found in wetland areas around the nature preserve provide essential basking sites for northern map turtles like these and other turtle species to aid in maintaining an ideal body temperature.

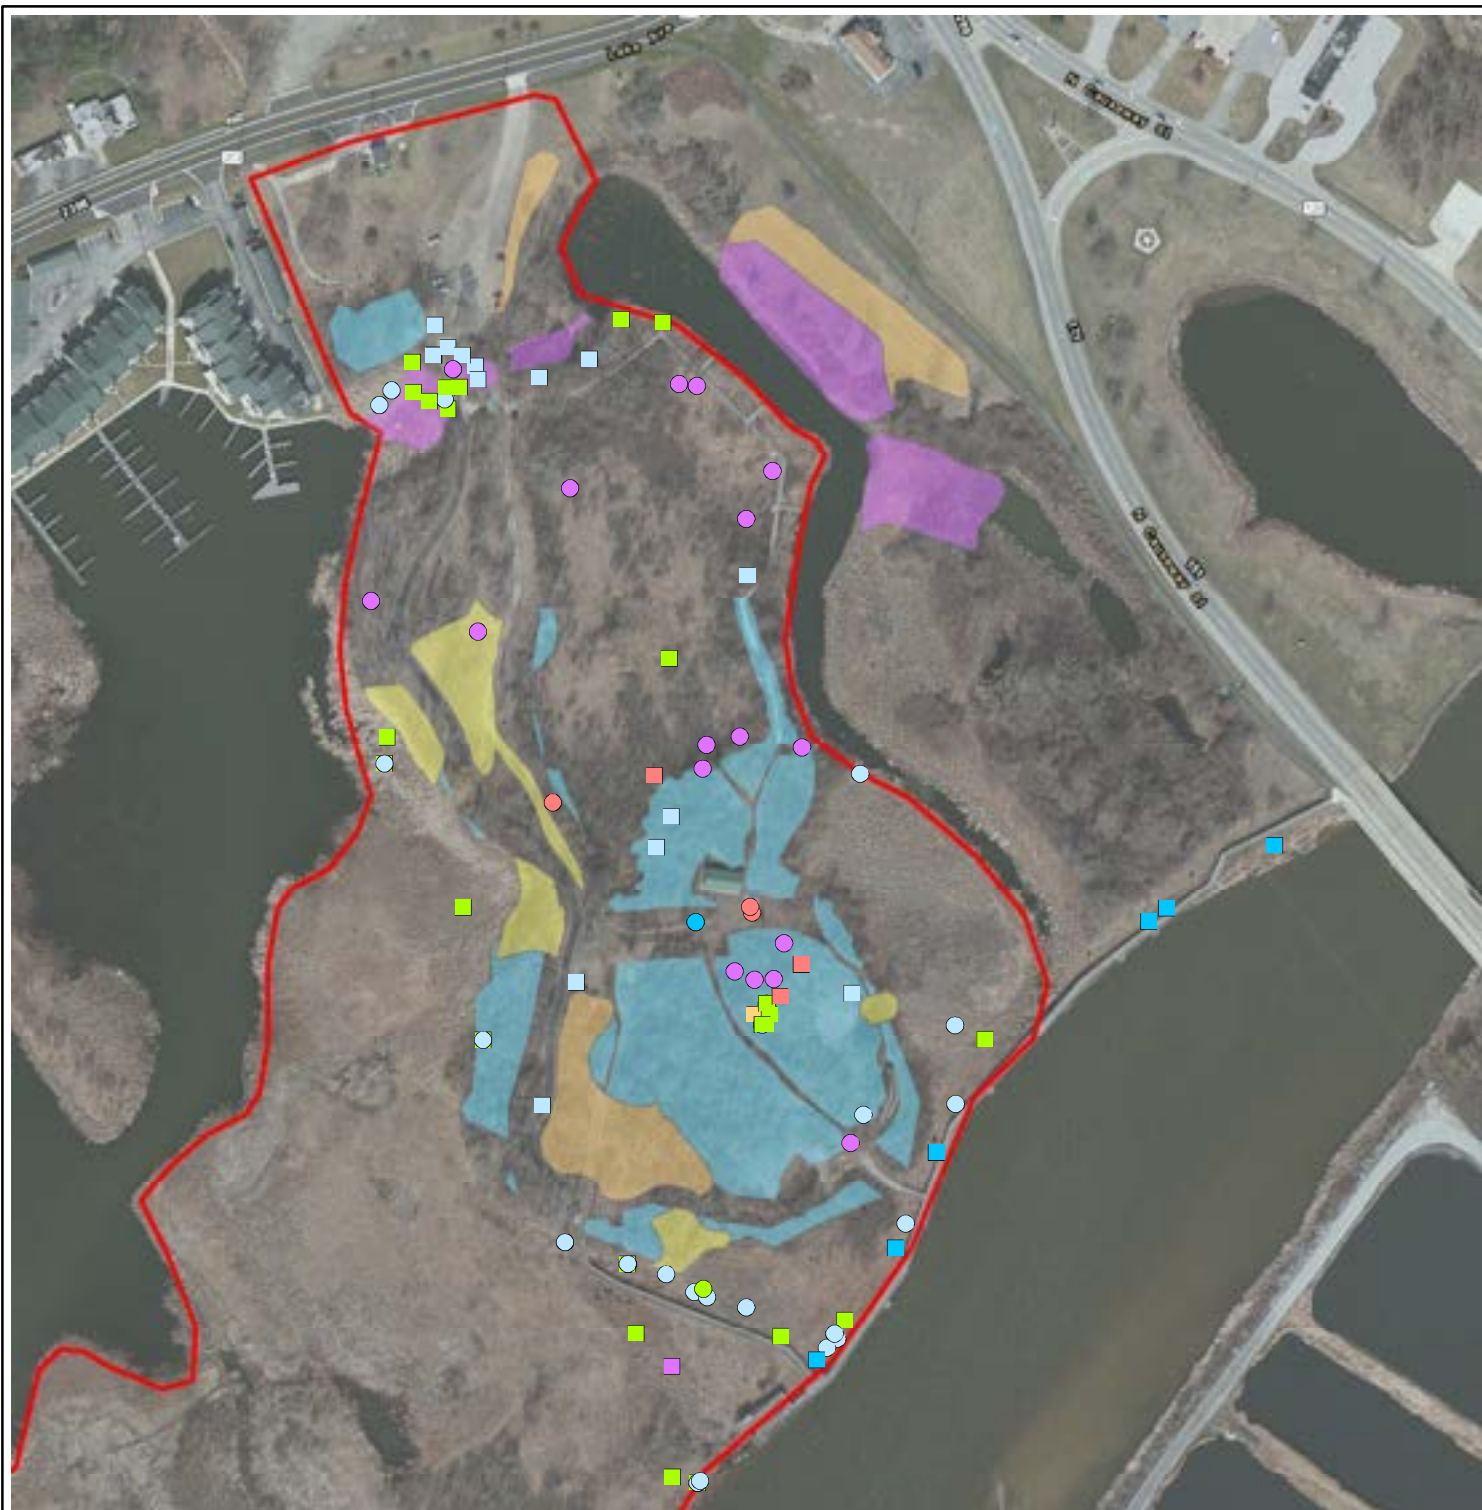
Restoration Area		
Floodplain Forest (0.86 ac)	American Toad	Northern Water Snake
Great Lakes Marsh (1.28 ac)	Blanding's Turtle	Painted Turtle
Mesic Northern Forest (4.00 ac)	Eastern Garter Snake	Tadpoles (unidentified)
Oak-Pine Barrens (1.23 ac)	Green Frog	Snapping turtle
Muskegon Lake Nature Preserve	Map Turtle	Turtle Nest
	Milk Snake	Bullfrog tadpole

During the July 5 visual encounter, surveyors visited the site two times, one survey in the afternoon (12:00 – 17:00) and once in the evening (20:30 – 22:00). During the afternoon survey, they observed two (2) Northern Water Snakes (*Nerodia sipedon*), thirty-one (31) Northern Map Turtles (*Graptemys geographic*), ten (10) Painted Turtles, three (3) Green Frogs, one (1) Eastern Garter Snake, and one (1) Eastern American Toad. In the evening survey, they visually encountered seven (7) Green Frogs. Herpetofauna in the July 5 survey were observed either swimming along the shoreline, hiding in vegetation, or basking on logs/branches. Occurrences were mapped and locations are shown in Figure 2.

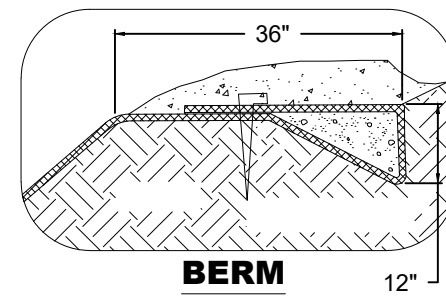
EROSION CONTROL BLANKET

BLANKETS/MATS INSTALLED
HORIZONTALLY ACROSS
SIDE SLOPES

1. SLOPE SURFACE SHALL BE FREE OF ROCKS, CLODS, STICKS AND GRASS. MATS/BLANKETS SHALL HAVE GOOD SOIL CONTACT.
2. APPLY PERMANENT SEEDING BEFORE PLACING BLANKETS
3. LAY BLANKETS LOOSELY AND USE WOODEN STAKES TO MAINTAIN DIRECT CONTACT WITH THE SOIL. DO NOT STRETCH.
