# **Cascade Metro Park Cuyahoga River Restoration Valley View Phase 2 (NAI6NMF463034I)**

**Post-Construction Monitoring Report: Year 3 (2023)**

**April 2024**

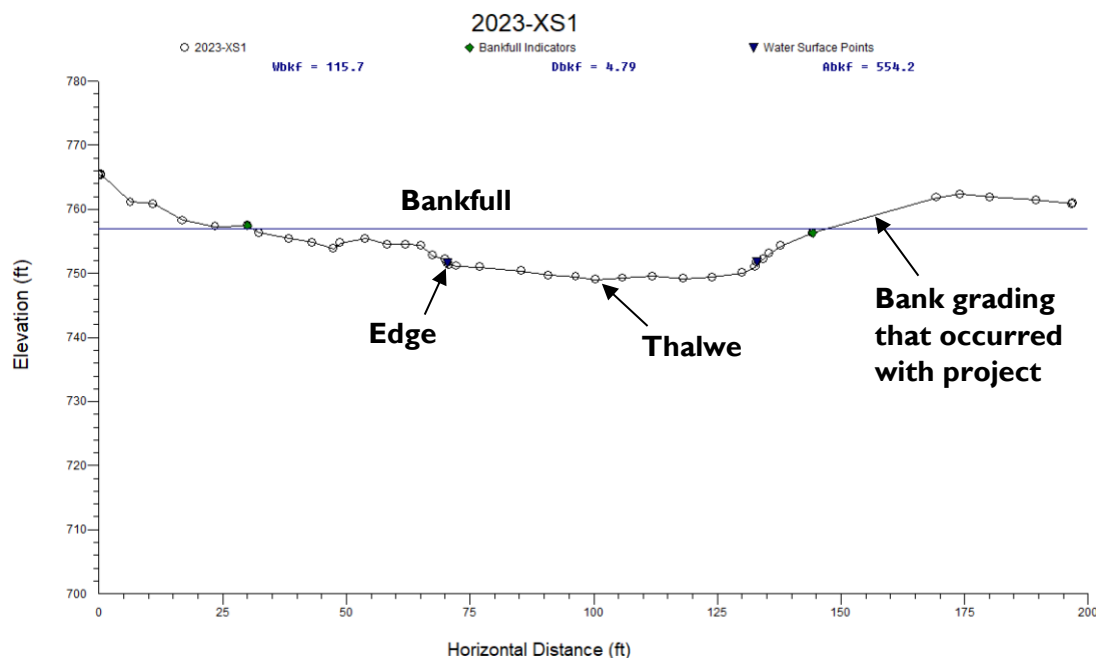
Cross Section 1 occurred at the upstream end of the project and captures the bank stabilization grading that occurred along the right descending bank. The slope was graded to approximately a 2:1 slope, treated with sandstone rip-rap, native seed and live stakes. No grading occurred on the left descending bank at this cross-section location.

The on-going recovery of the project area can be evaluated and compared to the baseline condition of cross sections 1-4. It is well documented that the created floodplains were cut to their proposed target grades accurately across the entire section as displayed by the flat consistent elevation through the floodplain tiers.

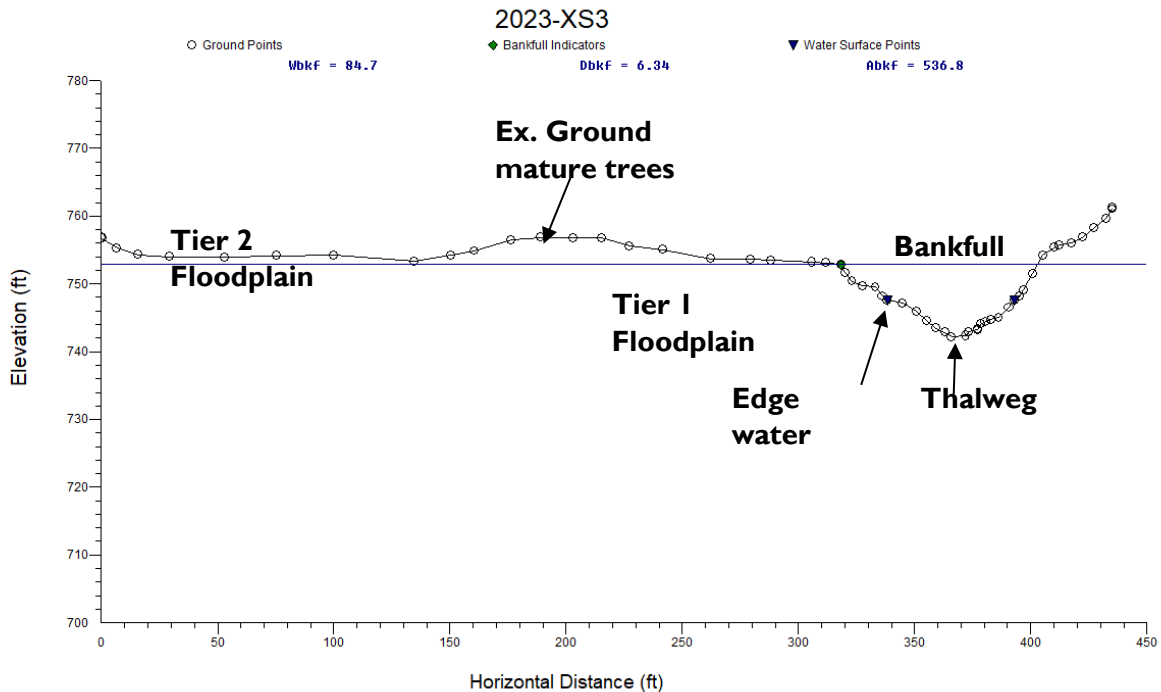
Cross section 3 represents an area where the left bank was excavated to create a Tier I floodplain. Station 10 to 150 on the section represents the Tier 2 floodplain area. The area between station 150 and 250 represents the existing ground elevation where a group of mature trees were preserved.

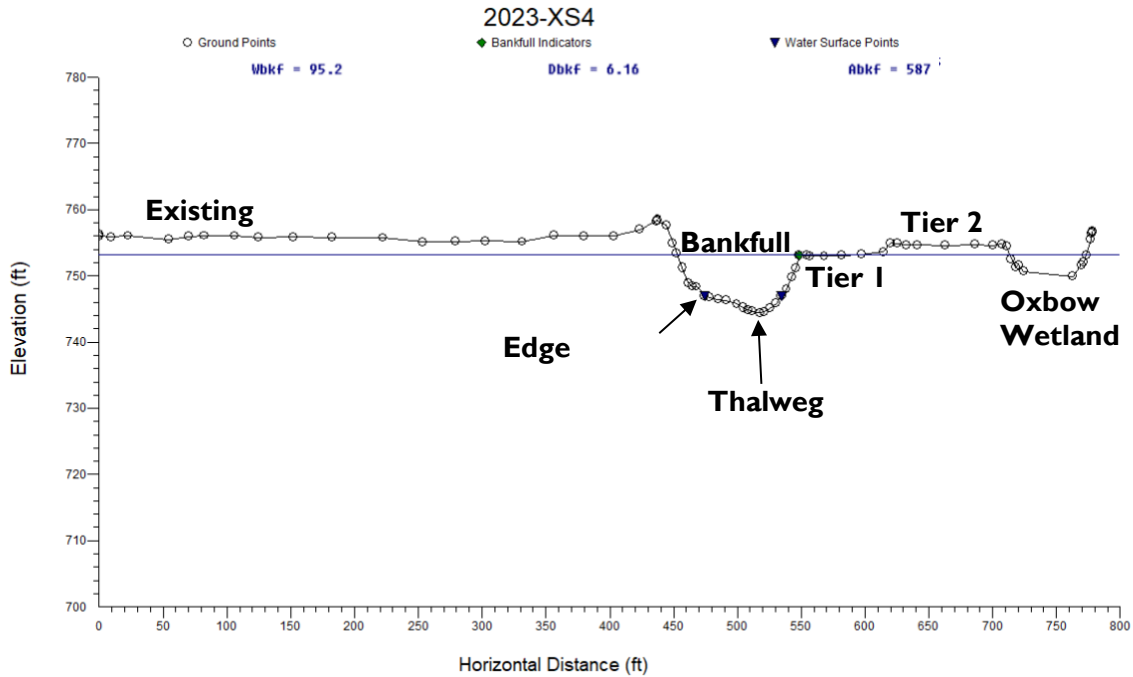
Cross section 4 represents the lower reach of the project where floodplain was created along the right descending bank. The cross section captures both the Tier 1 and 2 floodplain elevations as well as the former pond that was converted into an oxbow wetland.
