Technical Memorandum

Post-construction Vegetation Monitoring and Invasive Species Treatment for the Lakeview III Wetland Enhancement Project (2024)

Prepared by WSP USA for Audubon Great Lakes/National Audubon Society

July 2024

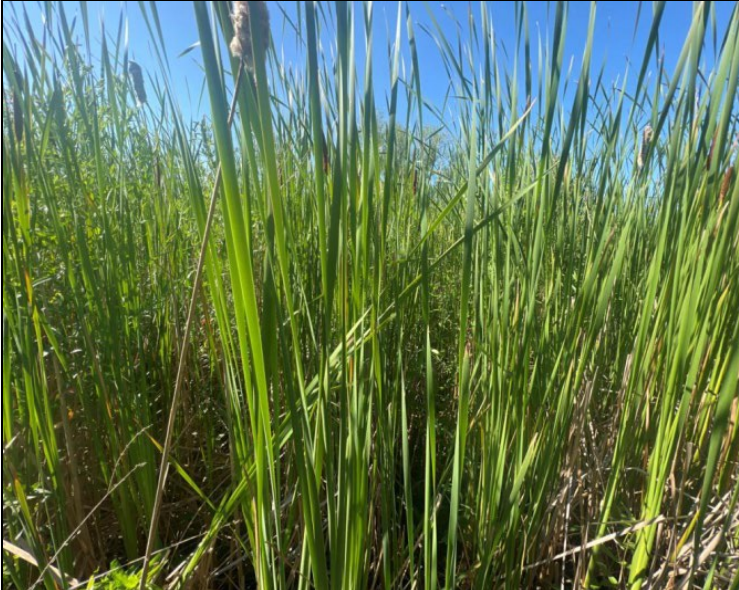
Photo 1. Meander M1 pre-construction: Location within the meander survey exhibiting typical dominance of narrow-leaf cattail with scattered purple loosestrife. This meander area was sampled prior to and after project construction. Photo taken August 1, 2023.

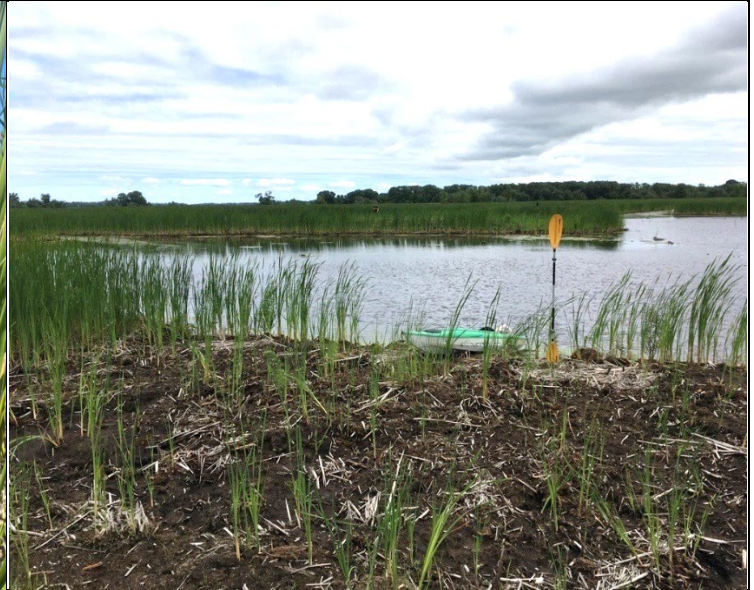
Photo 2. Meander M1 post-construction. Cattail, bluejoint grass, and other plants are recruiting to the habitat mound. Pothole 1 is visible beyond the habitat mound; one of seven potholes created or expanded as part of the Enhancement Project. Photo taken June 27, 2024.

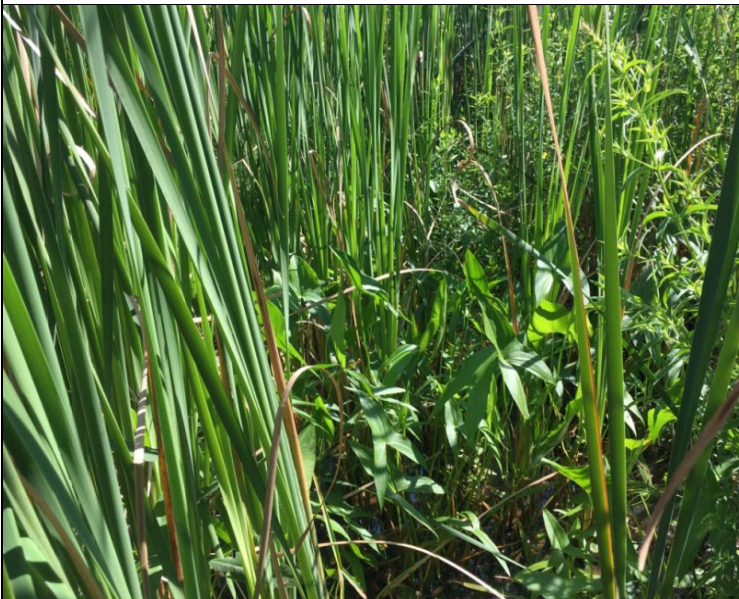
Photo 3. Transect M2 pre-construction: Sample quadrat with visible narrow-leaf cattail, duck potato, and purple loosestrife. This transect was monitored prior to project construction and after construction. Photo taken August 1, 2023.

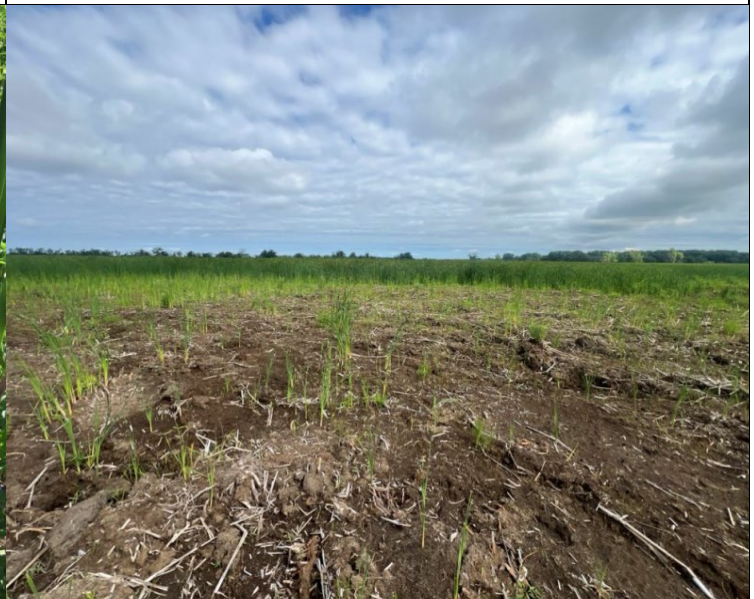
Photo 4. Transect M2 post-construction: Location within the transect exhibits typical re-colonization of the spoil piles, with scattered cattail and swaths of unvegetated soil. Photo taken June 27, 2024.

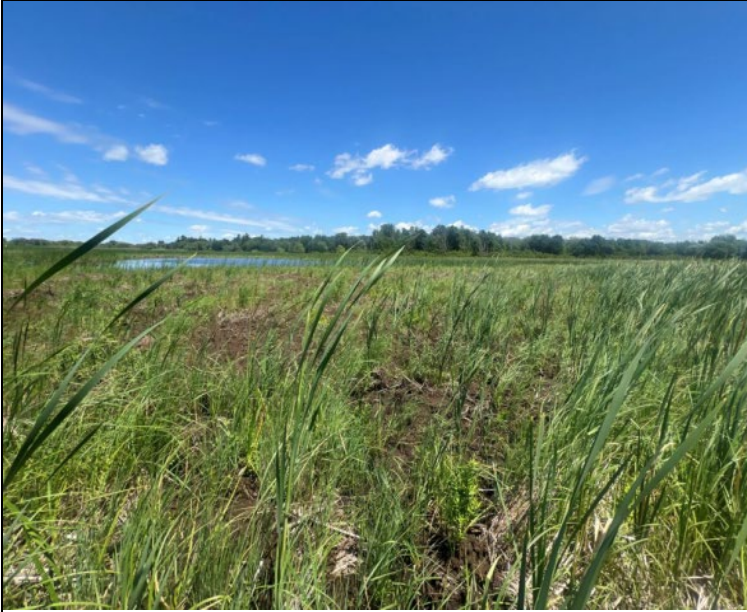
Photo 5. Transect M3 post-construction: This transect was monitored prior to and after project construction. This area has relatively strong vegetation recruitment, primarily cattail. Photo taken June 27, 2024.

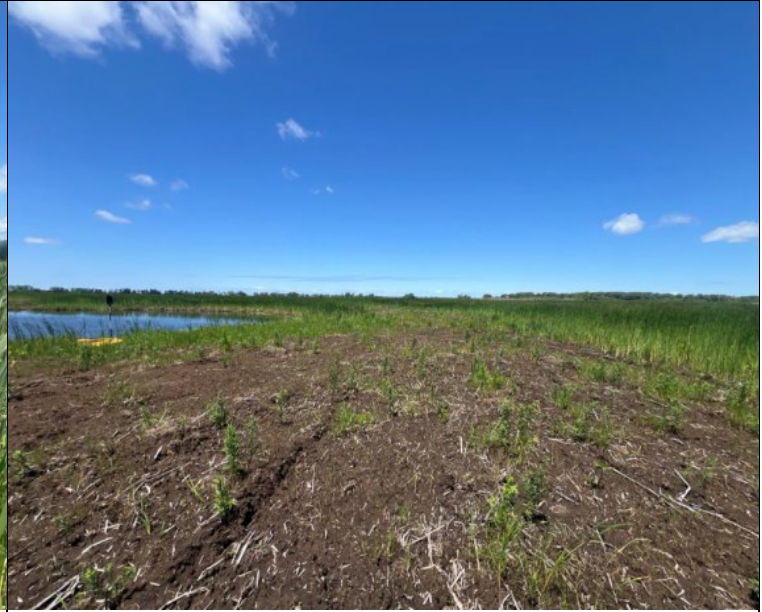
Photo 6. Transect S3 post-construction: New monitoring transect located on the habitat mound on northeast side of created pothole 3 (pothole visible on left side). Vegetation recruitment thus far is relatively low in this area. Photo taken June 27, 2024.

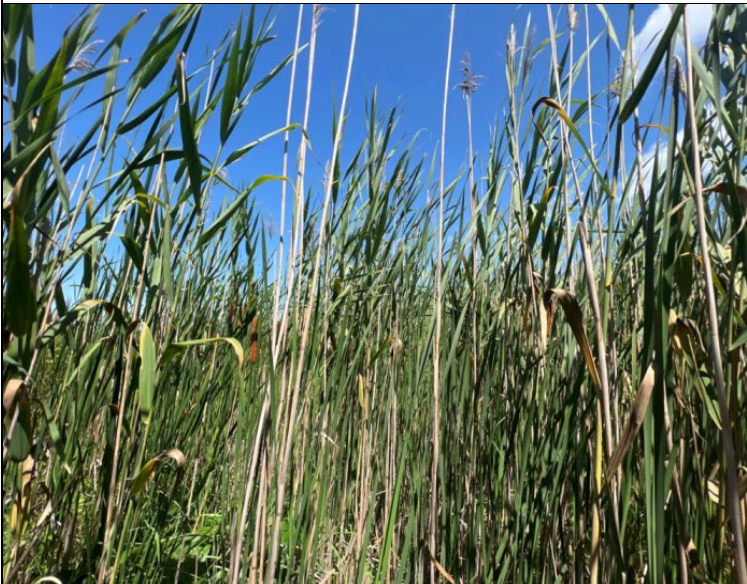
Phragmites was observed in 5% of the pre-construction quadrats (all in the habitat mound transect located north of pothole 4; see photo 7 in Attachment A) and 0% of the post-construction quadrats (see Table 1 and Figure 2).

Photo 7. Transect M4 pre-construction: Sample quadrat with mature Phragmites intermixed with narrow-leaf cattail. Transect M4 and meander M4 (later named CM4) were the areas sampled in 2023 where Phragmites was detected. Photo taken August 1, 2023.

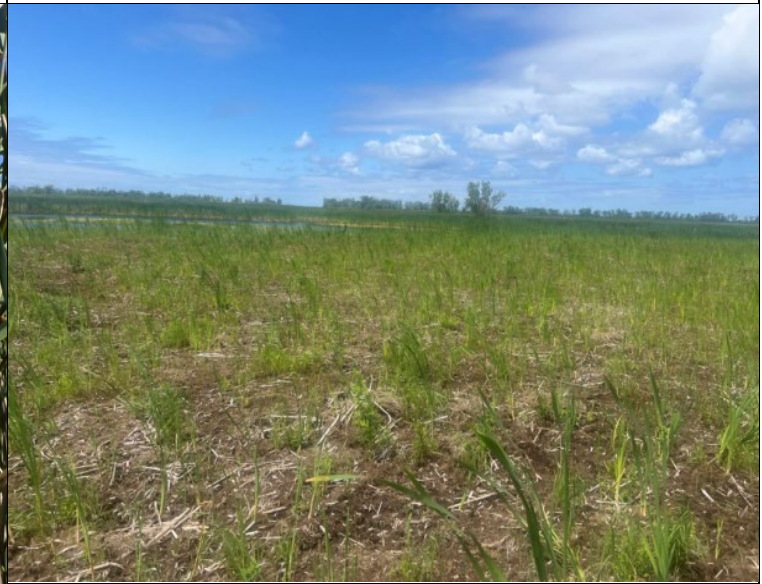
Photo 8. Transect M4 post-construction: Part of the existing Phragmites patch has been covered by the habitat mound. The majority of the Phragmites patch persists to the east of Transect M4. Photo taken June 27, 2024.

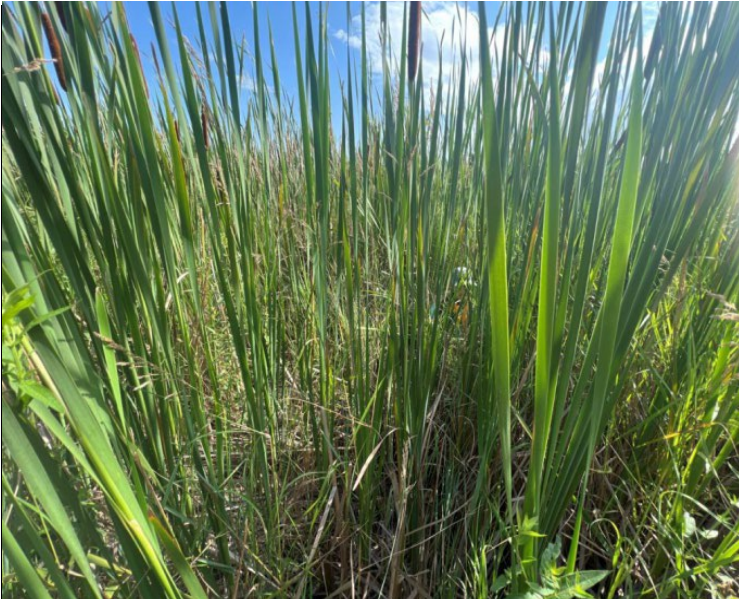
Photo 9. Transect P5 pre-construction: Sample quadrat with narrow-leaf cattail intermixed with a relatively high amount of bluejoint grass. Transect P5 was excavated as part of the Enhancement Project. Photo taken July 31, 2023.

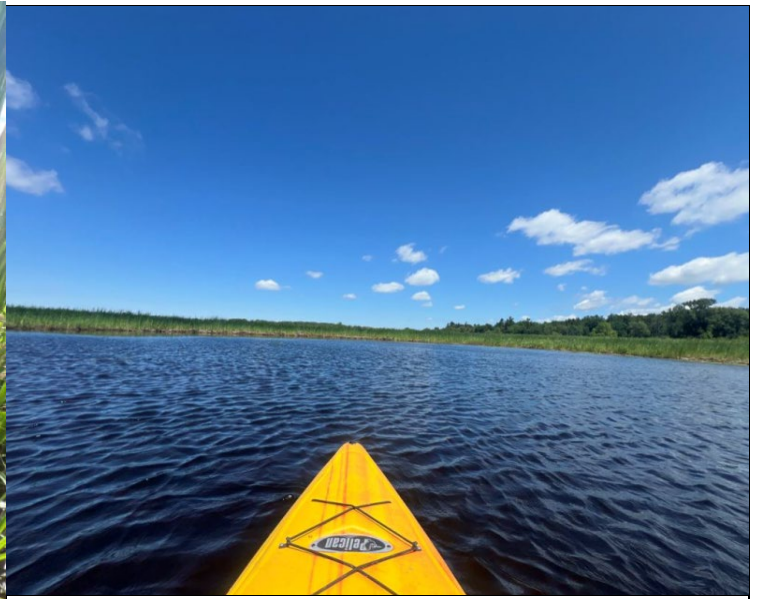
Photo 10. Pothole 5 post-construction: Wetland plants, predominantly narrow-leaf cattail, were excavated during construction to create the pothole. During the 2024 vegetation sampling the area was open water with virtually no plants to record for Meander P5 or Transect P5. Photo taken June 27, 2024.

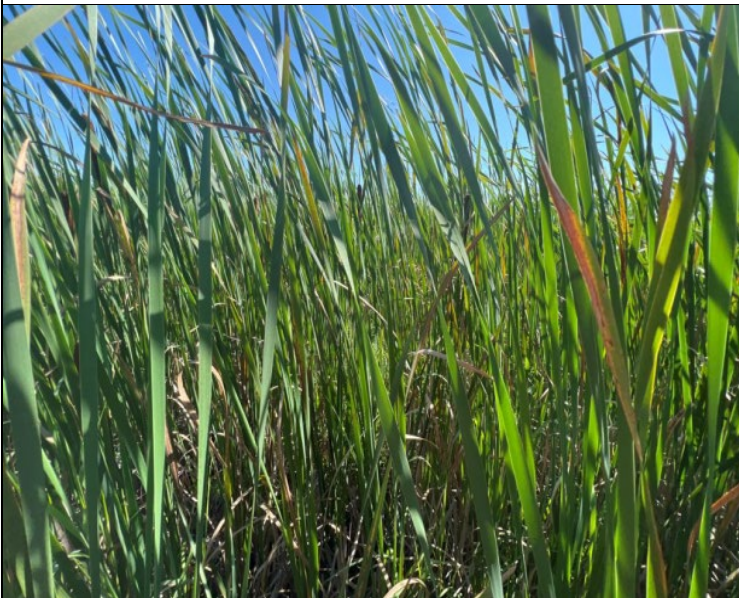
Photo 11. Meander P6 pre-construction: Pothole meander area dominated by narrow-leaf cattail. This area was excavated during Enhancement Project construction and became open water. Photo taken August 1, 2023.

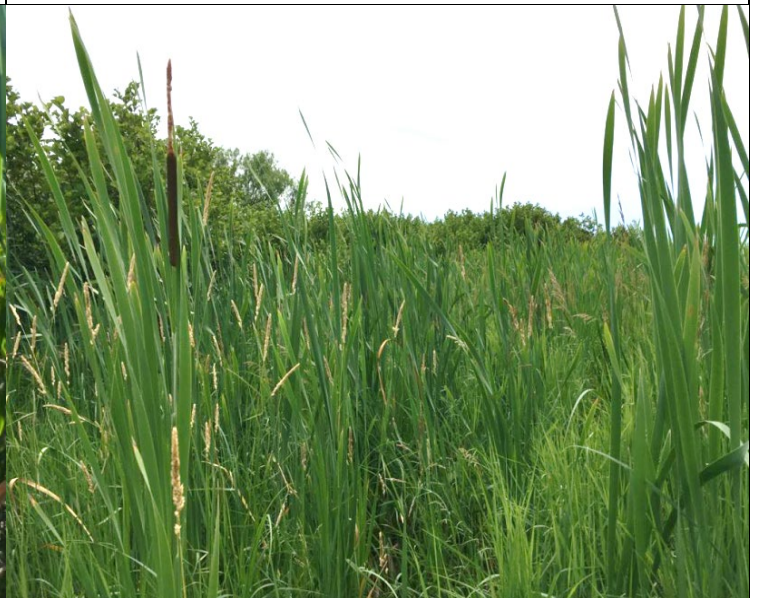
Photo 12. Meander C6 post-construction: This control meander area is adjacent to the constructed spoil pile and Meander M6. The vegetation within Meander C6 is similar to pre-construction conditions: narrow-leaf cattail intermixed with other wetland plants. Speckled alder stands are present near pothole 6 (visible on left). Photo taken June 26, 2024.

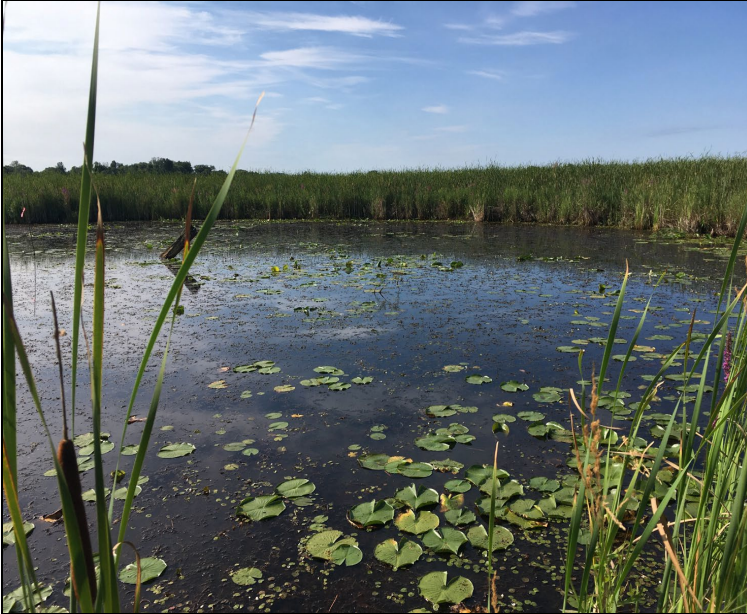
Photo 13. Meander P7 pre-construction: south end of the meander area looking south across the existing pothole. Photo taken August 2, 2023.

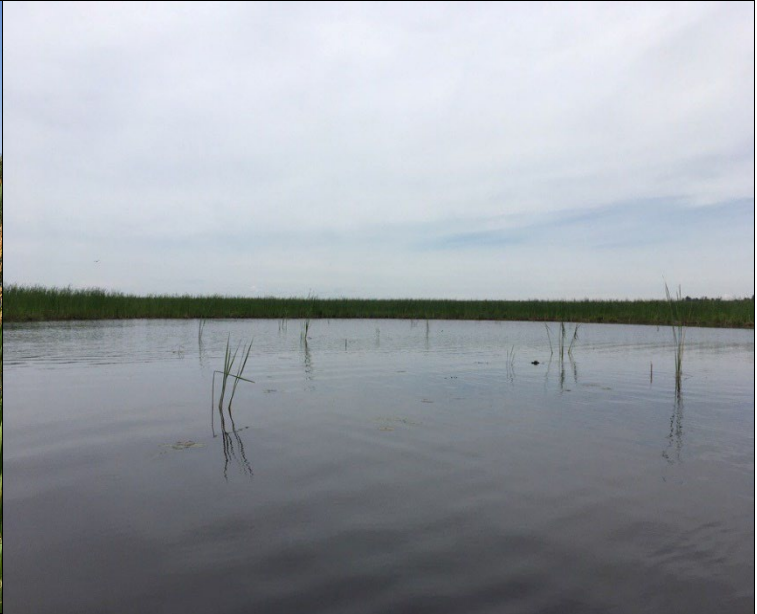
Photo 14. Pothole 7 post-construction: The existing pothole was expanded during construction. Habitat is now open water with only trace emergent plants to record for Meander P7 or Transect P7. Photo taken June 26, 2024.

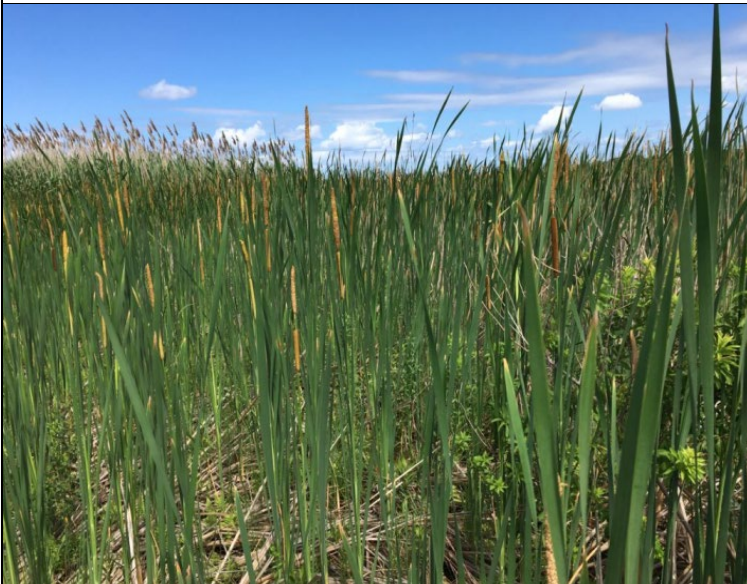
Photo 15: Meander CM4: This area was indicated as a habitat mound in the Project design but was not actually impacted by construction. Cattail still dominates but there were a variety of other wetland plants (e.g., meadowsweet and marsh fern are visible in the photo). The persisting Phragmites patch is visible in the background on the left side. Photo taken June 27, 2024.

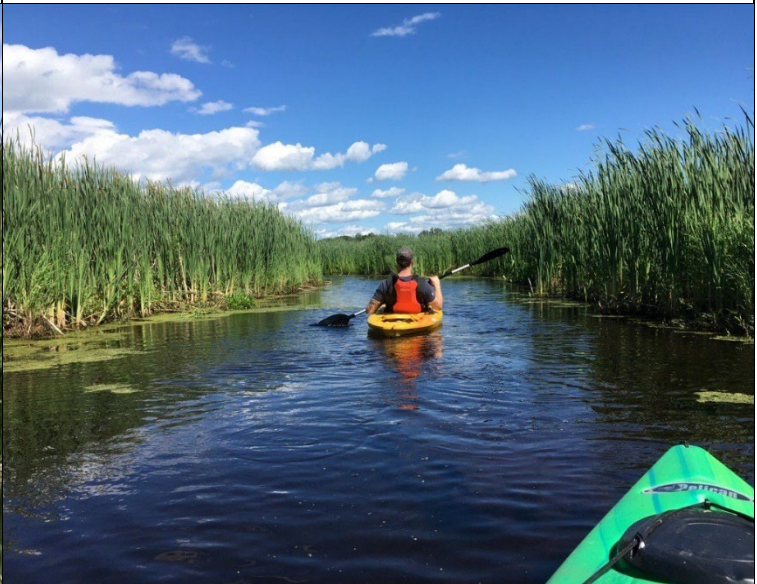
Photo 16. Pothole 5 channel: WSP biologists kayaking along one of the new channels created as part of the Enhancement Project, located east of Pothole 5. The recently created system of potholes and channels greatly improved site accessibility compared to pre-construction conditions. Photo taken June 27, 2024.
