Monitoring Report

OHIO STREET BOAT LAUNCH

Buffalo, NY

2018

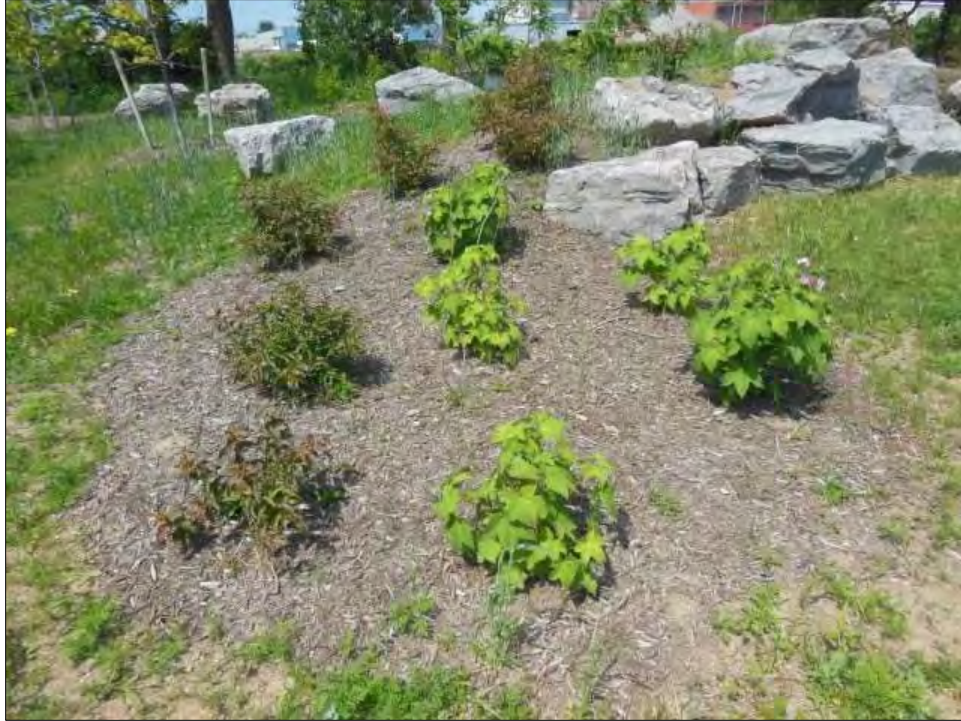
Figure 3-1. Shrub plantings in Area 5

Monitoring took place on June 6 and June 14, 2018. All trees and shrubs were in place per the project plans and specifications, and were in good health. [Figure 3-1](#) shows a typical shrub planting area.

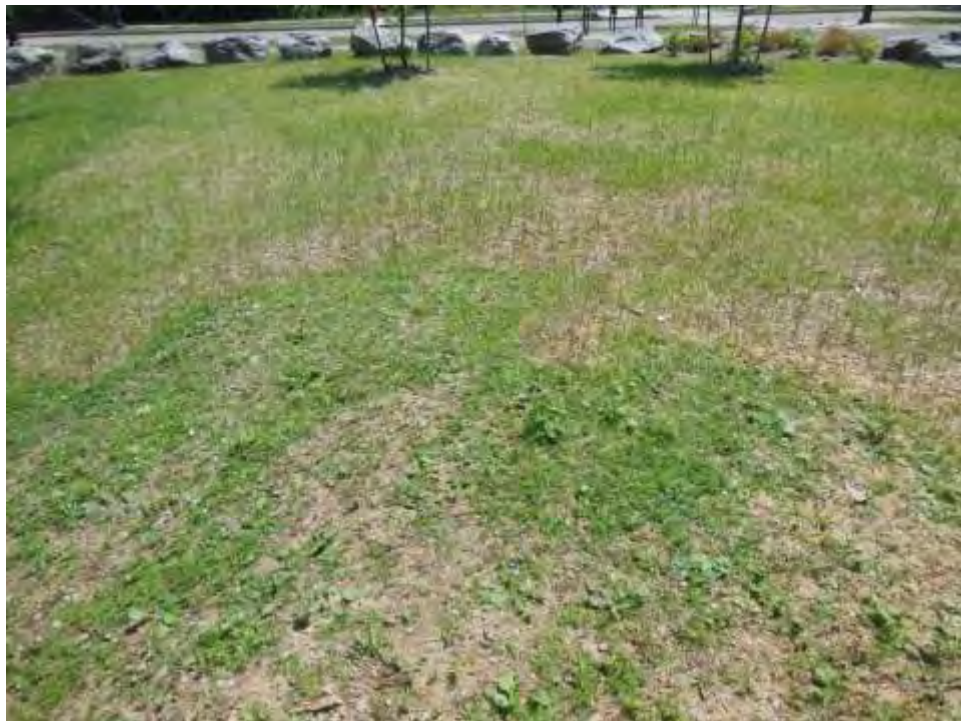
Figure 3-2. Meadow area with rye, small herbs, and gaps of exposed soil

At the time of monitoring, the meadow seed mix had been spread; however most of the meadow plants were not yet visible during the monitoring session, likely due to the short time period that had passed since the seeds were broadcast (37 days). Additionally, it was not clear that watering was taking place per the restoration plan technical specifications, and lack of water may have been contributing to slow establishment of the meadow plants. Rye, which was part of the seed mix, had sprouted and was a dominant plant in meadow areas. Three species of rye were included in the seed mix and the plants were not identified to species. Black mustard, which was not planted and is not native, also dominated portions of the meadow areas. Up to fifteen additional species may sprout in the meadows throughout the season (See meadow seed mix list in [Appendix A, Plate A.1](#)). The meadow and lawn areas included spotty bare soil, as shown in [Figure 3-2](#); however, these bare spots are expected to fill with meadow vegetation throughout the growing season.

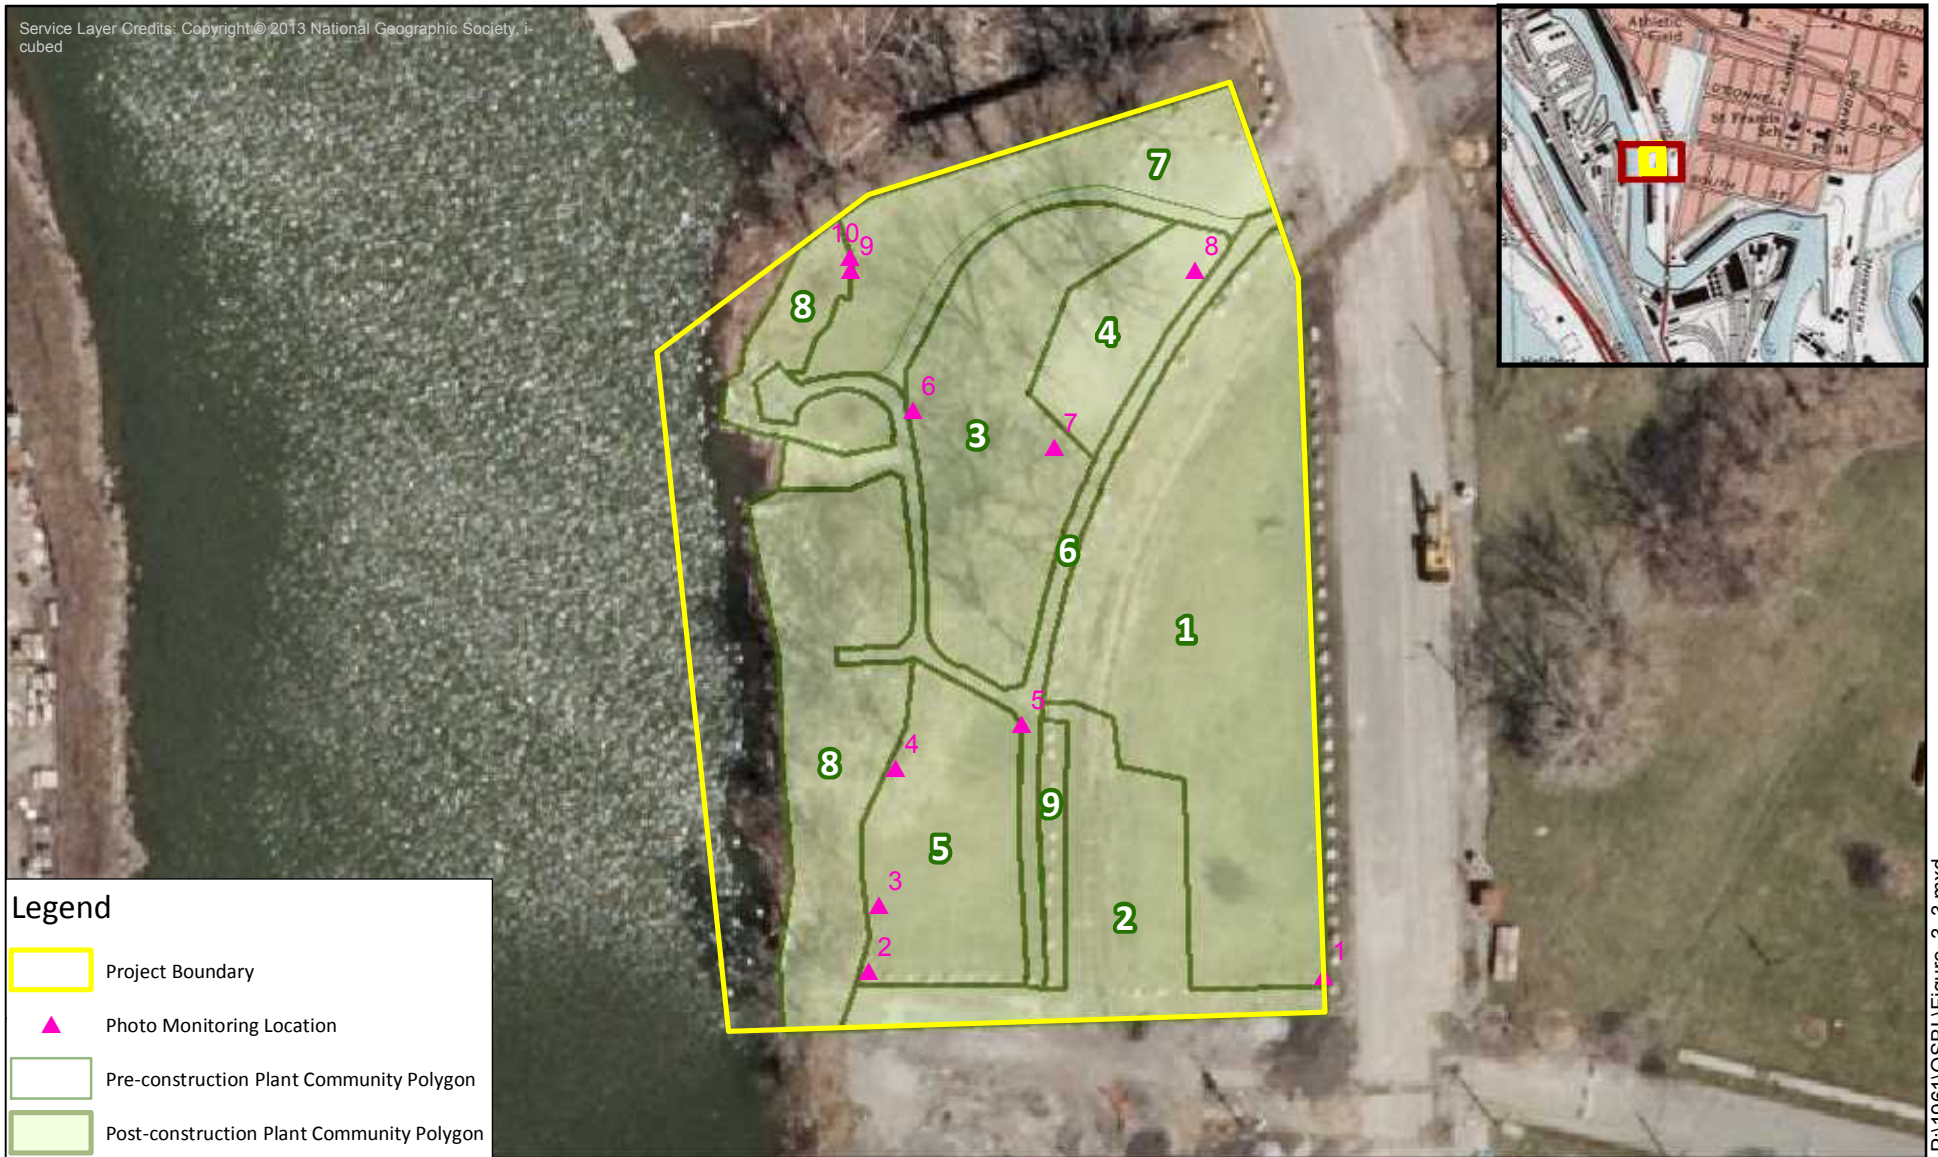
Figure 3-3:
NYSDEC Ohio Street Boat Launch Project Area

Prior to habitat enhancement, eleven cover type polygons were mapped at the Ohio Street Boat Launch site. These polygons were kept for post-construction monitoring with an expansion to Area 7 and reduction of Area 6 due to the removal of sidewalk between Area 7 and Area 3. ([Figure 3-3](#)). These polygons are summarized in [Table 3-1](#).

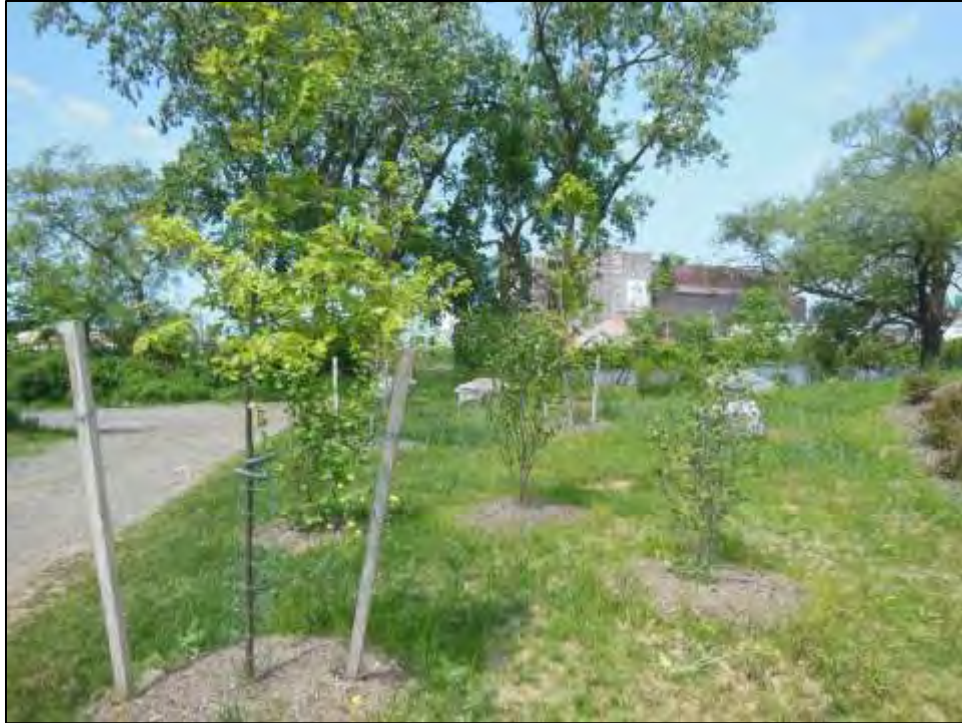
Figure 3-4. Planted trees and shrubs in Area 5.

Area 5 was a natural herbaceous cover type in the category Grasses and Lawns, occupying 0.15 acres. Grasses were the dominant taxa, with common lawn weeds narrow leaved plantain (*Plantago lanceolata*) and common dandelion (*Taraxacum officinale*) occurring abundantly. This area was re-graded to include berms new trees and shrubs were planted, landscape boulders were placed to create features of interest, and a meadow seed mix was spread throughout the area ([Figure 3-4](#)).

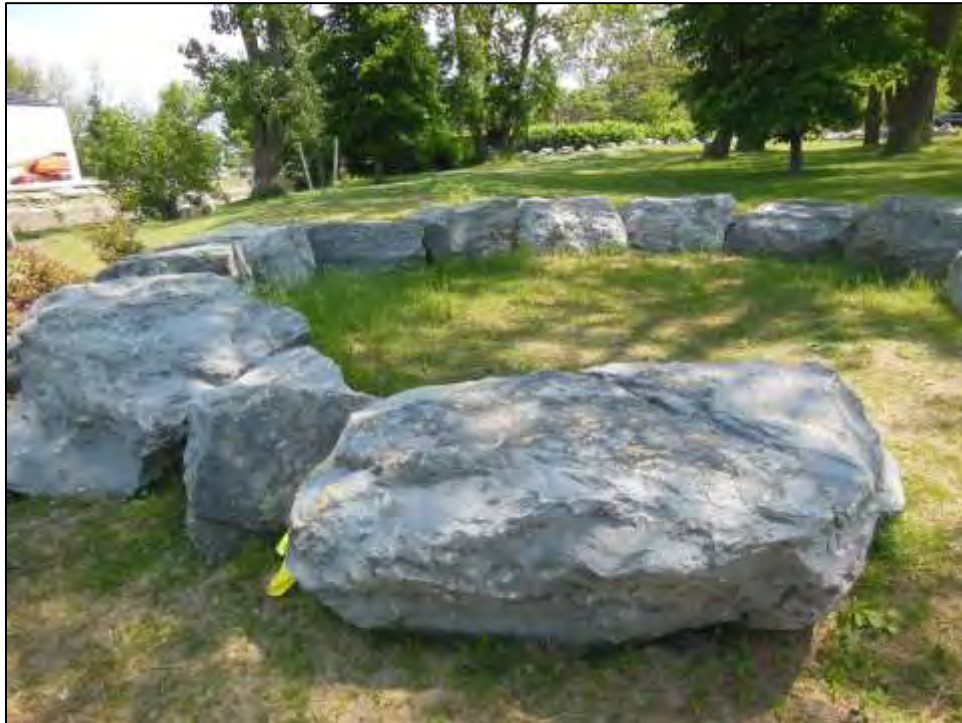
Figure 3-5. "Council ring" in Area 7.

sidewalk and is now 0.17 acres. It includes meadow and planted trees as well as a “council ring” feature made from landscape stones that were relocated from previous locations at the site (Figure 3-5).

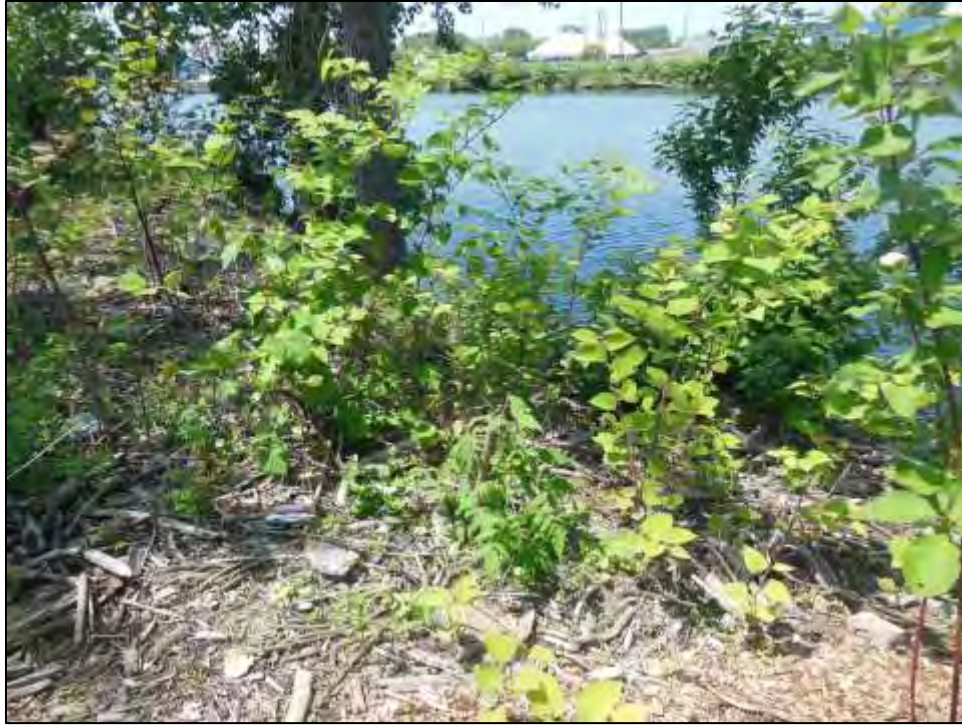
Figure 3-6. Knotweed growing in Area 8

The only riparian wooded area on the site is Area 8, an area of 0.26 acres which borders the Buffalo River on the west side of the site. The riparian area includes cottonwood and willow trees, as well as shrubs and herbaceous plants. It was dominated by non-native European buckthorn (*Rhamnus cathartica*); which was targeted for removal. Japanese knotweed and European black alder were also treated, but are still present in the area (Figures 3-6 and 3-7). The iris in this area was not identified to species prior to restoration, as it was not flowering or fruiting. During post-construction monitoring, the iris was in flower and determined to be non-native yellow iris (*Iris pseudoacorus*) (Figure 3-8).

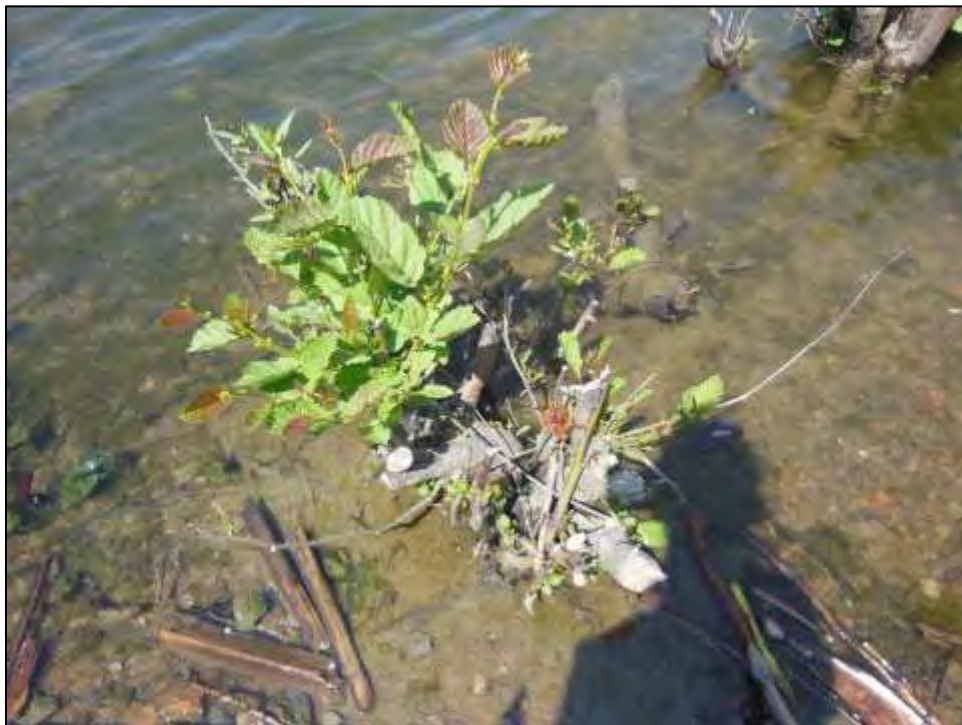
Figure 3-7. Black alder that has been cut and is resprouting along the project shoreline

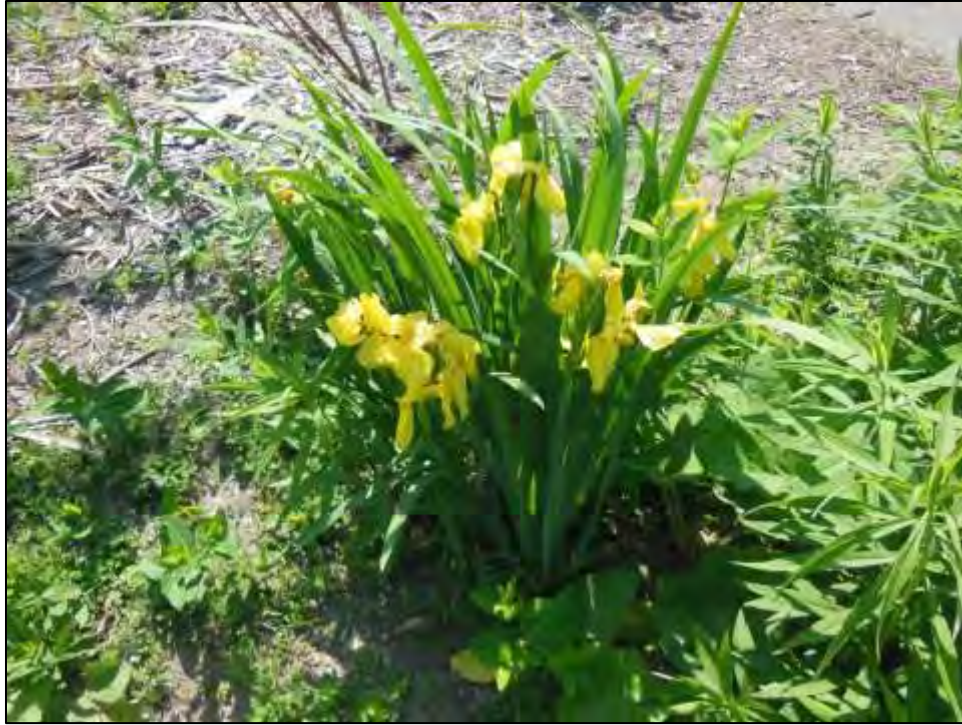
Figure 3-8. Yellow Iris (*Iris pseudoacorus*) growing near the boat launch

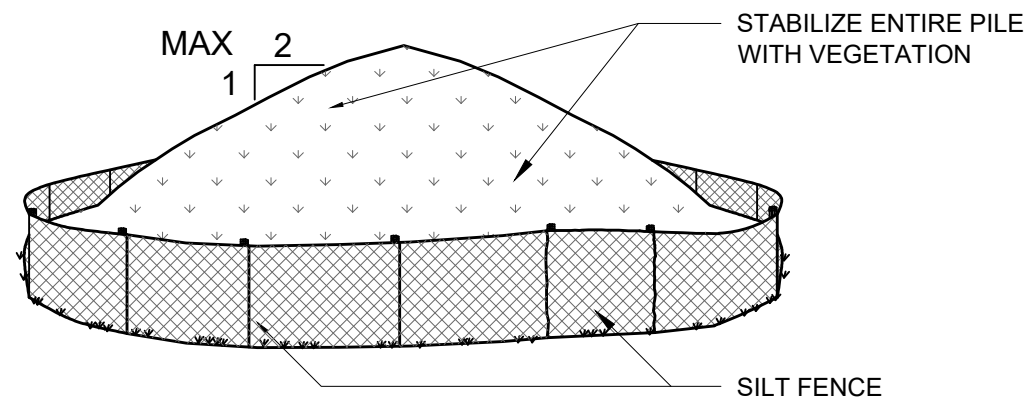
- INSTALLATION NOTES:
1. AREA CHOSEN FOR STOCKPILING OPERATIONS SHALL BE DRY AND STABLE.
 2. MAXIMUM SLOPE OF STOCKPILE SHALL BE 2:1. MAXIMUM HEIGHT SHALL BE 12 FEET.
 3. EACH PILE SHALL BE SURROUNDED WITH SILT FENCING, INSTALLED PER CORRESPONDING DETAIL, THEN STABILIZED WITH ANNUAL GRAIN WITHIN 3 DAYS.
 4. A PERIMETER DIKE/SWALE SHALL BE LOCATED UP-SLOPE OF THE TOPSOIL STOCKPILE TO DIVERT STORMWATER AROUND THE STOCKPILE.

3 STABILIZED SOIL STOCKPILE
601 Scale: NTS TEMPORARY

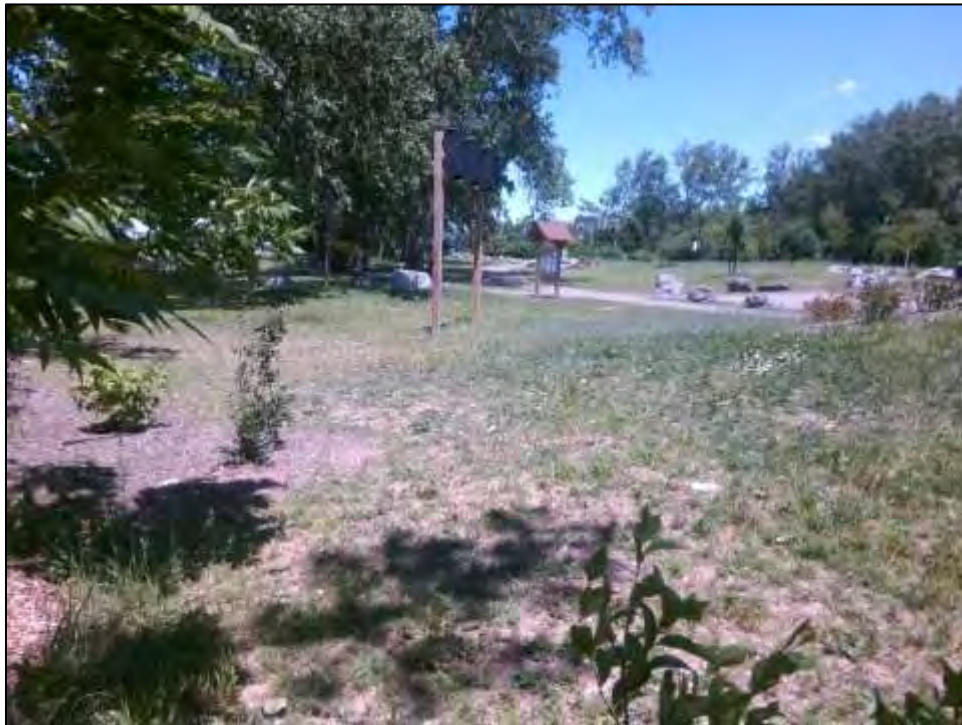
Photo monitoring point 2. Bat boxes are visible in the center of the photo.
