# **PENN 7 OPERATIONS AND MAINTENANCE PLAN**

**FOR THE:  
ENGINEERING AND SITE DESIGN ACTIVITIES FOR  
RESTORATION OF EMERGENT COASTAL/FLOODPLAIN WETLANDS  
AT PENN 7  
TOLEDO, OHIO**

**PREPARED FOR:  
CITY OF TOLEDO**

**JUNE 2022**

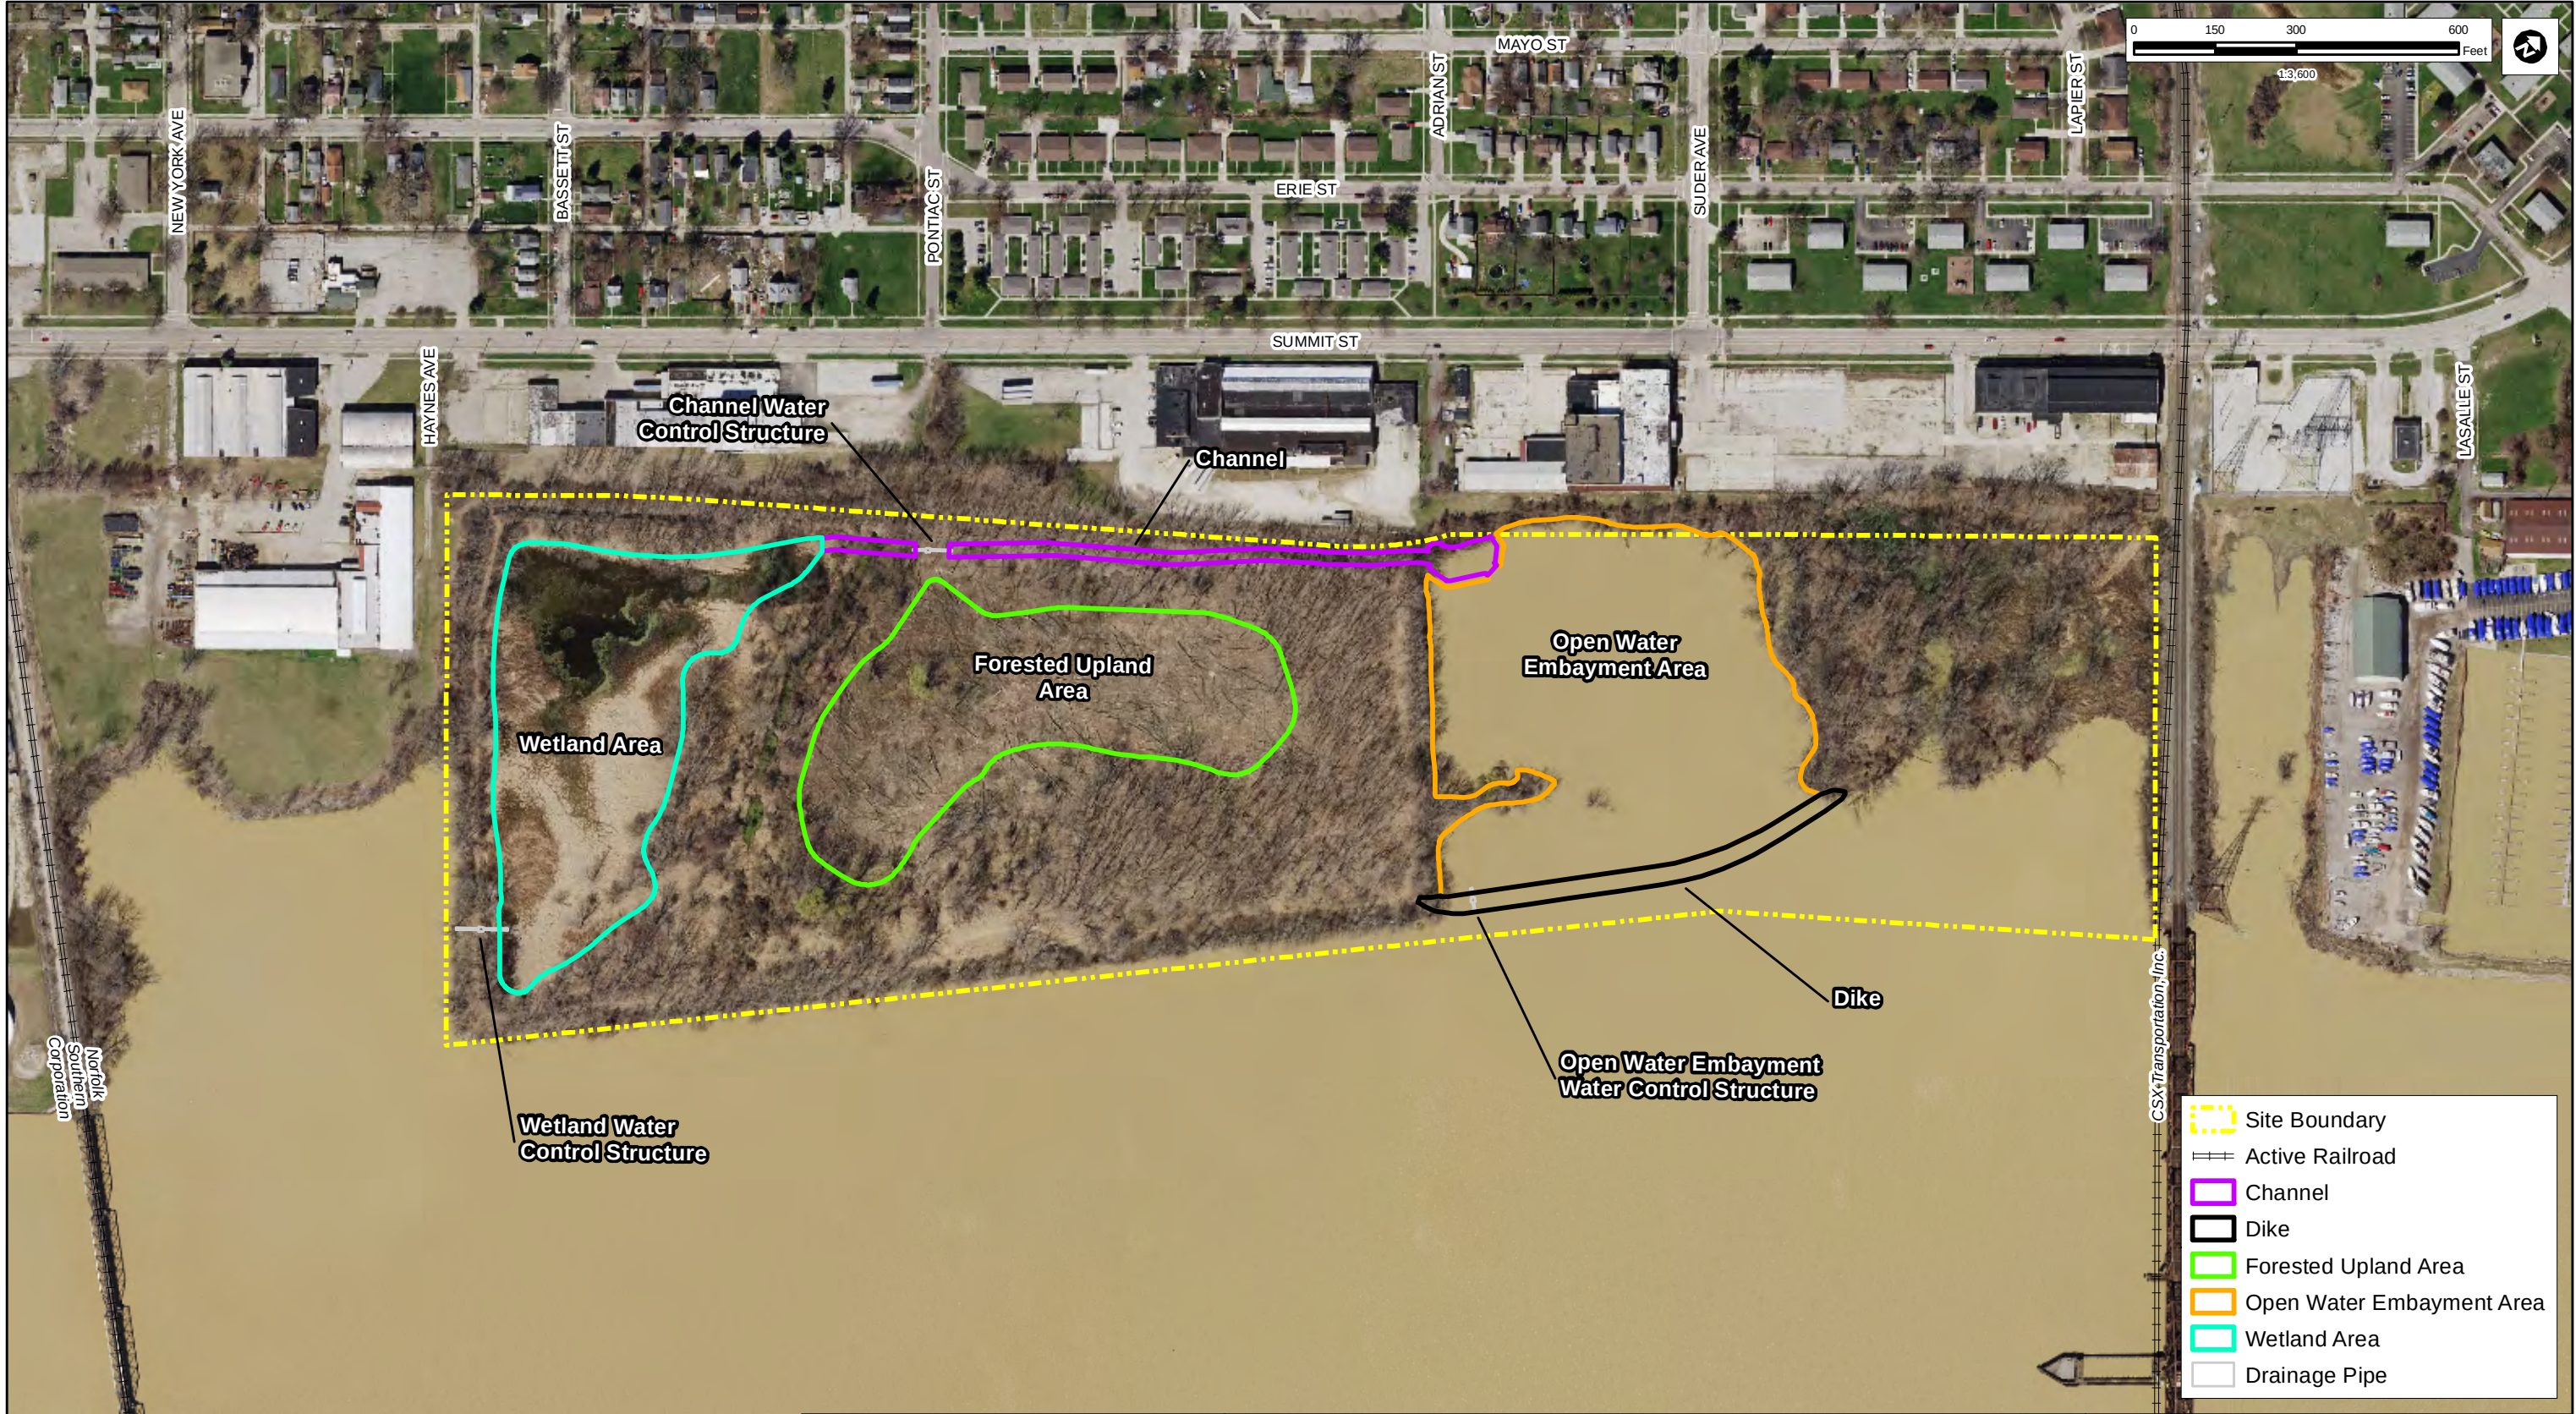
1

**Note:**  
The aerial photo was acquired from the Ohio Statewide Imagery Program (OSIP).  
Aerial photography dated 2020.

August 2021  
Penn 7 Existing Conditions Report  
**Site Layout with Improvements**  
Toledo, Lucas County, Ohio

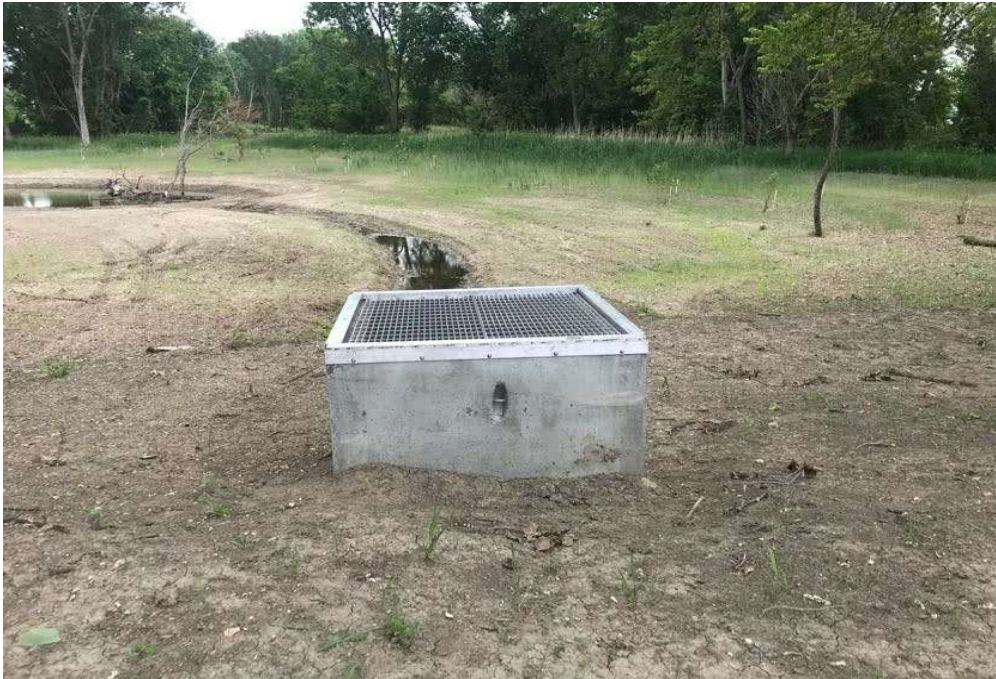
PHOTO 1: Overview of the Wetland Water Control Structure (WCS).

The inspector should visually inspect all components of the water control structure (i.e., culvert pipe, catch basin, stoplogs, and fish grate) that are visible or accessible at the time of the inspection. Any components that are not able to be visually inspected at the time of inspection should be noted. It may be necessary to perform another inspection when the water level has lowered if there is reason to expect these components may be damaged. Any damage observed should be documented, photographed and reported to the Commissioner of the City's Division of Parks, Recreation and Forestry. The Commissioner shall consult with an engineer as needed, determine if any corrective measures are required and implement the identified corrective measures.

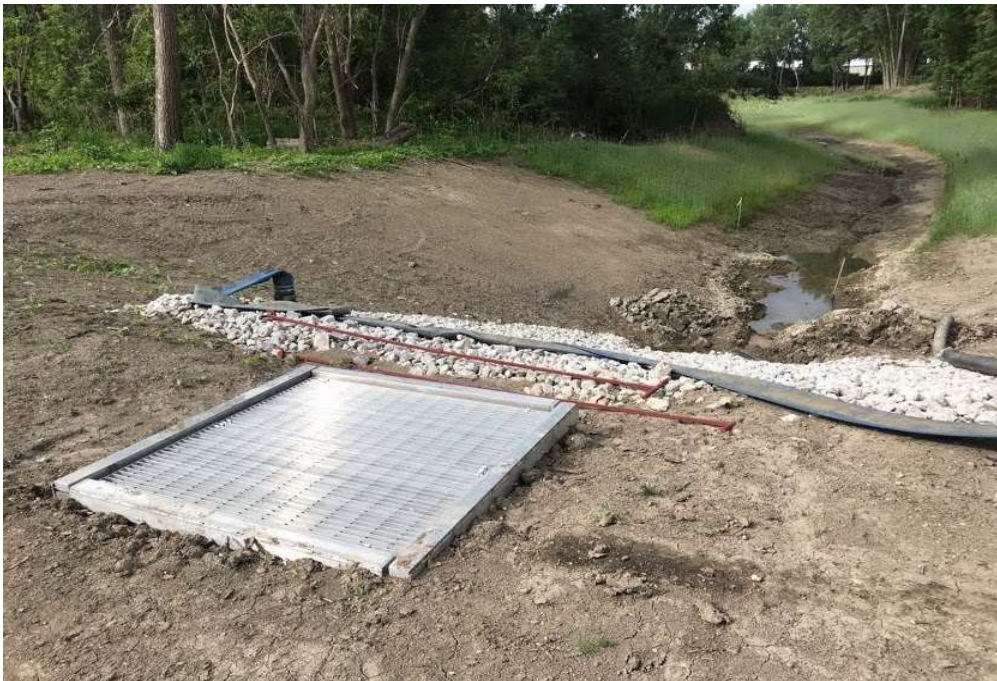
PHOTO 2: Overview of the Channel WCS.

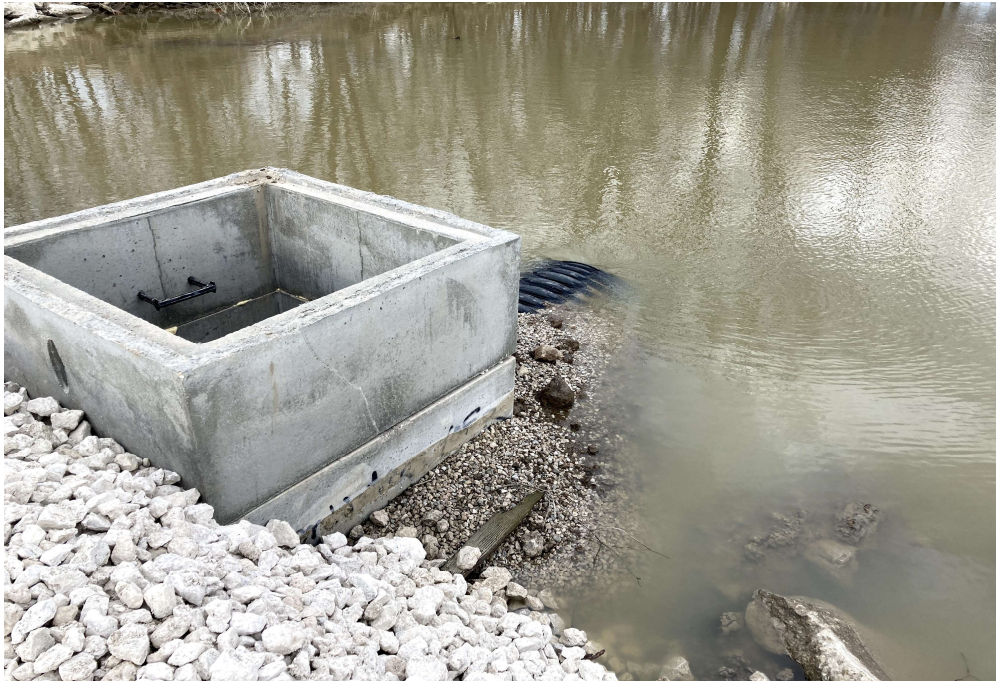
PHOTO 3: Overview of Open Water Embayment WCS.

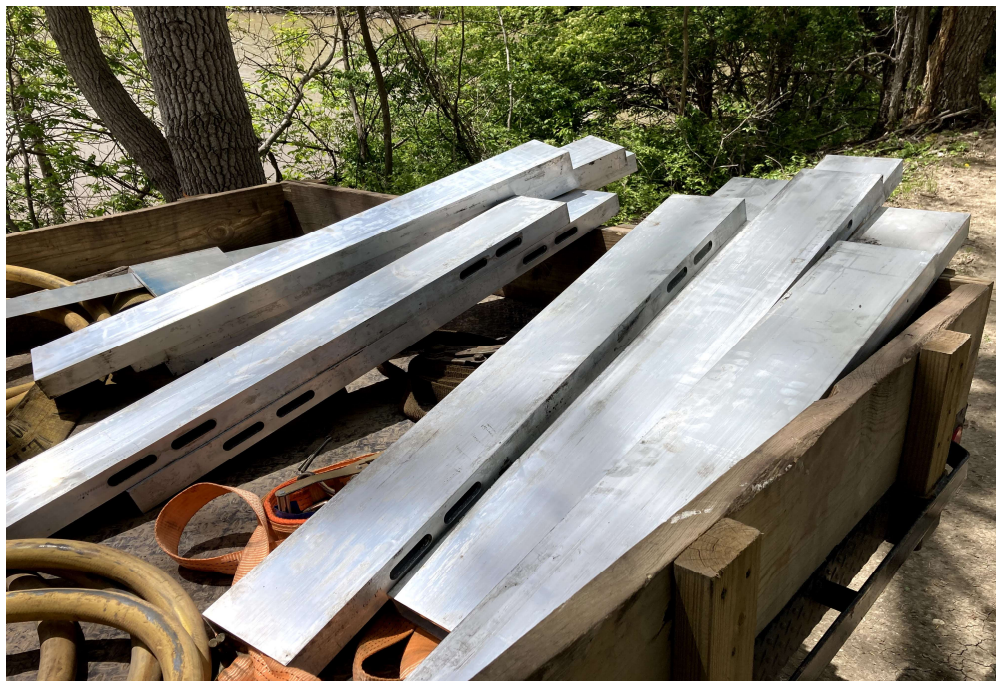
PHOTO 4: Overview of stop logs for the WCSs.

If active management is desired to help manage invasive species more effectively, it is recommended to vary the water depth in the Site depending on the season and year. During the first year of active management, stoplogs should be inserted during late spring to flood the target area(s) 12 to 18 inches (see Table 1 for required number of stoplogs). In three (3) to five (5) years, the stoplogs should be removed, except for the bottom stoplog, during May or June to allow drawdown to encourage native plant establishment. Stoplogs should then be inserted to reestablish the 12 to 18-inch water depth in the target area(s) during early Autumn. The drawdown should again occur in three (3) to five (5) years and this process should be continued as long as active management is desired to manage invasive species, or in accordance with a specific active management plan that is developed in the future. Note that after flooding to manage invasive species, it may be necessary to reseed/plant the flooded areas. The as-built planting plan provided by the Contractor is provided in Appendix C for reference to appropriate species to plant in each area.

Active management for extreme water levels in Lake Erie would involve installing stoplogs to either prevent the raising or lowering of water levels in the Site as the Maumee River and Lake Erie water levels fluctuate. In general, when extreme low-water levels are forecasted, stoplogs may be recommended to be installed to prevent the drawdown of water within the Site and when extreme high-water levels are forecasted, stoplogs may be installed to prevent the raising of water levels. If this type of active management is desired, it is recommended to develop an active management plan that considers the anticipated low- and high-water levels as well as the probable seiche events.

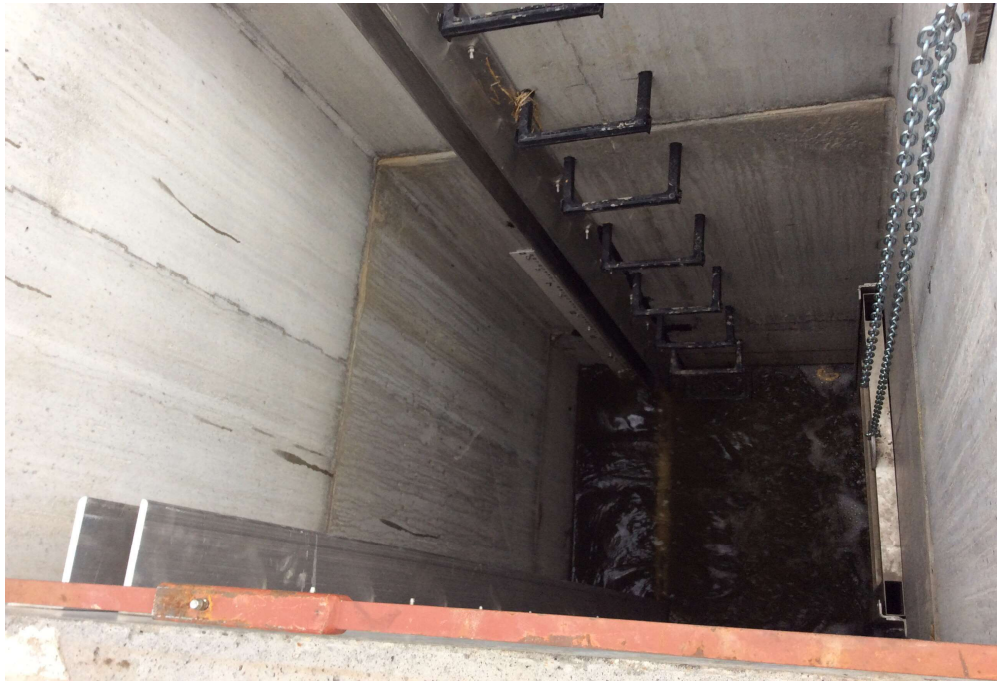
PHOTO 5: Interior of the Wetland WCS showing, from left to right, the staff gauge, stop log guides, steps, and fish grate.

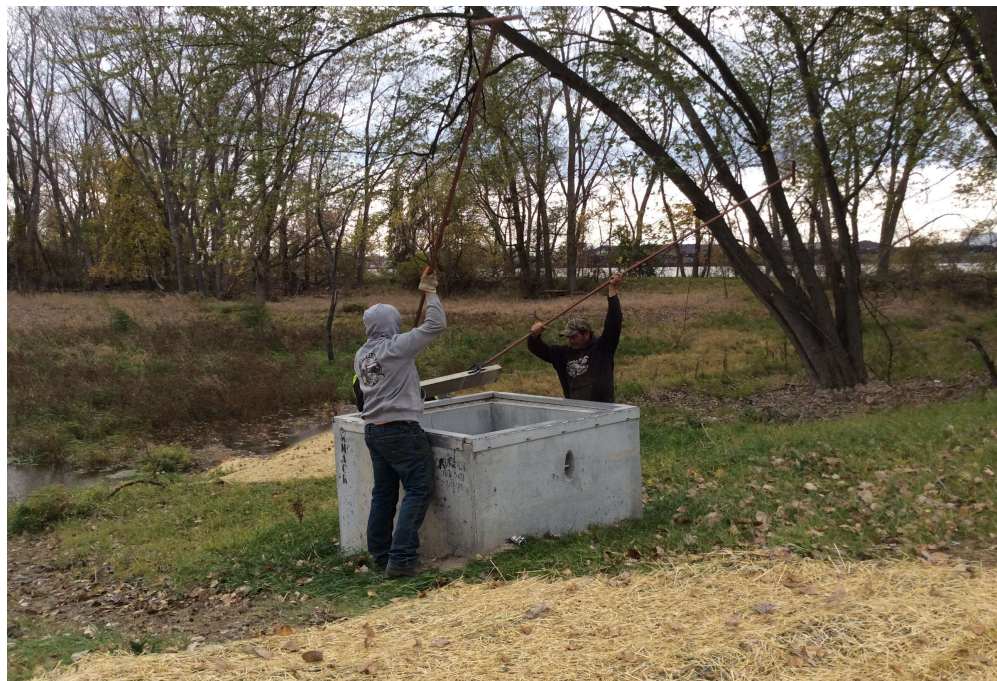
PHOTO 6: Removal of stop log from the Wetland WCS using lifting hooks.

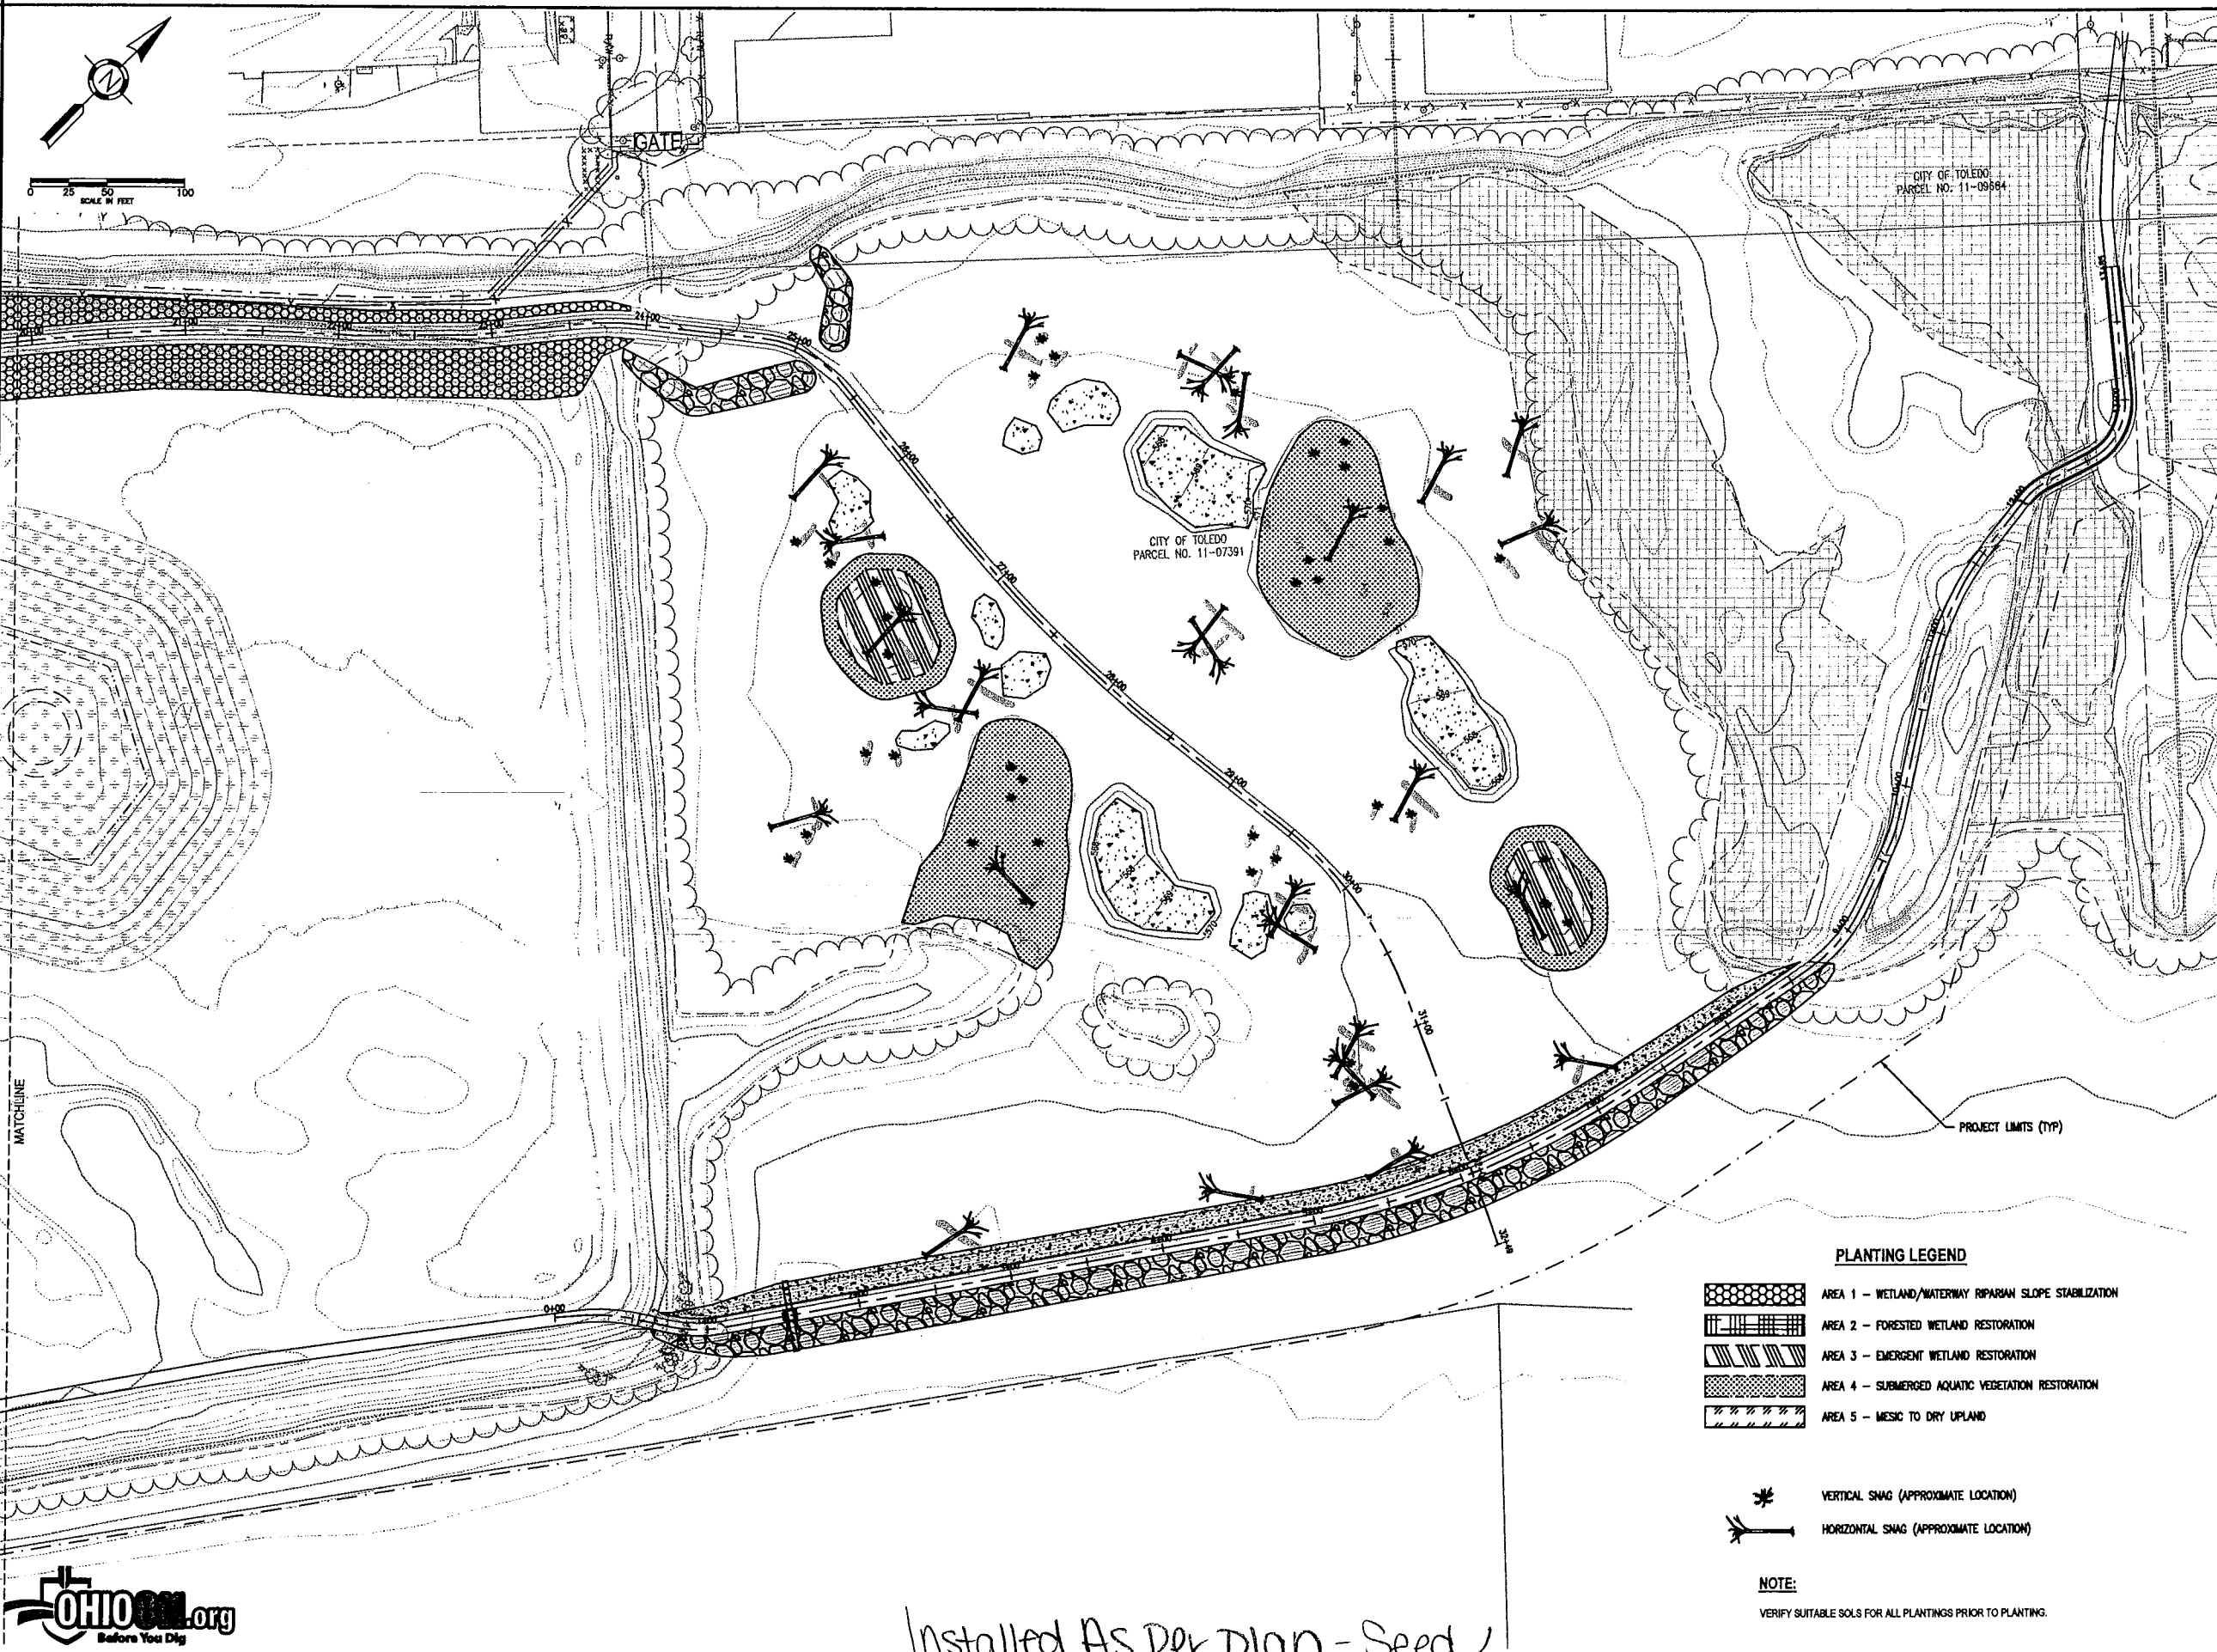
PLANTING PLAN

| [Pattern] | AREA 1 - WETLAND/WATERWAY RIPARIAN SLOPE STABILIZATION |

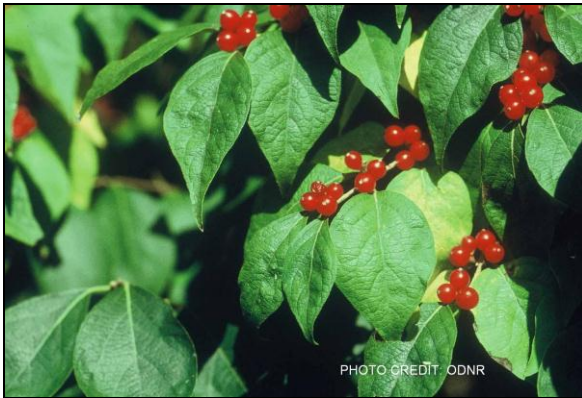
### AMUR HONEYSUCKLE

Amur, Morrow's and Tatarian bush honeysuckles are upright, deciduous shrubs that range from 6 to 15 feet in height at maturity. Older stems have hollow pith (center). Two native bush honeysuckles, bush honeysuckle (*Diervilla lonicera*) and Canada fly honeysuckle (*Lonicera canadensis*) may be confused with these non-natives; proper identification is necessary. Branches of the native species have solid stems, while the non-natives have hollow pith.

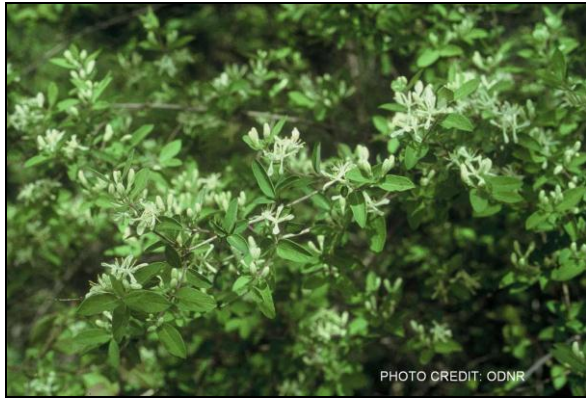
### MORROW'S HONEYSUCKLE

These non-native bush honeysuckles are relatively shade-tolerant, invading mesic to moist woods as well as forest edges, abandoned fields, prairie remnants, pastures, and other open, upland habitats. Woods that have been grazed or disturbed are more susceptible to invasion. Morrow's honeysuckle is capable of invading bogs, fens, lakeshores, and sandy plains. Amur honeysuckle prefers limestone-based soils.

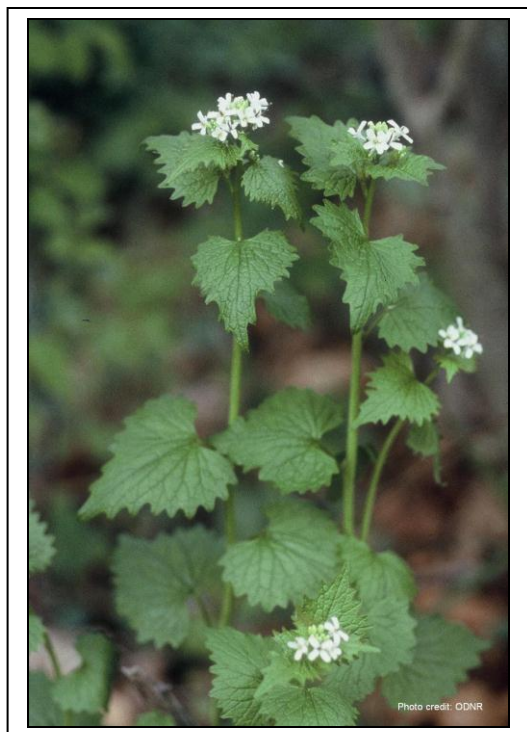
## Garlic Mustard

Garlic mustard is a biennial herb that emits a garlic-like odor from crushed leaves. In the first year, a rosette of kidney-shaped leaves hug the ground and remain green throughout the winter. Sharply-toothed, triangular leaves form on the 2-4 foot tall flower stem during the second year. White flowers with four petals bloom in clusters at the end of the stem from late April to mid June. The fruit is a long, green capsule that turns brown as the seeds mature. As the plant dies, the long, brown seed capsules at the end of a long naked stem split and release hundreds of seeds.

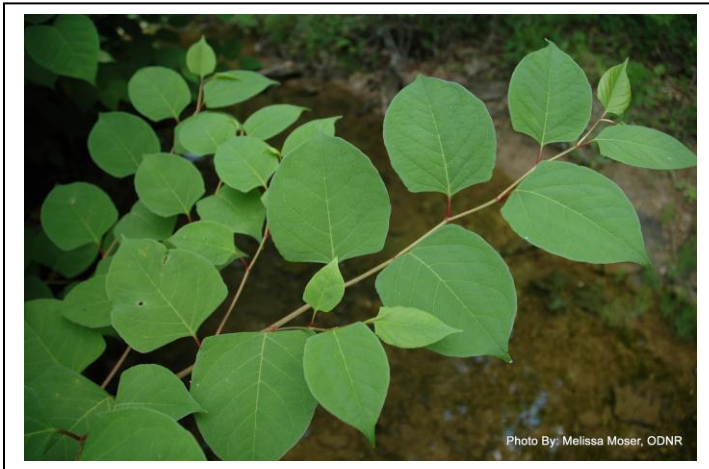
## Japanese Knotweed

Japanese knotweed is an upright, shrub-like, herbaceous perennial that can grow to over 10 feet in height. The stout, hollow stems are reddish-brown and the nodes are swollen, giving them a bamboo-like appearance. Typical of the smartweed family, nodes are enclosed by a modified leaf-like structure. Leaves are alternate and egg-shaped (4-6 inches long and 3-4 inches wide), narrowing to a point at

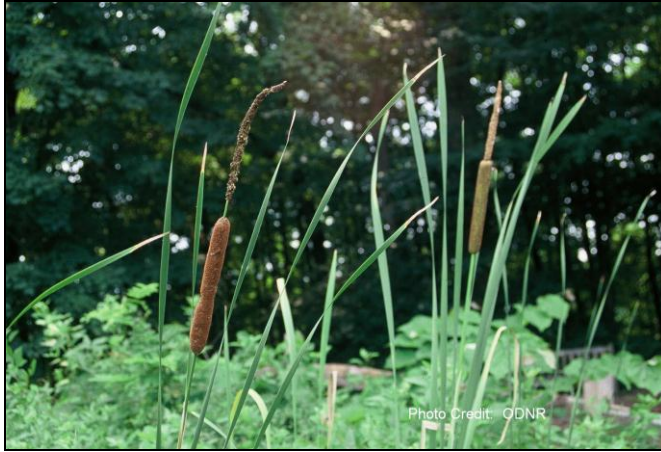
### NARROW-LEAVED CATTAIL (on left)

Narrow-leaved cattail is an introduced species which hybridizes with the native common cattail (*T. latifolia*), shown at right in the photo. The hybrid produced is also an invasive, *T. x glauca*. All three aquatic/wetland perennials may grow to a height of 10 feet and produce a velvety brown spike of flowers. The hybrid and narrow-leaved cattail flower spikes have a gap of 1 to 4 inches between the male and female flowers, while there

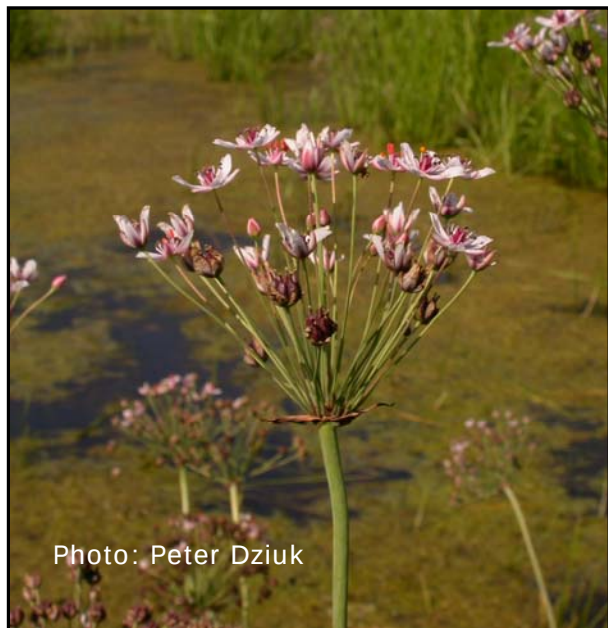
Photo: Peter Dziuk

Identification of flowering rush can be difficult, especially when the plants do not have flowers. It closely resembles many native emergent plants, such as bulrush. The emergent form of flowering rush has three-angled fleshy leaves and may produce a cluster of pink flowers (Figure above and photo below).
