MONITORING REPORT

RIVERBEND I

BUFFALO, NY
2018

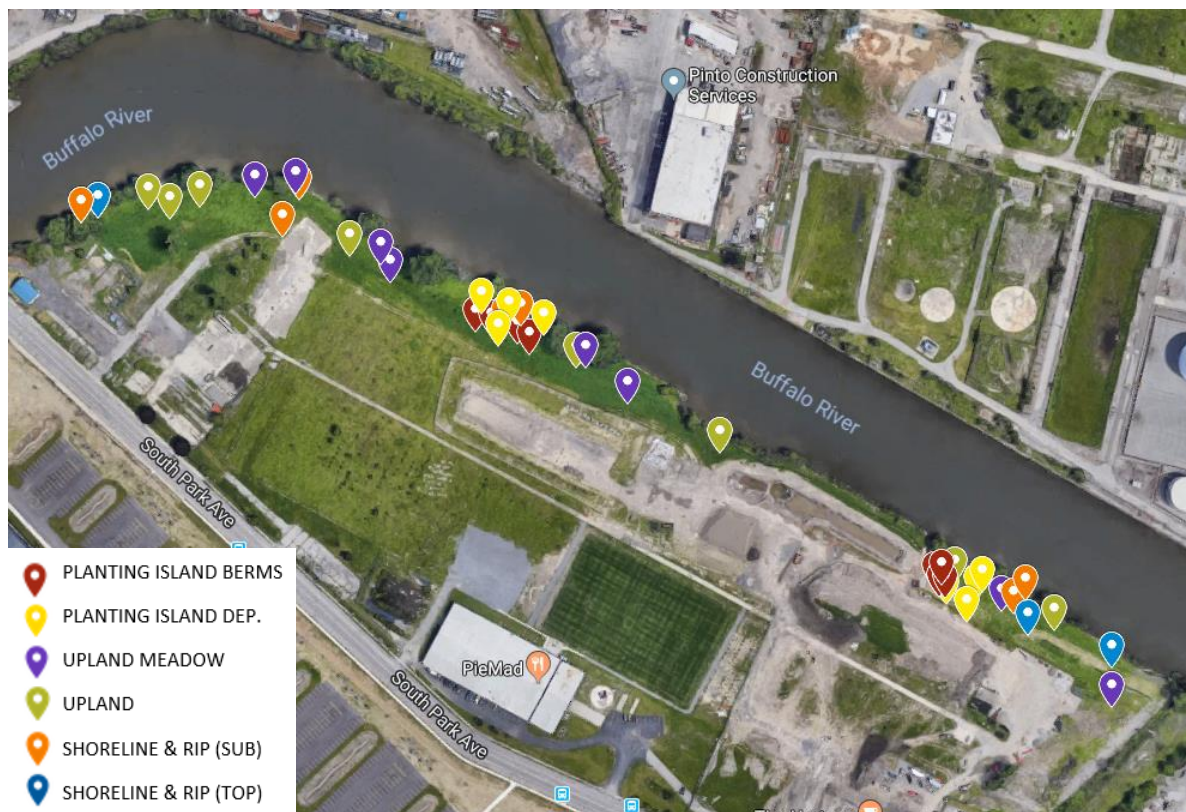
Figure 2 – 1. Riverbend I Soil Subsample GPS Locations, July

Depressions, Planting Island Berms) as seen in Appendix D. Eight subsamples were collected via randomized meander throughout each community, shown in Figure 2 - 1 and Table 2 - 1, for a total of 48 subsamples. Once gathered for a community type, the eight subsamples were mixed with a hand trowel in a large bucket until homogeneity was attained. Rocks, litter, large twigs and other debris were removed according to Agro-One instructions. De-littered and mixed composite samples were then compacted into the lab's provided sample boxes and labeled appropriately. The samples were shipped the same day via USPS Priority Mail to Agro-One Agronomy Services lab at 730 Warren Road in Ithaca, NY for testing.
