September 2018 Buffalo Motor Generator Corporation and Blue Tower Turning Basin Habitat Restoration

## Habitat Restoration Monitoring Report

Prepared for Buffalo Niagara Waterkeeper

Anchor QEA Engineering, PLLC 290 Elwood Davis Road, Suite 340 Liverpool, New York 13088

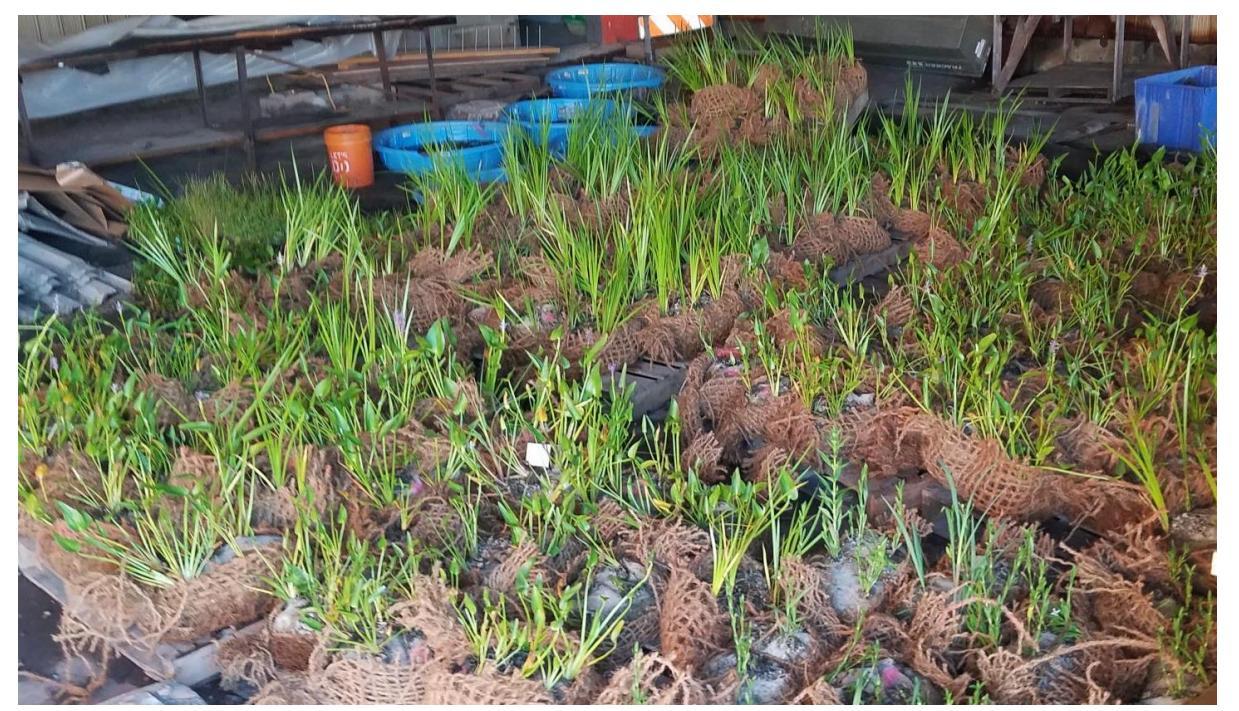
#### Figure 1 EV Rock Socks Staged Prior to Installation

areas. The rock socks were generally comprised of a bank run planting substrate with fertilizer amendment contained within a burlap sack and outer coir jute fabric. EV species were planted within the rock sock units early in the spring of 2018 and allowed to mature at Cardno's off-site nursery prior to delivery to Buffalo. Each rock sock contained approximately 4 to 6 mature plants. Figure 1 shows the rock socks being staged prior to installation.

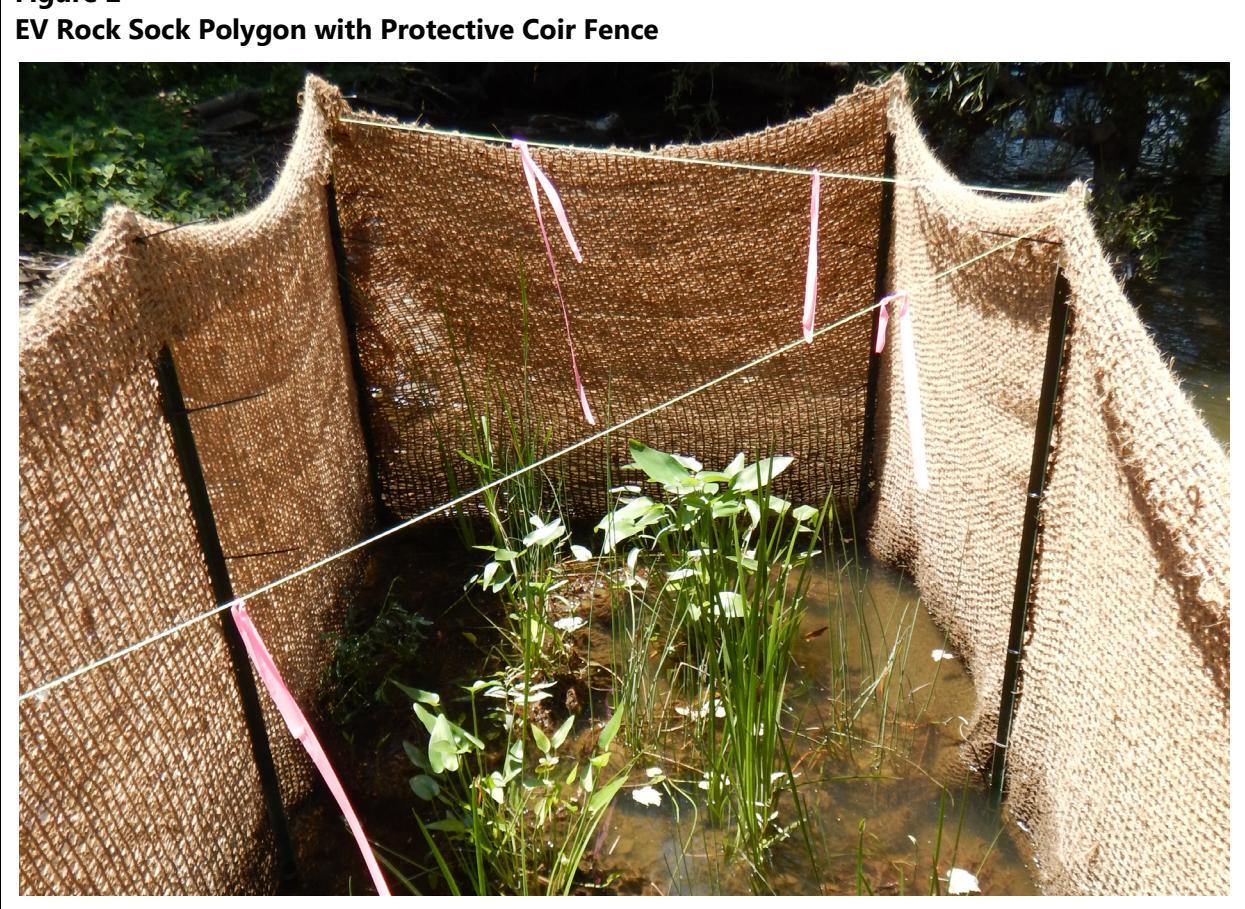
## Figure 2

A protective coir fence was constructed around the perimeter of each polygon to deflect debris and provide herbivory protection. Figure 2 shows an example of the rock sock groupings contained within the coir fabric enclosure.

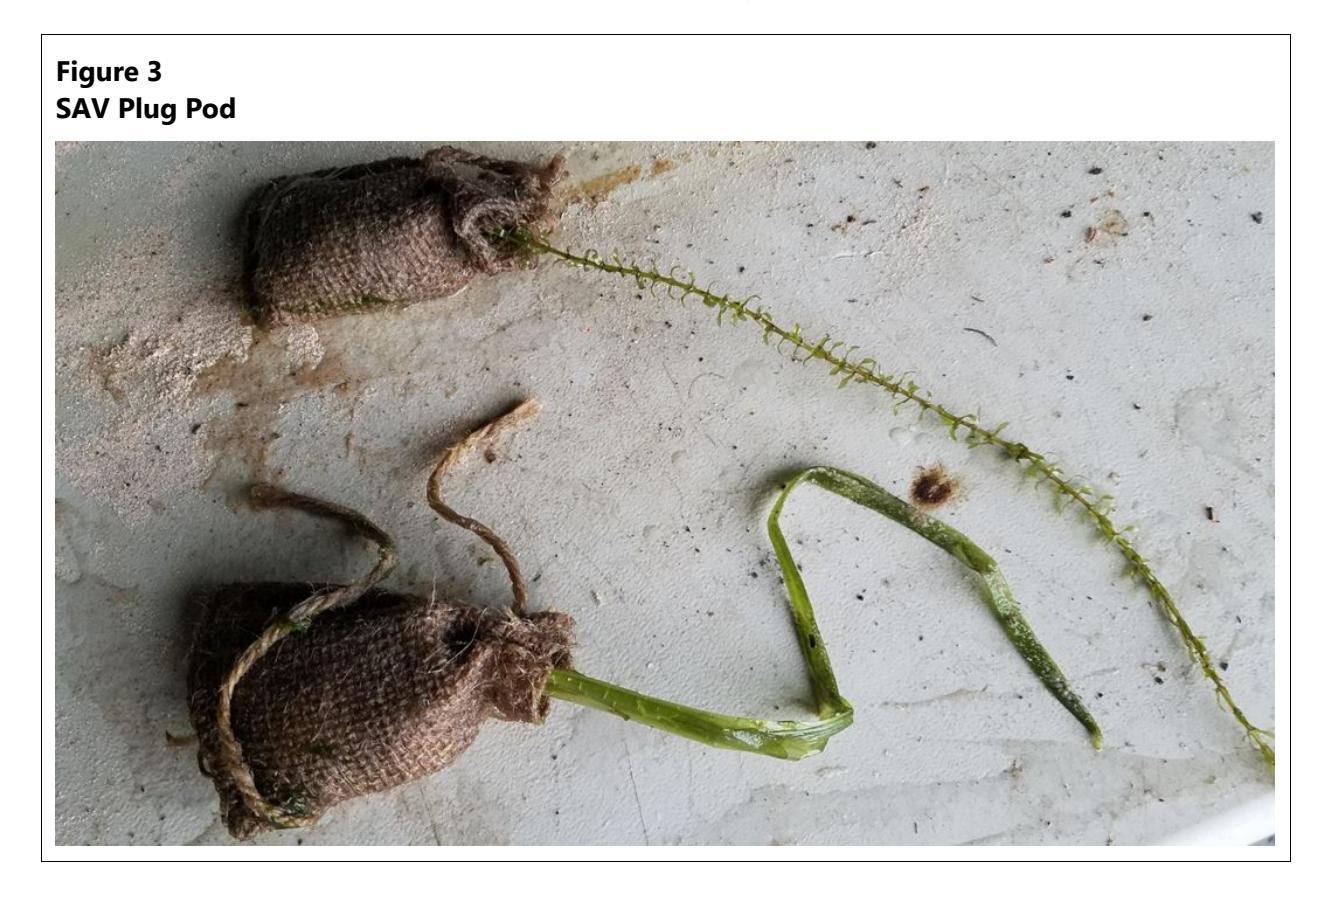
As-built figures of the SAV planting polygons, including breakdowns of SAV plants contained within each, are provided in Appendix B. Figure 3 shows the plug pods prior to installation.
