Cascade Metro Park Cuyahoga River Restoration Valley View Phase 2 (NA16NMF4630341)

Post-Construction Monitoring Report: Year 2 (2022)

January 2023

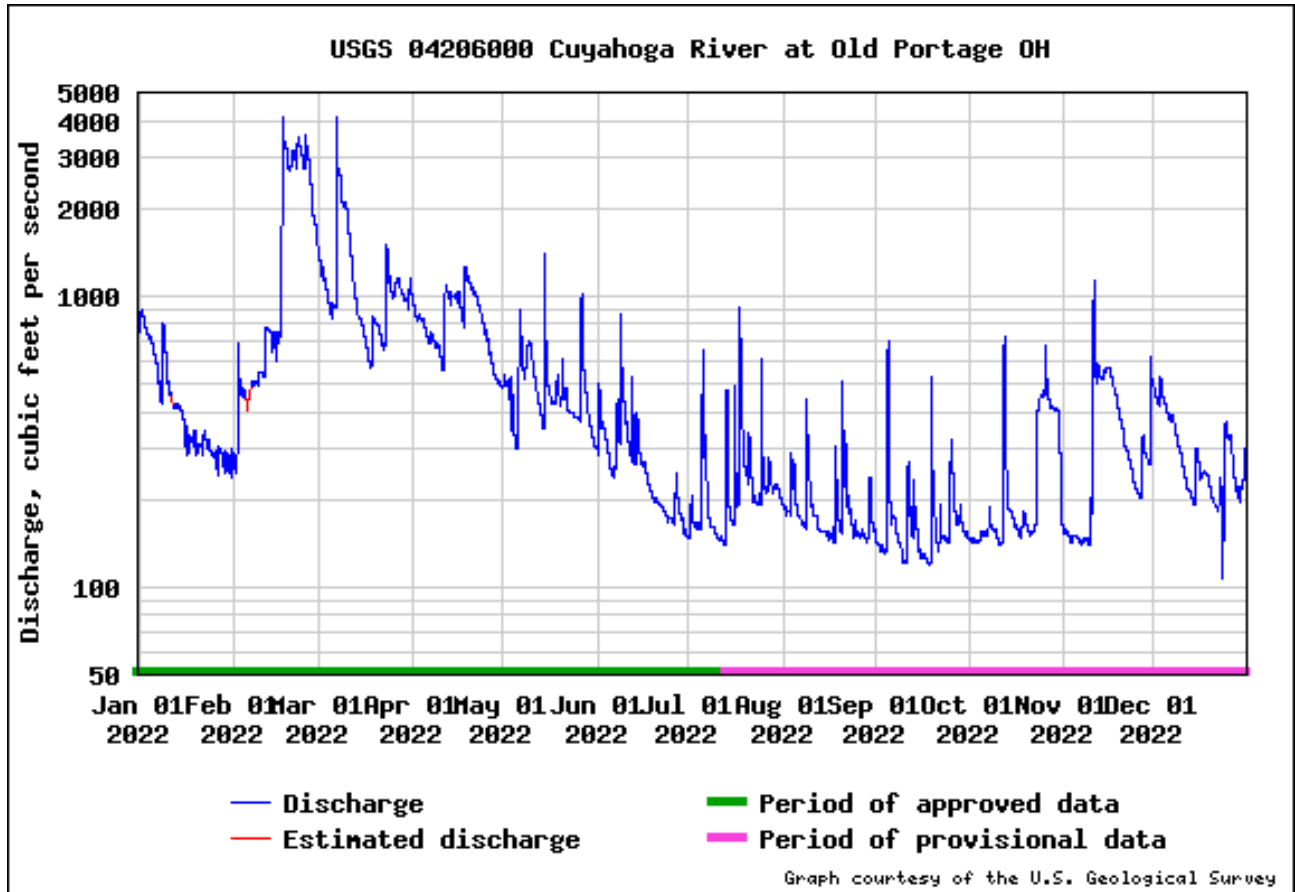
Figure 2: USGS Staff Gage at Old Portage Site, Valley View 2022

Per the Monitoring Plan, two flow meters (Intellisense Systems, Inc.) were installed at the Project site to corroborate the USGS staff gage just downstream (USGS 04206000 Cuyahoga River at Old Portage OH). Unfortunately, the monitors continue to be plagued by technical faults and the USGS gage remains the most reliable source of data.

Two major flooding events were recorded in 2022, February 18 and March 8. Photos were taken of the flooding events and the floodplain is behaving as designed and desired. Discharges above ~3,800 cubic feet per second will expand the river into the restored floodplain and potentially alleviate downstream flooding events.

Recommendations for Continued Monitoring: None. Year 3 (2023) will not have mandatory flood monitoring. Should the floodplain no longer behaves as designed, monitoring will continue.
