Monitoring Report

TOE OF KATHERINE STREET PENINSULA

Buffalo, NY

2018

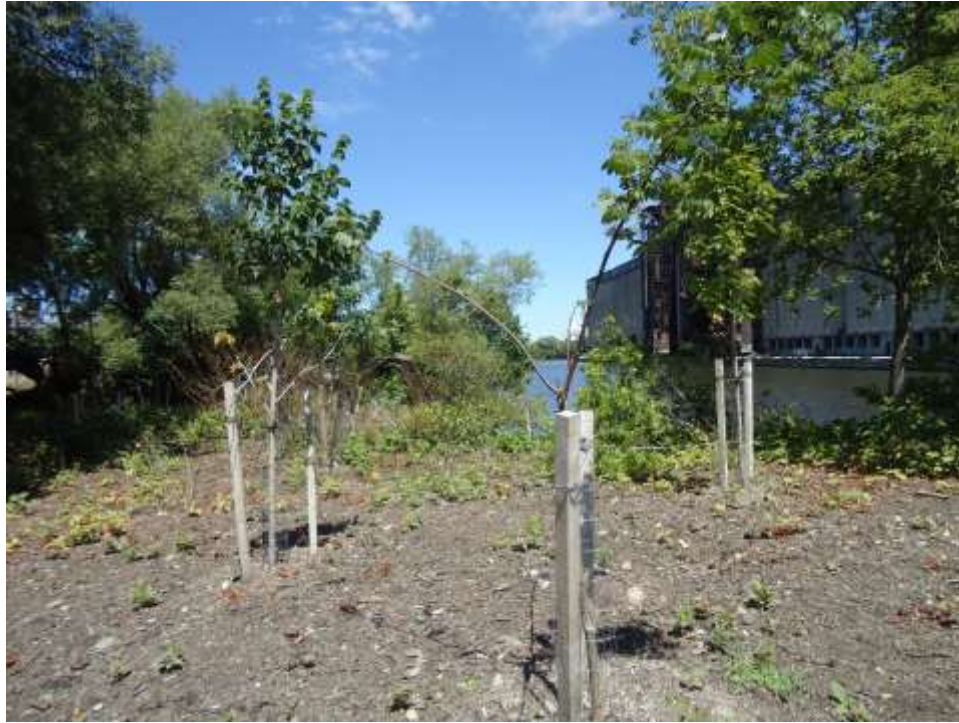
Plantings

[Table 3-1](#) shows plant composition and structure, process, and environment grading factors. Plant richness and plant community structure have improved due to plantings. Habitat improvement efforts included the installation of 1,700 native trees and shrubs composed of twenty-six species. Gomez and Sullivan found that many of the planted trees and shrubs were dead or dying, but some have survived. A staff person from the planting contractor was on site during the monitoring visit, and he was recording which installed plants needed to be replaced. [Figures 3-1](#) and [3-2](#) show examples of planted shrubs and saplings that appeared dead or dying. [Table 3-2](#) lists plant species that were observed at the site.

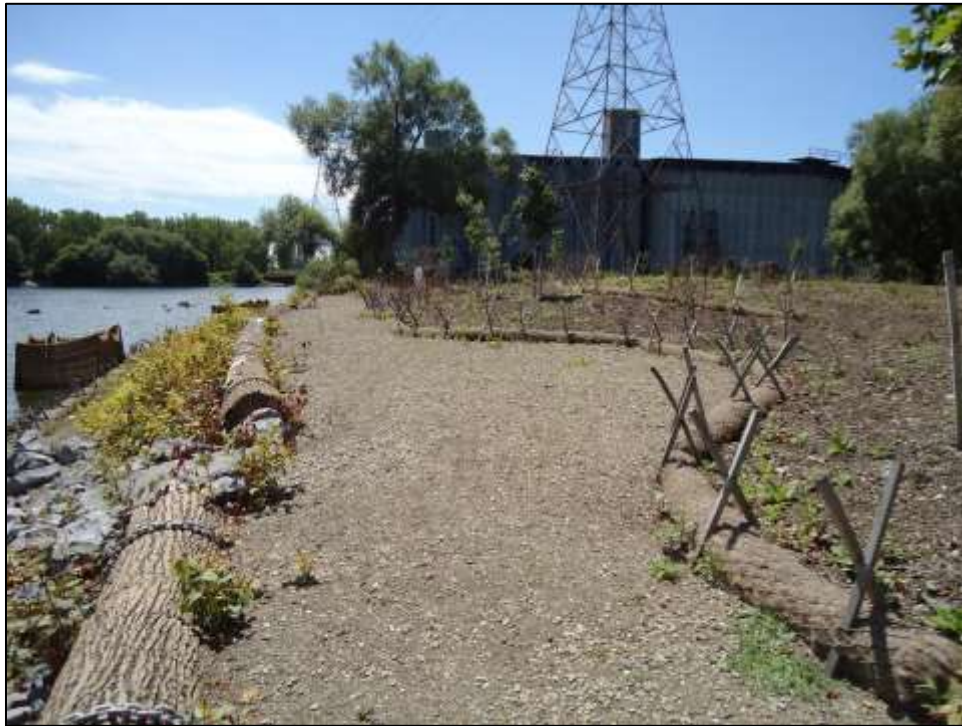
Shoreline Restoration Area

The shoreline along the Toe of Katherine Street Peninsula is stable, and erosion, classified on [Table 3-1](#) as "Lack of Erosion," improved from Low to High. This is due to regrading of the shoreline and installation tiered habitat logs and stones, which give the shoreline stability while also providing habitat and accessibility to and from the river for native animals. The habitat logs and stones all appeared to be in place and well secured and did not show signs of decay. The shoreline features complimented the emergent plantings that were installed near the site as part of a separate project. [Figure 3-3](#) shows an example of the shoreline. More photographs of the shoreline are included in [Appendix C](#). No erosion was visible at the time of monitoring.

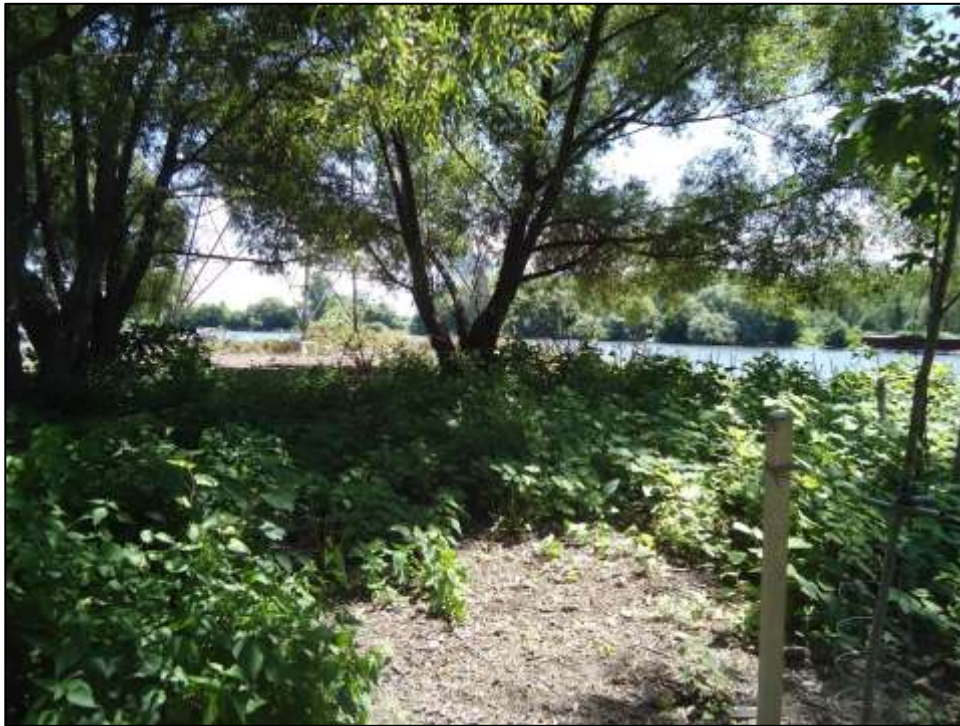
Understory regrowth dominated by invasive species

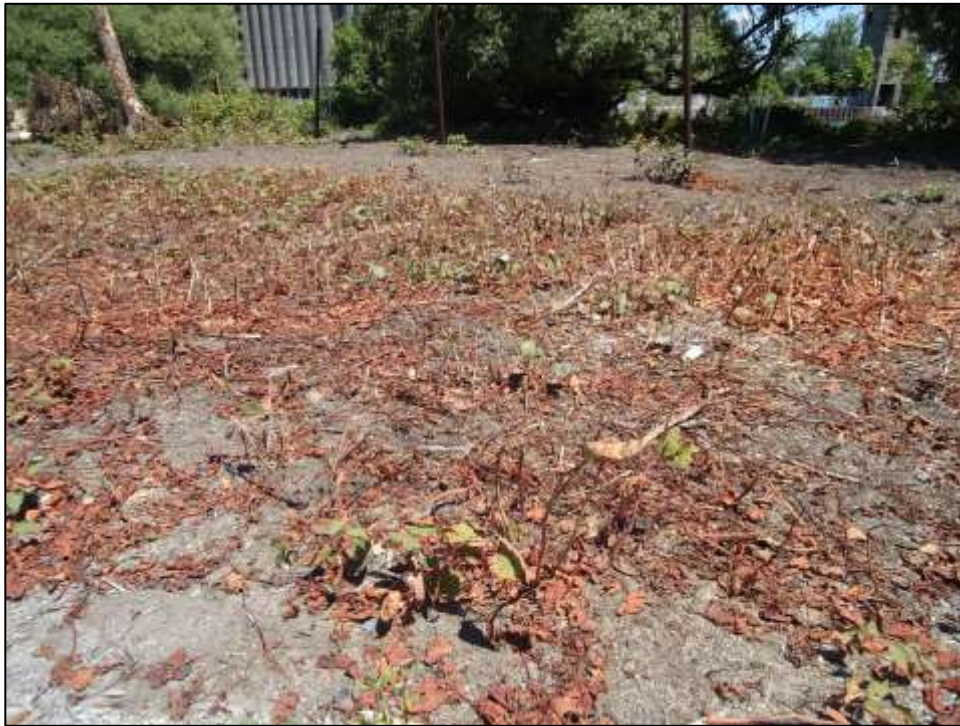
Treated knotweed in the Premier Towing Extension Area

At the time of monitoring, planting efforts had been completed in the primary project area. Invasive species treatment had taken place but additional treatments were planned for future dates. Warranty replacement plantings were expected to take place. Waterkeeper reported that additional plantings were planned for the Premier Towing extension area following invasive plant species treatments.
