## **REPORT OF GEOTECHNICAL EXPLORATION**

VALLEY VIEW AREA  
NATURAL AREA RESTORATION PROJECT

1212 CUYAHOGA STREET  
AKRON, SUMMIT COUNTY, OHIO

**STL Project No. S017506**

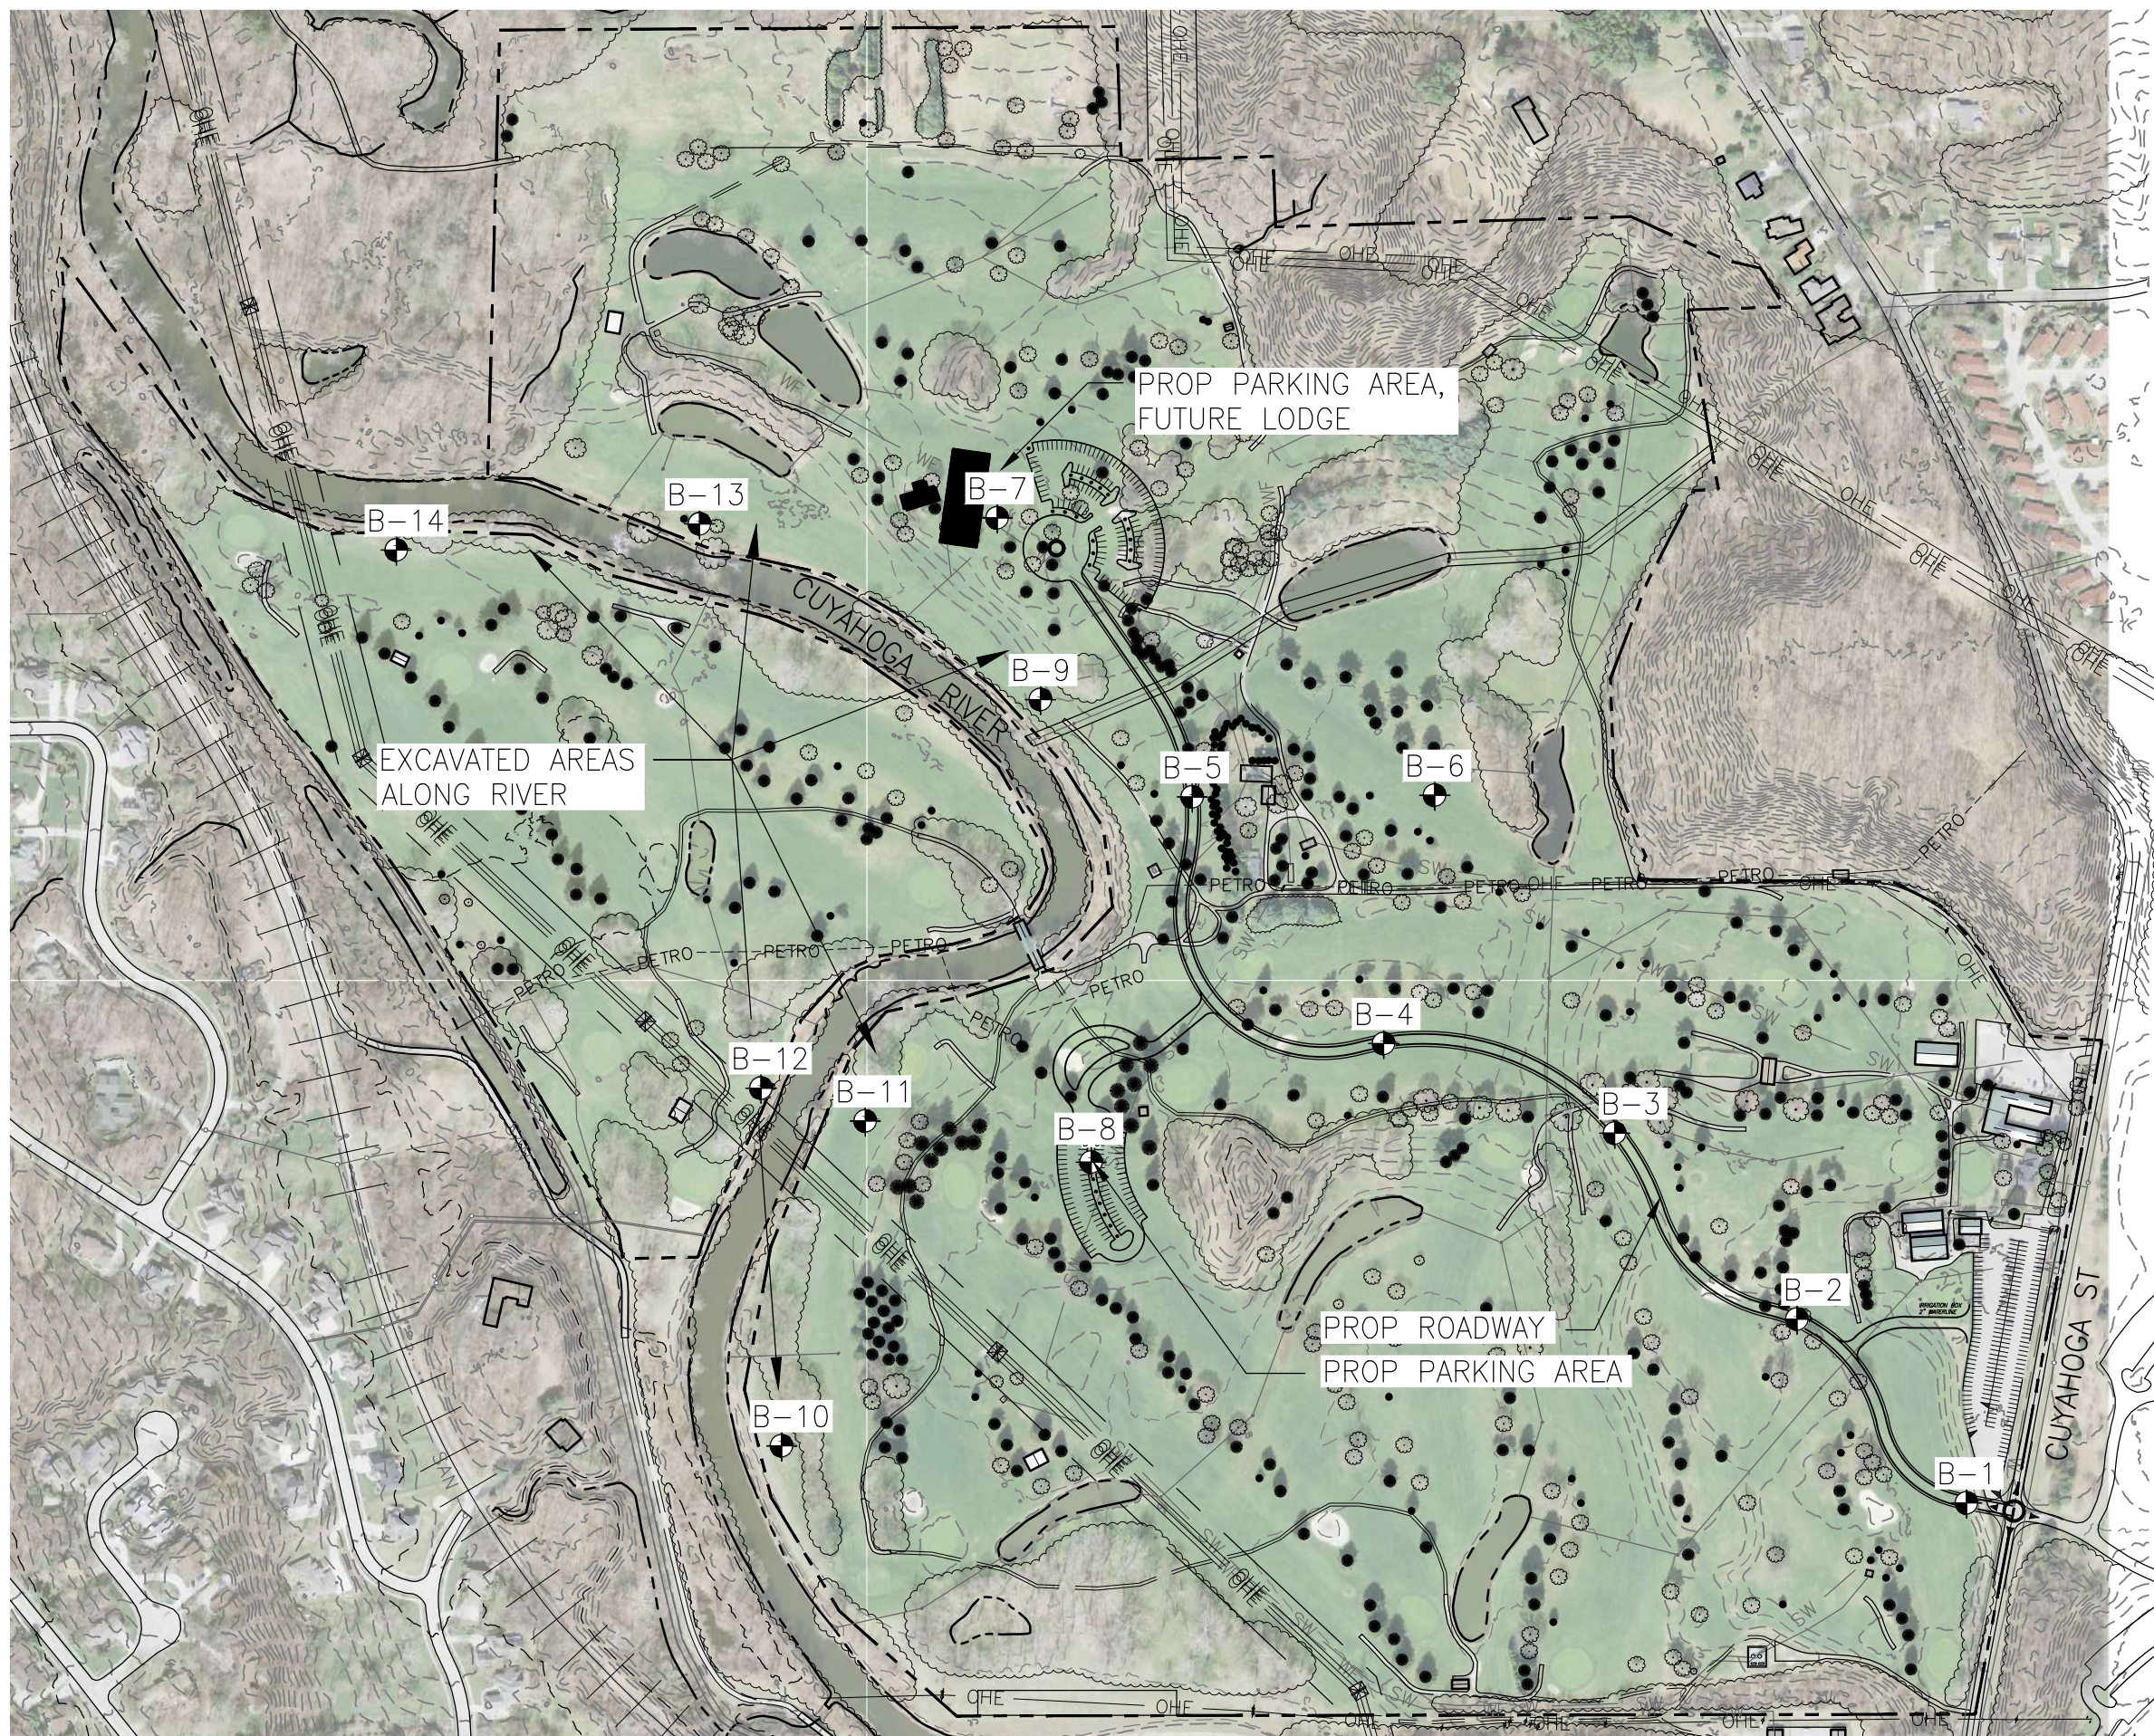
## BORING LOCATION PLAN

Valley View Area  
 Natural Area Restoration Project  
 1212 Cuyahoga Street, Akron, OH  
 STL Project No. S017506  
 September 19 to 22, 2017

The proposed entrance roadway encompasses borings B-1 through B-5 while the two parking areas are located at borings B-7 and B-8. Except for a thin layer of clayey silt immediately under the topsoil at boring B-2 and a thicker deposit of clayey silt below 5 feet at boring B-8, the subsurface throughout these borings consists of granular soil. It should be noted that the granular soil near the surface at boring B-4 was classified as ODOT A-4b soil. Settlement of granular soil is governed by immediate, elastic settlement that occurs over a relatively short time period (weeks) compared to consolidation settlement of cohesive soil that occurs over a period of months or years. Compared to consolidation settlement, elastic settlement is small and often ignored when competent SPT-N blow counts are encountered.

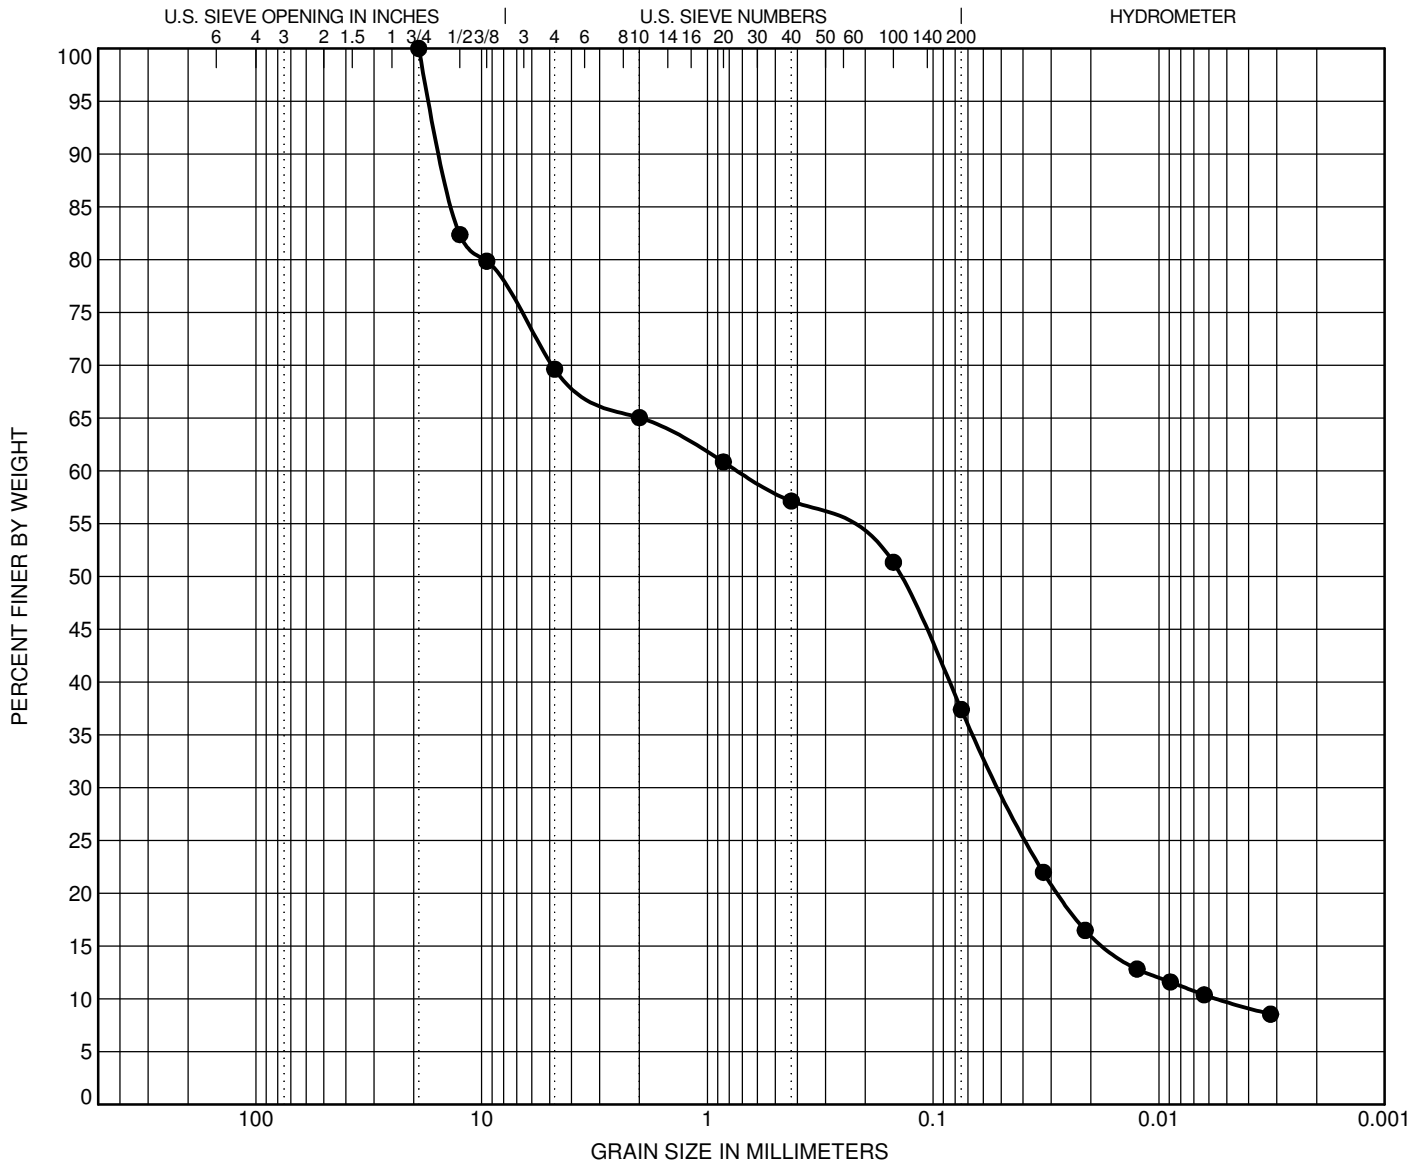
# GRAIN SIZE DISTRIBUTION TEST REPORT

| % +3" | %Gravel | %Sand | %Silt | %Clay |
| 0.0 | 35.0 | 27.6 | 27.6 | 9.8 |

| REMARKS | USCS<br>SM | AASHTO<br>A-4 |
|---|--|---|
| <p><b>PROJECT NUMBER</b> <u>S017506</u></p> <p><b>PROJECT NAME</b> <u>Valley View Area Restoration Project</u></p> <p><b>LOCATION</b> <u>B-1, 2'-4'</u></p> <p><b>DATE</b> <u>10/9/17</u></p> | <p><b>MATERIAL DESCRIPTION</b></p> <p>Medium dense to loose brown and grey <b>SILTY SAND</b> and <b>GRAVEL</b>, trace clay (A-4a).</p> | |

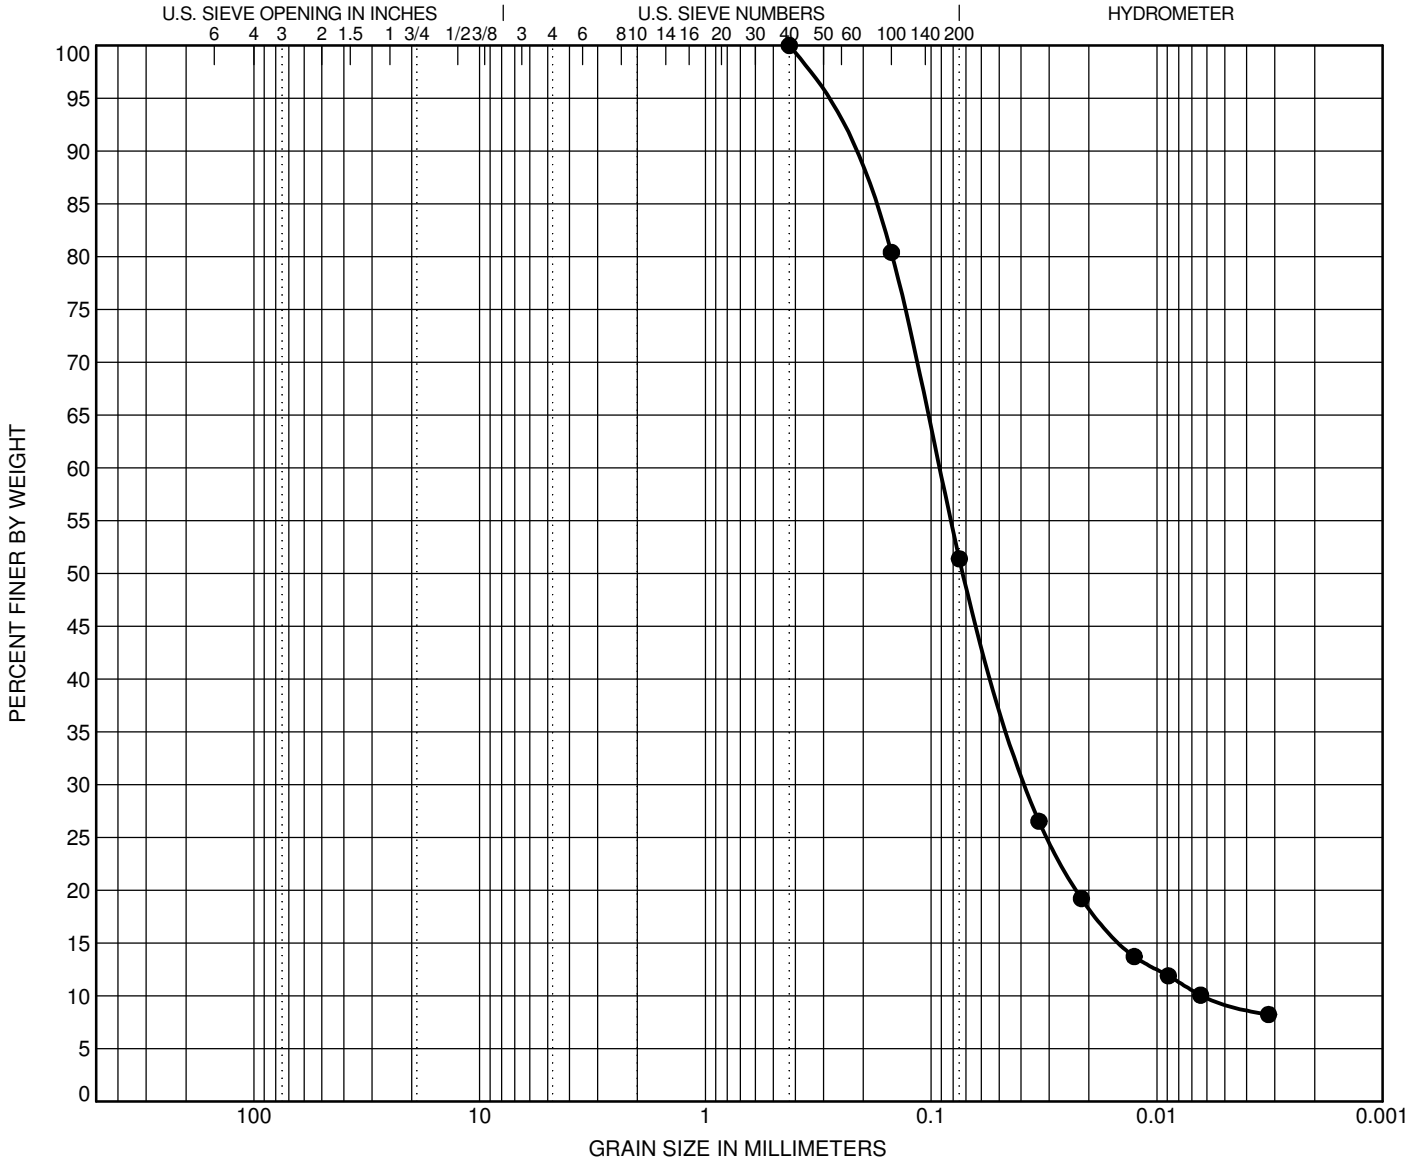
# GRAIN SIZE DISTRIBUTION TEST REPORT

| % +3" | % Gravel | % Sand | % Silt | % Clay |
| 0.0 | 0.0 | 48.6 | 42.0 | 9.4 |

| REMARKS | USCS<br>ML | AASHTO<br>A-4 |
|---|--|---|
| <p><b>PROJECT NUMBER</b> <u>S017506</u></p> <p><b>PROJECT NAME</b> <u>Valley View Area Restoration Project</u></p> <p><b>LOCATION</b> <u>B-2, 4'-6'</u></p> <p><b>DATE</b> <u>10/9/17</u></p> | <p><b>MATERIAL DESCRIPTION</b></p> <p>Loose to medium dense grey SILT and SAND, trace clay seams (A-4a).</p> | |

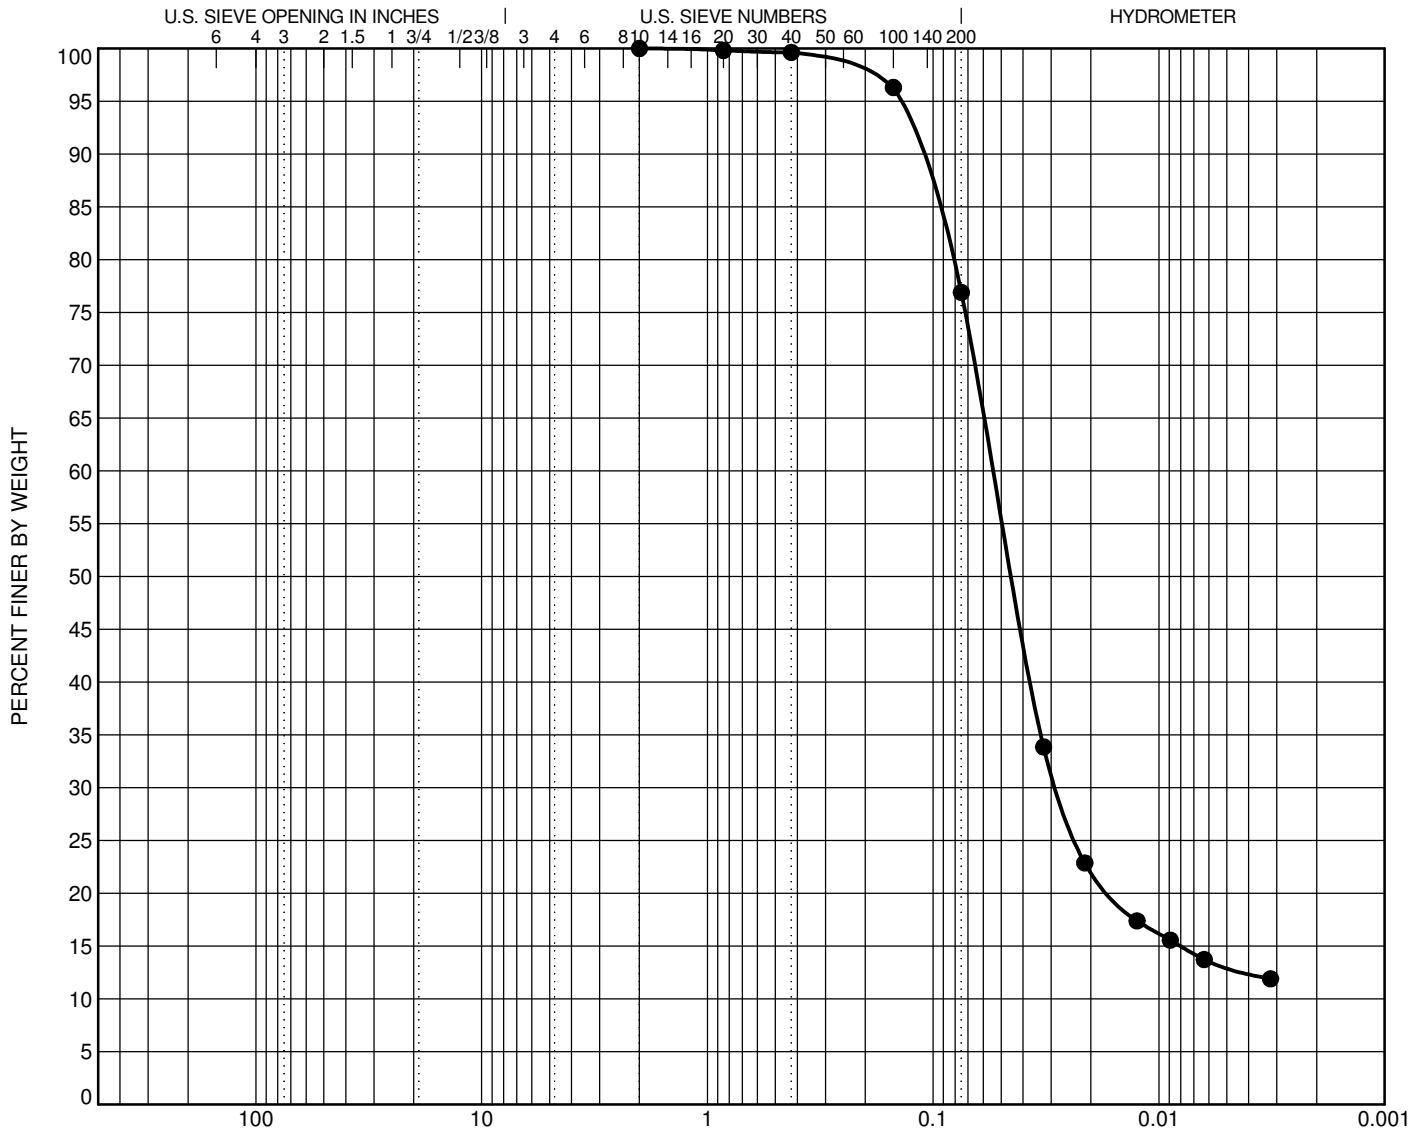
# GRAIN SIZE DISTRIBUTION TEST REPORT

| % +3" | %Gravel | %Sand | %Silt | %Clay |
| 0.0 | 0.0 | 23.1 | 63.8 | 13.1 |

| REMARKS | USCS<br>ML | AASHTO<br>A-4 |
|---|---|---|
| <p><b>PROJECT NUMBER</b> <u>S017506</u></p> <p><b>PROJECT NAME</b> <u>Valley View Area Restoration Project</u></p> <p><b>LOCATION</b> <u>B-4, 0.5'-2'</u></p> <p><b>DATE</b> <u>10/9/17</u></p> | <p><b>MATERIAL DESCRIPTION</b></p> <p>Very loose brown SILT, some sand, little clay (A-4b).</p> | |

Only near the surface of borings B-3 and B-4 are there SPT-N blow counts less than 5 for granular soil, which can be classified as “very loose.” However, we recommend that all subgrade under the new roadway and parking areas be compacted with a vibratory roller before any fill material or the pavement section is placed. The vibratory roller should densify the granular soil and lead to even smaller magnitudes of immediate, elastic settlement after any fill material is placed. It should be noted that the ODOT A-4b soil at boring B-4 may prove difficult to compact with a vibratory roller because of its high silt content. Other pockets of such soil likely exist across the project site. If soil breakdown occurs during vibratory compaction or fill placement due to high silt content, this subgrade may need undercut and replaced with engineered fill that is not ODOT A-4b soil.

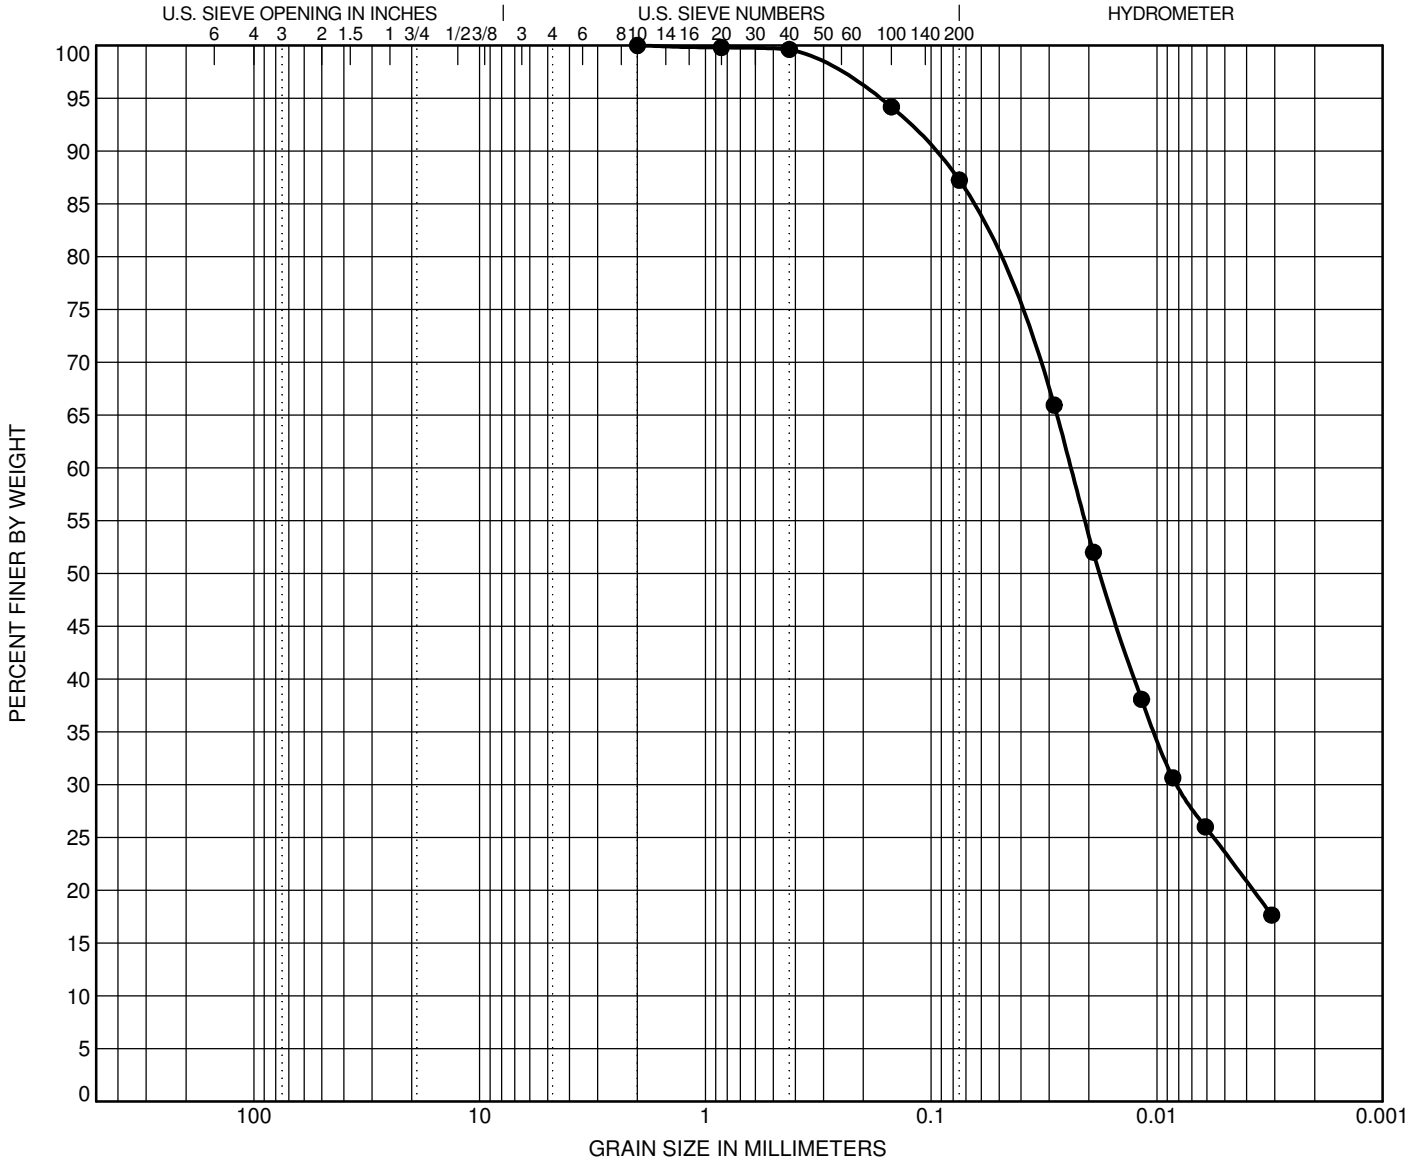
# GRAIN SIZE DISTRIBUTION TEST REPORT

| % +3" | %Gravel | %Sand | %Silt | %Clay |
| 0.0 | 0.0 | 12.8 | 63.7 | 23.5 |

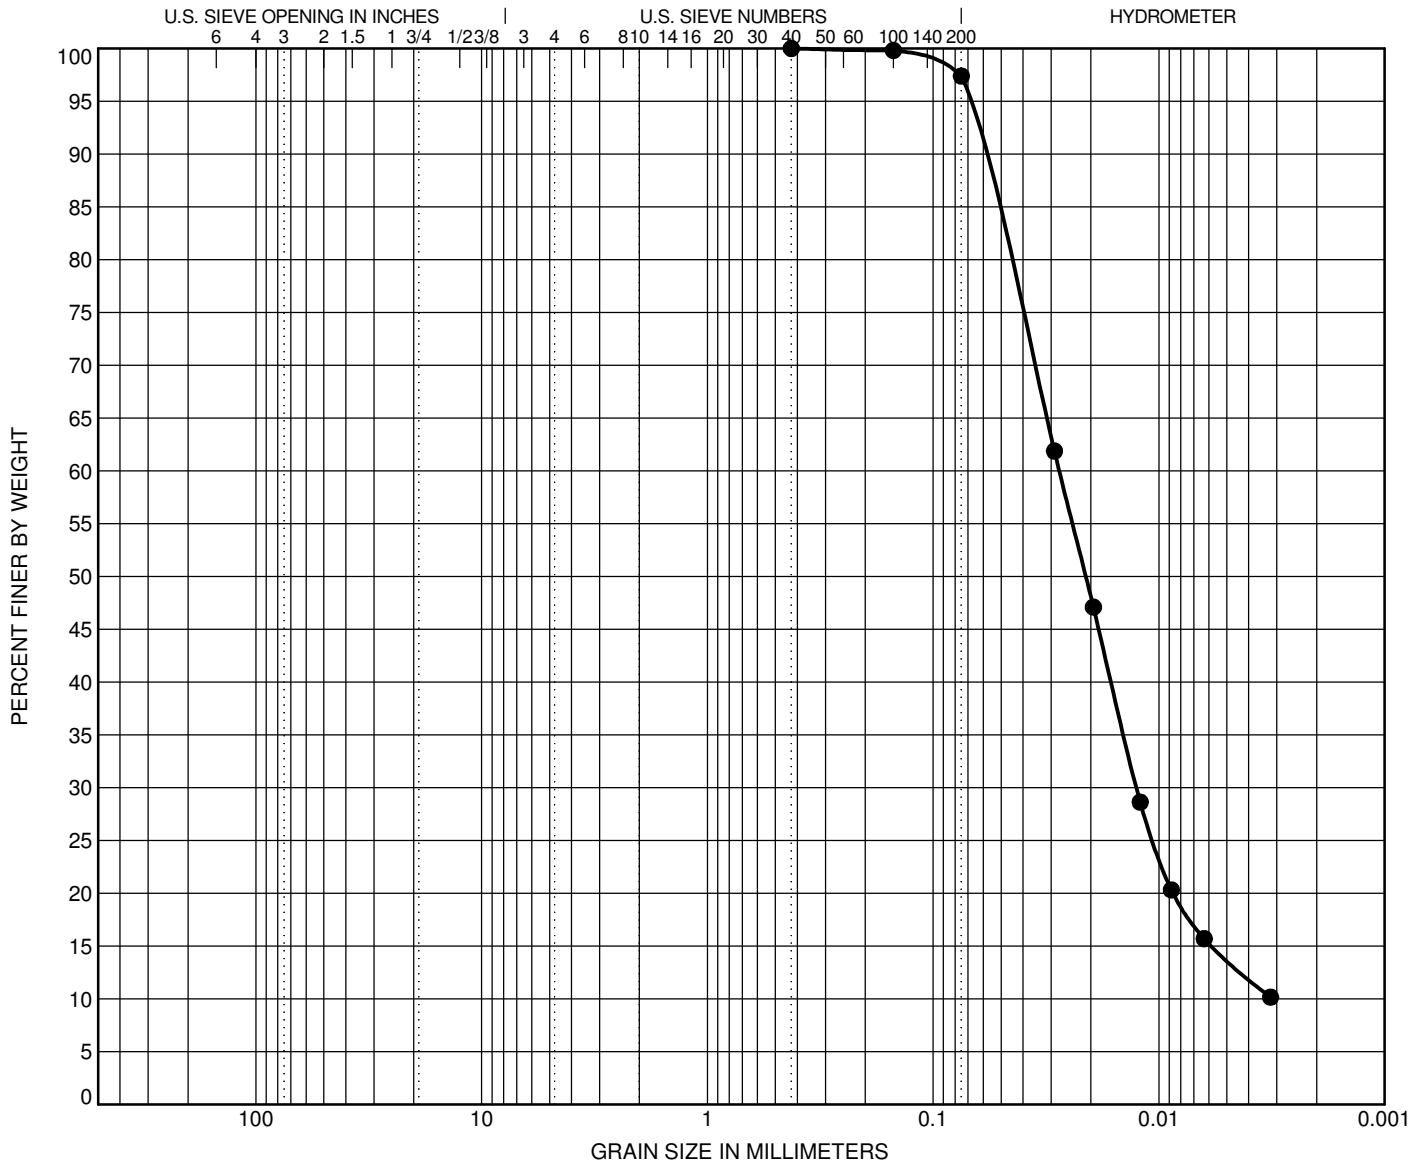
# GRAIN SIZE DISTRIBUTION TEST REPORT

| % +3" | % Gravel | % Sand | % Silt | % Clay |
| 0.0 | 0.0 | 2.6 | 83.6 | 13.8 |

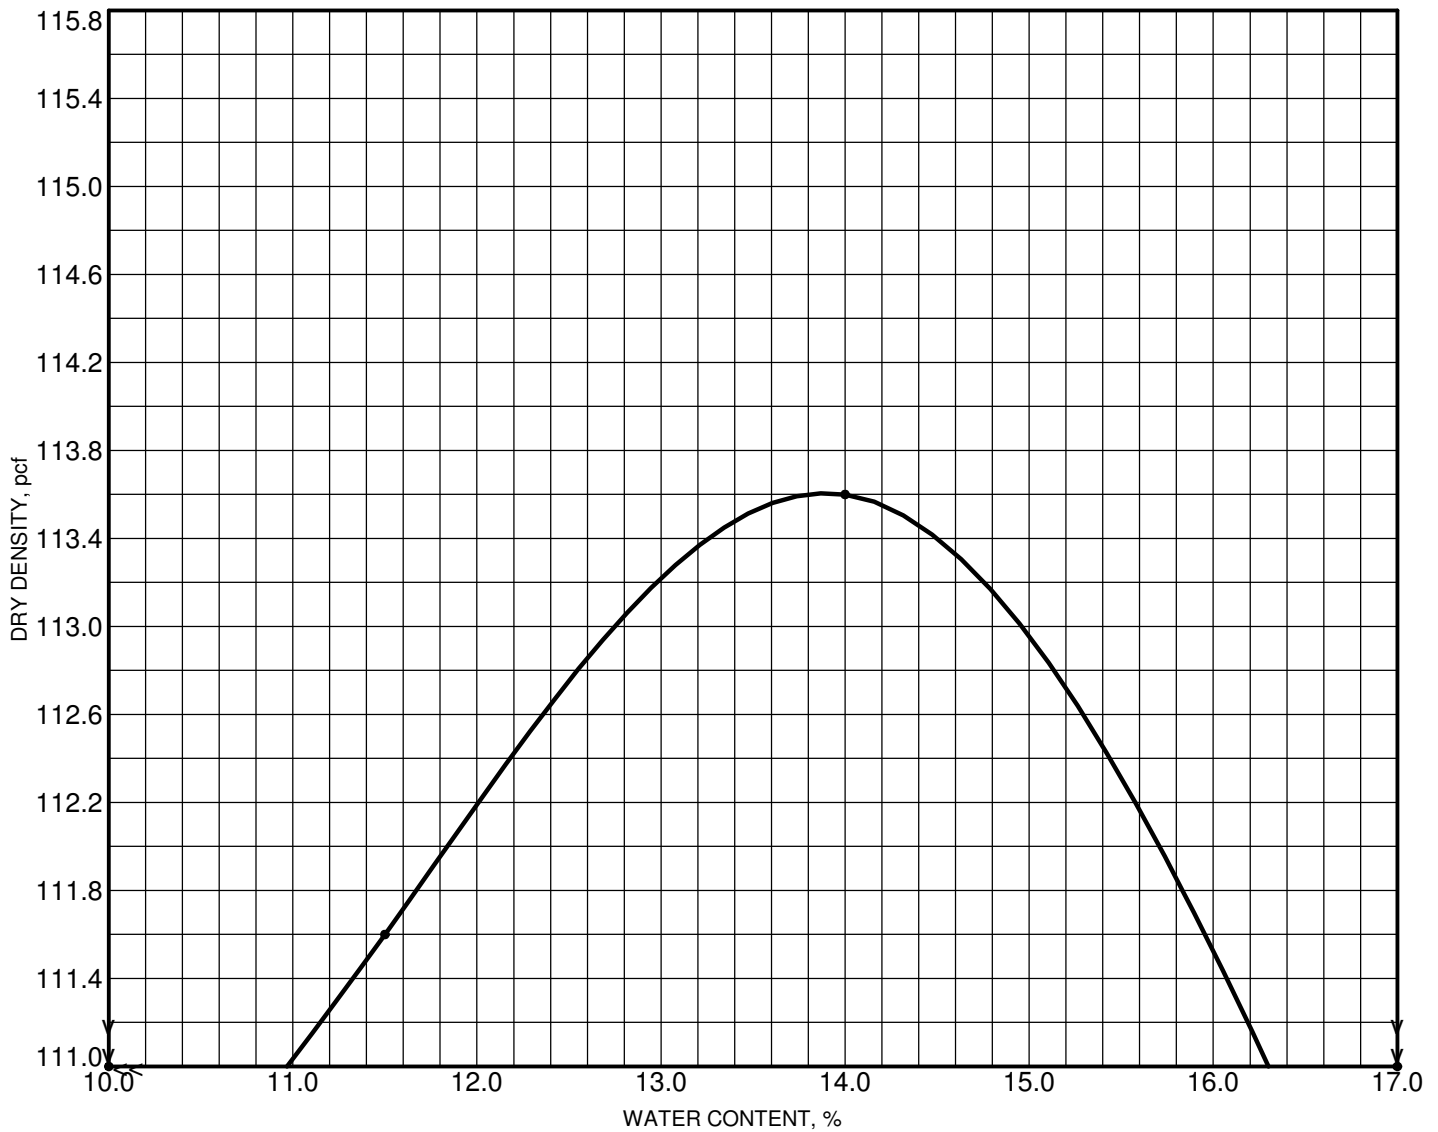
# MOISTURE-DENSITY RELATIONSHIP TEST

Test Specification

**ASTM D698 Method B**

| CLASSIFICATION | | Nat. Moist | Sp. G. | LL | PI | % > 3/4 in | % < No.200 |

2. Excavated, clean materials at the proposed site should be conditioned to their optimum moisture content as determined by the Standard Proctor Test. Standard Proctor Tests should be completed on representative samples of the designated fill materials a few days before construction begins. During construction, care should be taken that the fill materials placed correspond to the samples on which Standard Proctor Tests were performed.

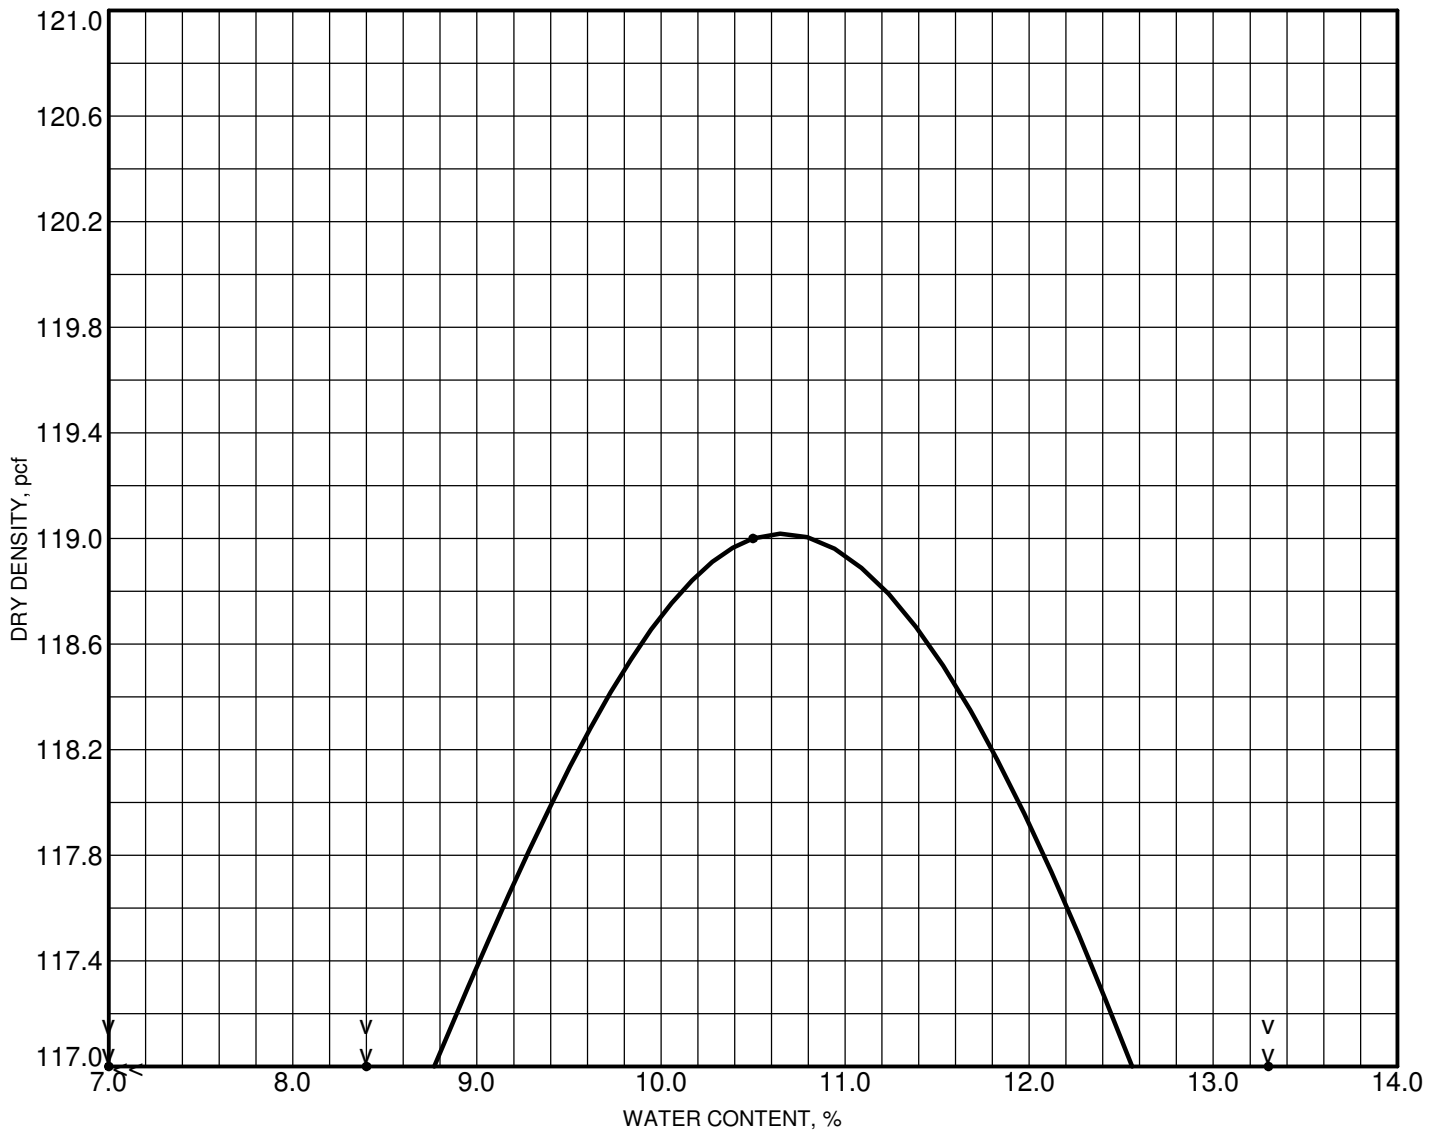
# MOISTURE-DENSITY RELATIONSHIP TEST

Test Specification

**ASTM D698 Method B**

| CLASSIFICATION | | Nat. Moist | Sp. G. | LL | PI | % > 3/4 in | % < No.200 |
| Maximum Dry Density <u>119.1 PCF</u><br>Optimum Water Content <u>10.6 %</u> | | Very loose to medium dense brown and grey <b>COARSE SAND</b> , little gravel. | | | | | |

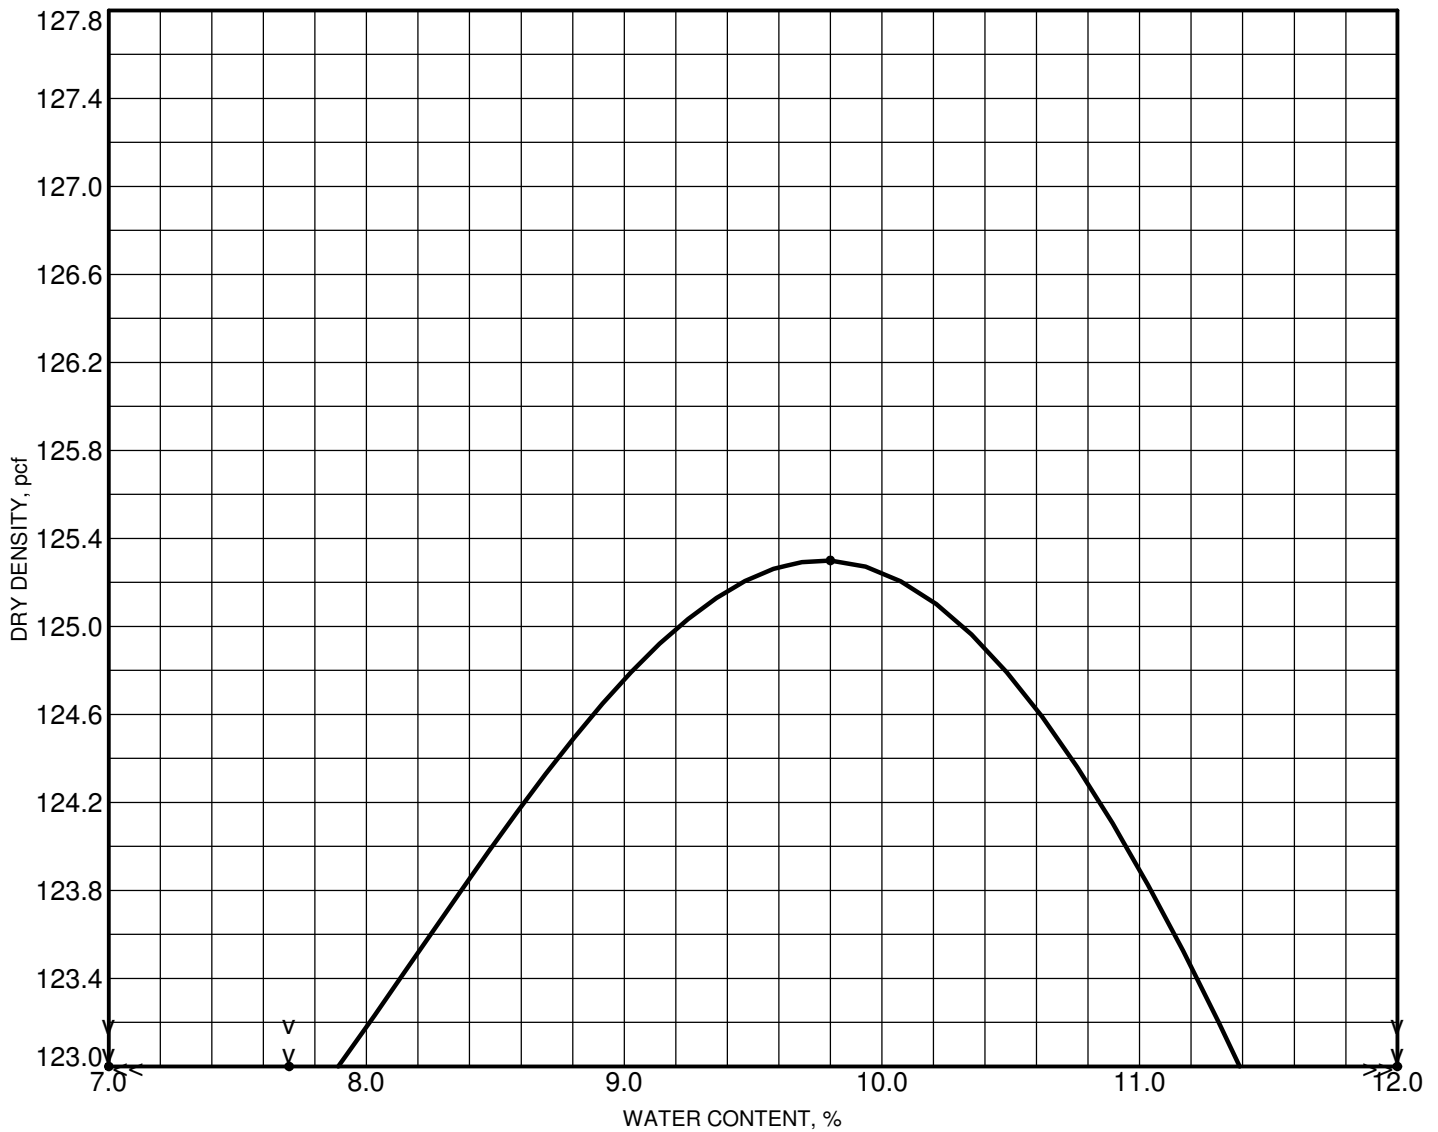
# MOISTURE-DENSITY RELATIONSHIP TEST

Test Specification

**ASTM D698 Method B**

| CLASSIFICATION | | Nat. Moist | Sp. G. | LL | PI | % > 3/4 in | % < No.200 |
| Maximum Dry Density | <u>125.3</u> PCF | Loose to medium dense brown COARSE SAND, little gravel. | | | | | |
